Title: Building Condition Reports 2017

Meeting and Date: Administration Committee - September 20, 2017

Synopsis: Discussion of the Preliminary Reports from the Building Condition Survey that
EMG performed on City-owned structures and facilities.

FACILITY CONDITION ASSESSMENT

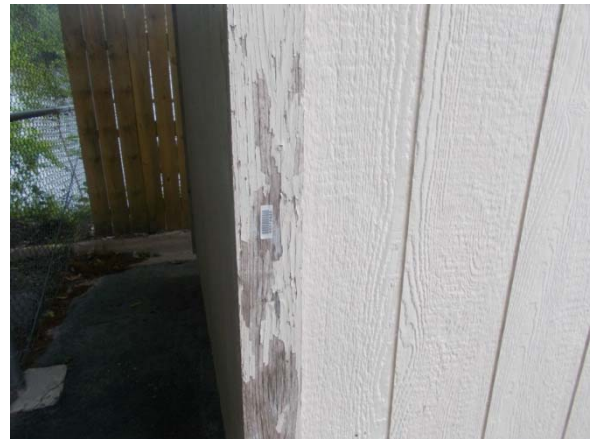
PHOTO #13: SHED PAINT DETAIL
