Title: Old Jail Demolition and Site Restoration RFP results

Re: 111 W. Madison St., Yorkville, IL
Hutter Trankina # 18496

Per your request, I visited the above referenced site. The purpose of the visit was to perform a general, visual observation of the structure. The project is composed of 2 structures: the original historic jail/sheriff's house and a 1980's garage/office addition. Both structures are built of conventional timber framing with the exception of the jail area. The inmate housing is built of concrete and steel. The majority of the structure was covered by finishes with the exception of the basement and a few drywall holes in the attic framing.

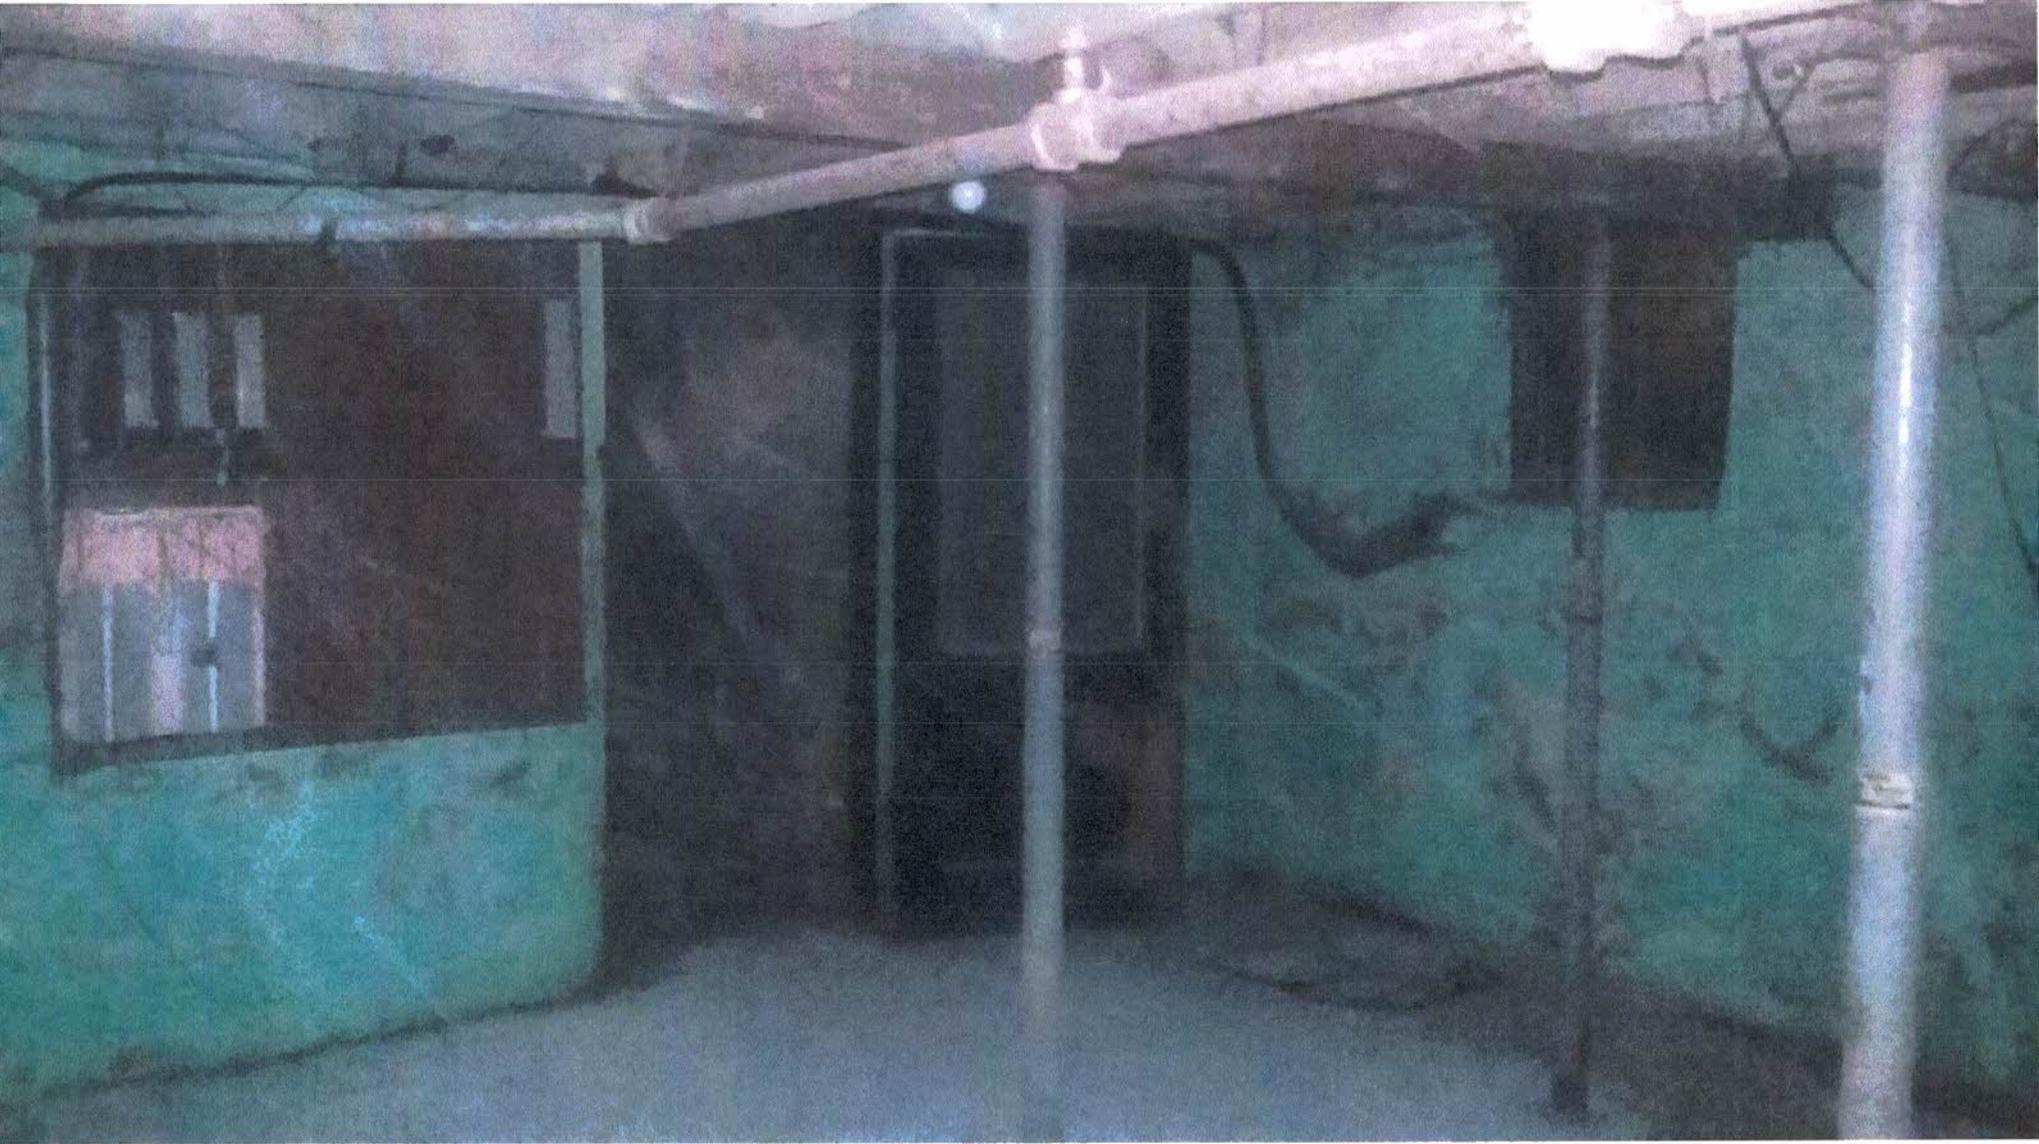
Within the basement, there are numerous temporary columns added, along with undersized beams (see picture #1). A more sizable and permanent structure is required. W8 steel beams, 3" pipe columns and individual spread footings would have to replace all the temporary structures.

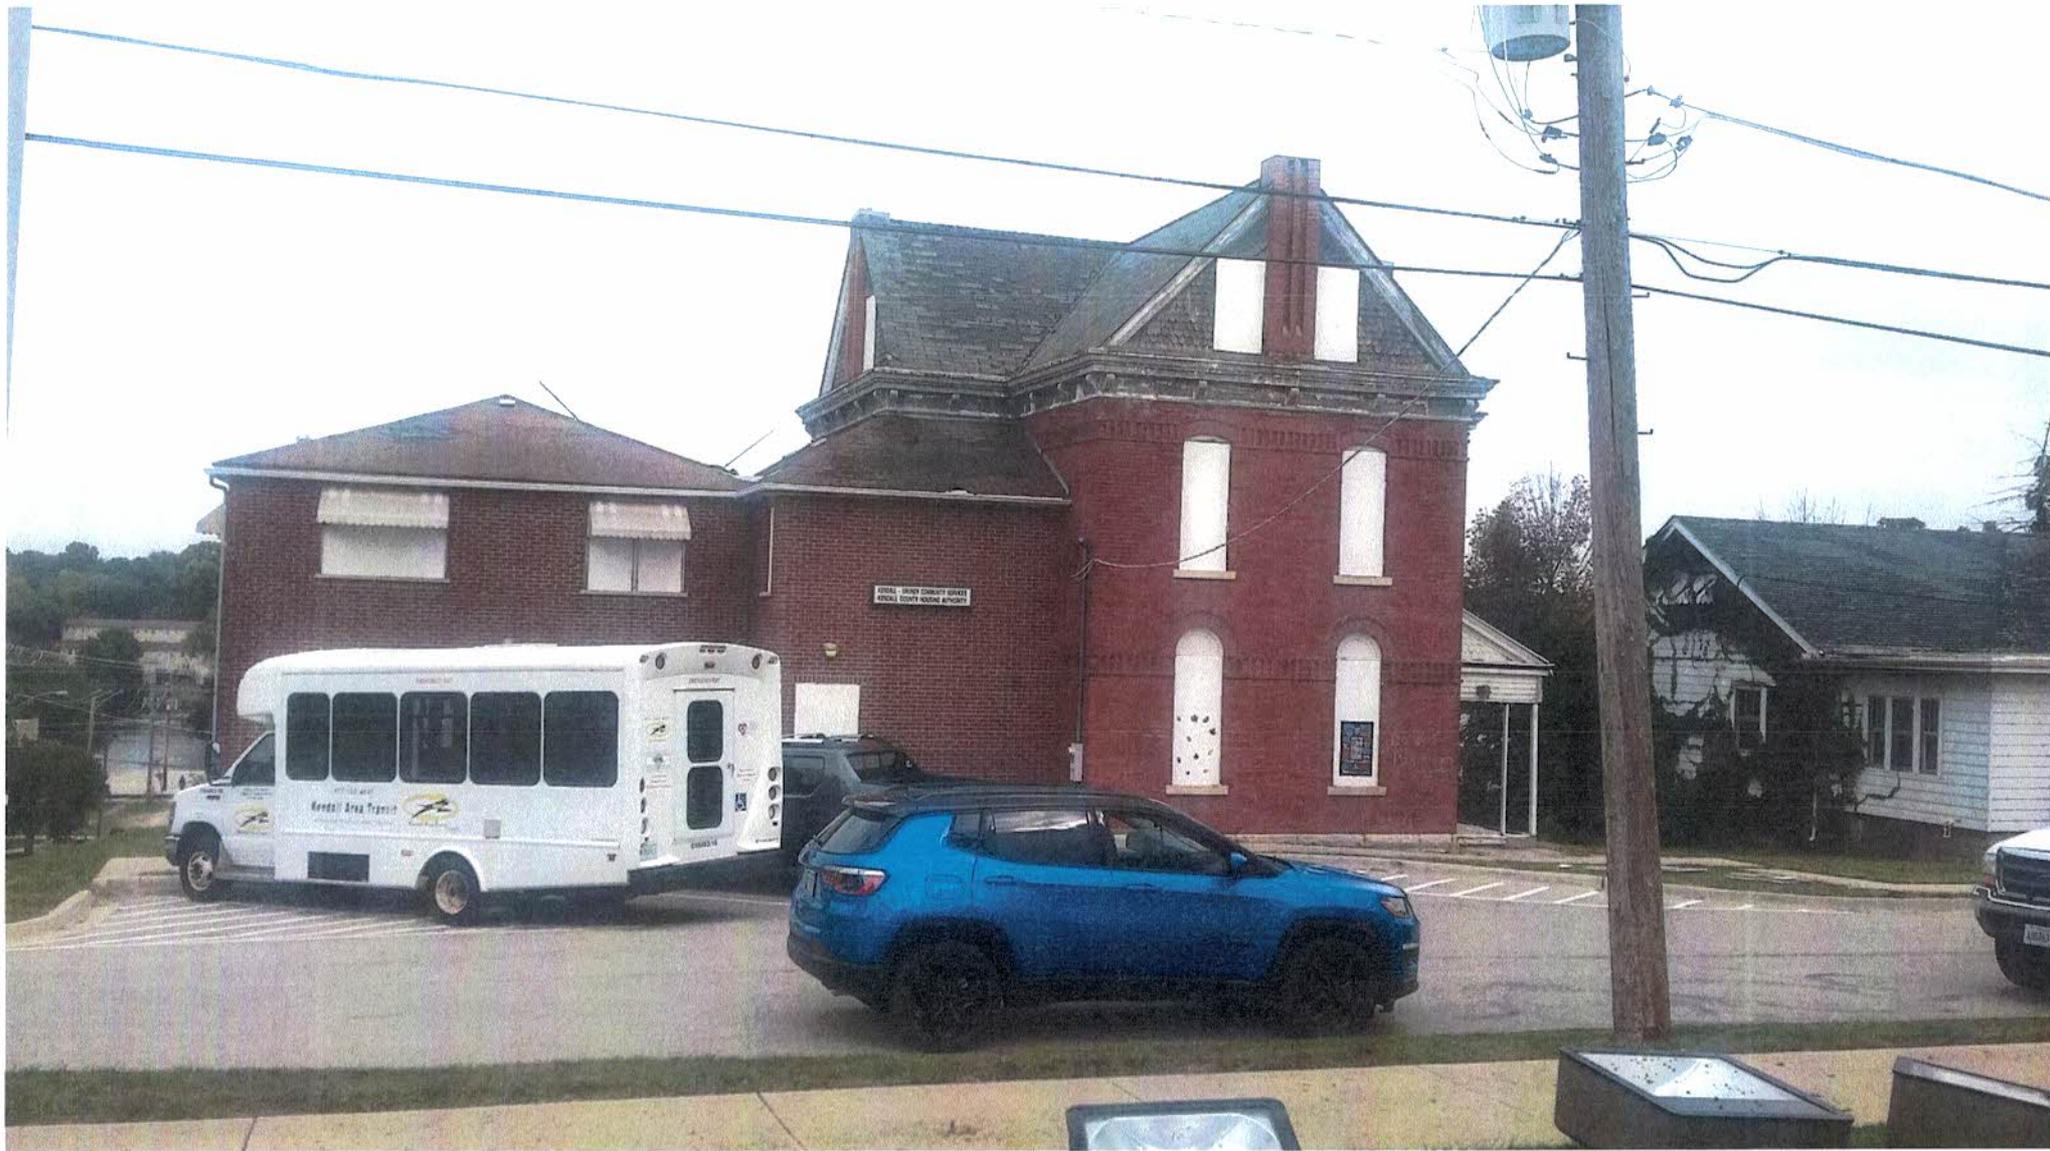
The exterior wood framing has extensive water damage/rot and is in need of replacement (picture #2). Most of this exterior framing is decorative in nature. This framing includes windows, roof overhangs, and porches to name a few.
