Yorkville Municipal Facility Condition Assessment Review

Report #003

- Historic Jail
- 111 West Madison Street

- Beecher Concession Stand
- 908 Game Farm Road

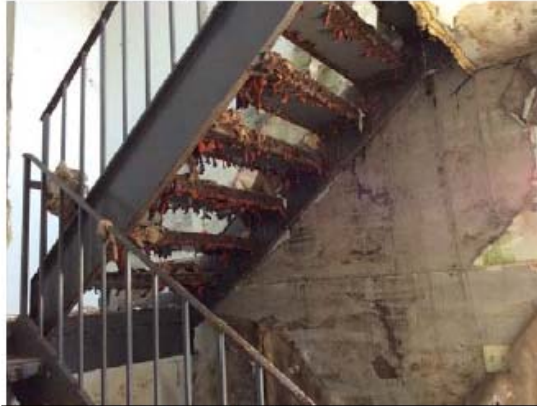
PHOTO #37: SOUTH STAIRS

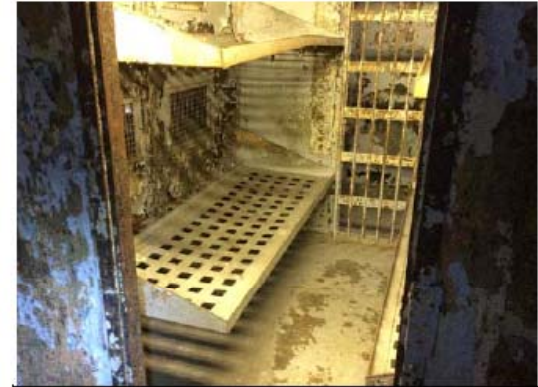
PHOTO #34: CELL INTERIOR

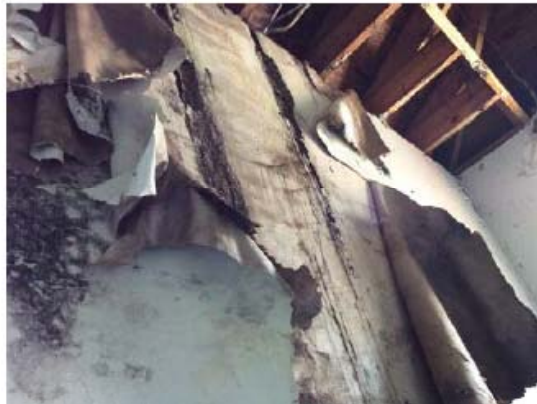
PHOTO #39: WATER DAMAGE

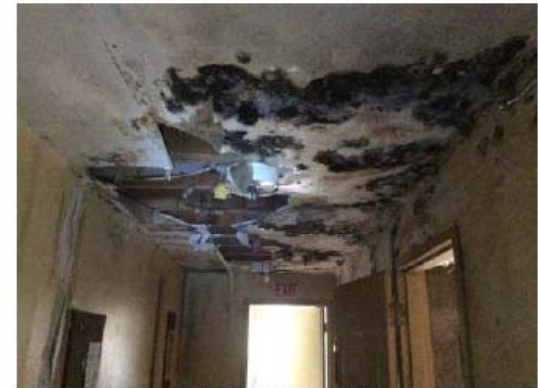
PHOTO #36: WATER DAMAGE, CENTRAL HALLWAY

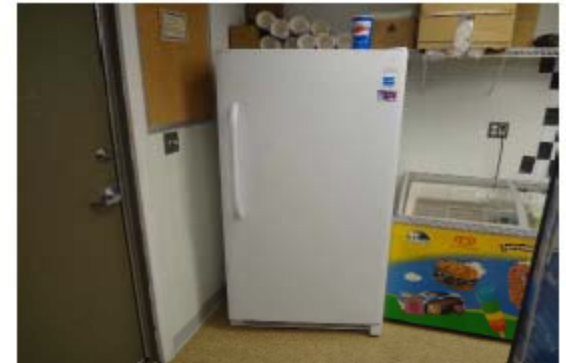
#31: RESIDENTIAL APPLIANCES,
REFRIGERATOR

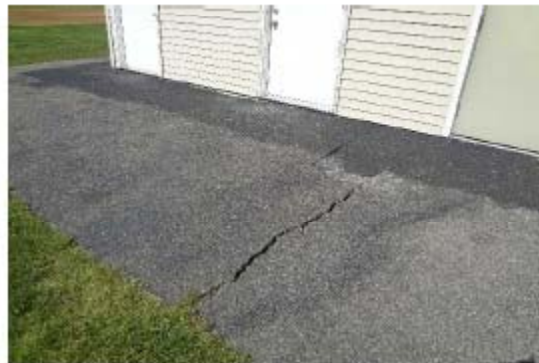
#6: PEDESTRIAN PAVEMENT,
SIDEWALK, CRACKING

Location Name	EMG Renamed Item NumberID	Cost Description	Quantity	Unit	Unit Cost	Subtotal	Deficiency Repair Estimate *
Beecher Concession Stand	3.1	611358 ADA, Door, Lever Handle Hardware, Install	2	EA	\$202.40	\$405	\$405
Beecher Concession Stand	5.2	611442 Pedestrian Pavement, Sidewalk, Asphalt, Repair	100	SF	\$1.60	\$160	\$160
Immediate Repairs Total							\$565

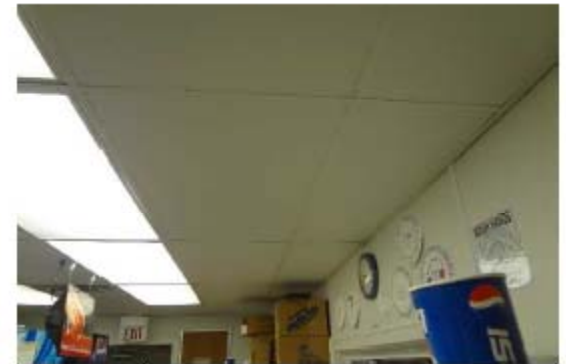
#33: INTERIOR CEILING FINISH,
ACOUSTICAL TILE (ACT)
