FACILITY CONDITION ASSESSMENT

Park & Rec Office
201 West Hydraulic Avenue
Yorkville, Illinois 60560

June 30, 2017

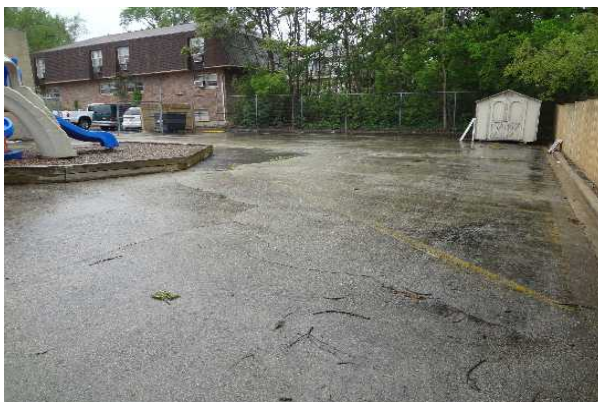
#5: PARKING LOTS, ASPHALT PAVEMENT

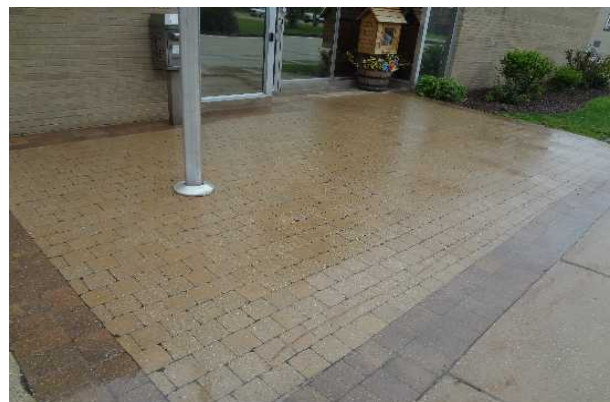
#6: SIDEWALK, CLAY BRICK/MASONRY PAVERS

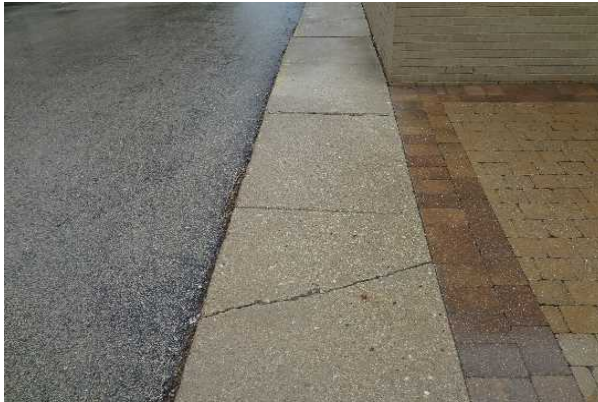
#7:

PEDESTRIAN PAVEMENT,
SIDEWALK, CONCRETE

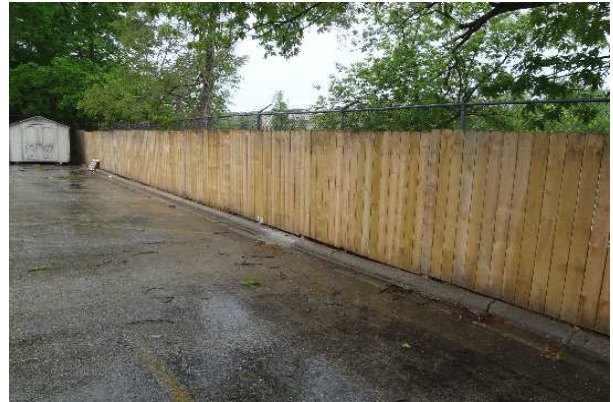
#8:

FENCES & GATES, WOOD
BOARD

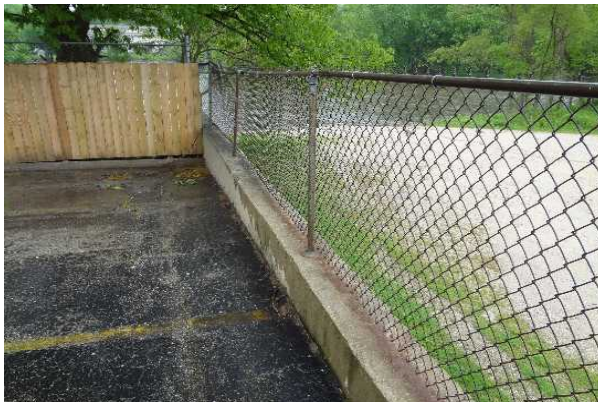
#9:

FENCES & GATES, CHAIN LINK

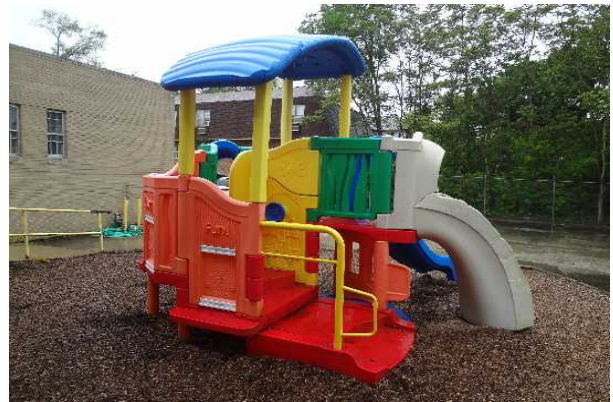
#10:

PLAY STRUCTURE, PRE-
SCHOOL

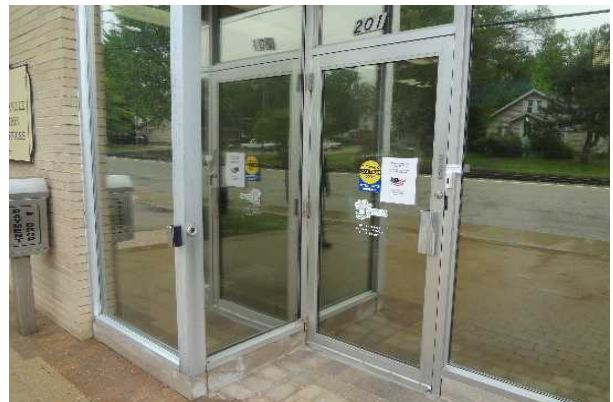
#12:

EXTERIOR DOOR, FULLY-
GLAZED ALUMINUM-FRAMED
SWINGING MOTOR-OPERATED

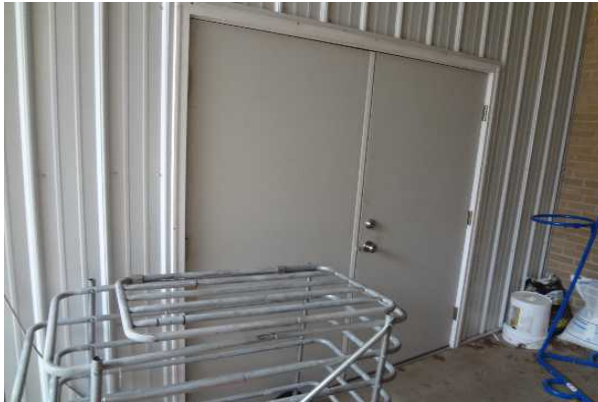
#13: EXTERIOR DOOR, STEEL

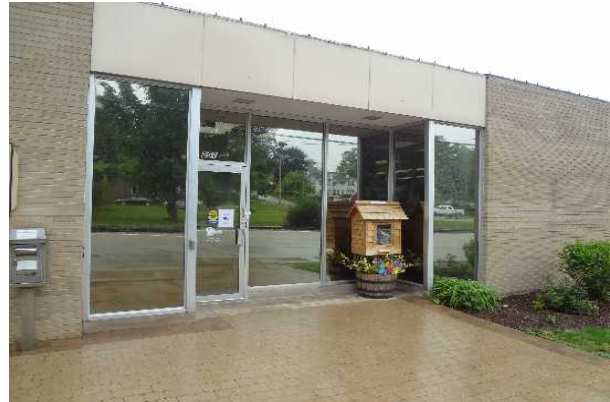
#14: STOREFRONT, METAL-FRAMED WINDOWS

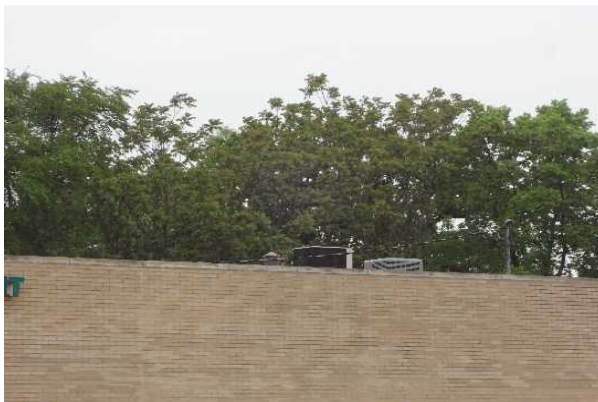
#17: CONDENSING UNIT, SPLIT SYSTEM

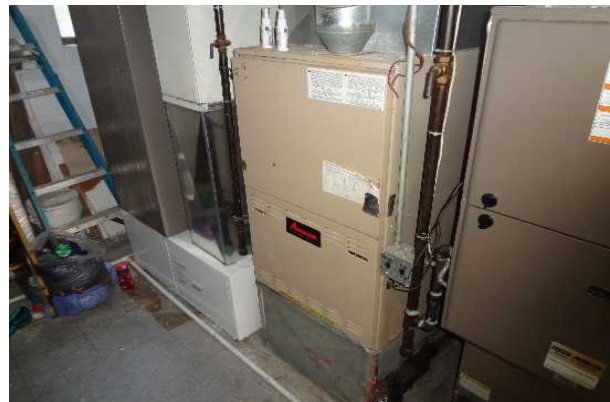
#18: AIR HANDLER, INTERIOR

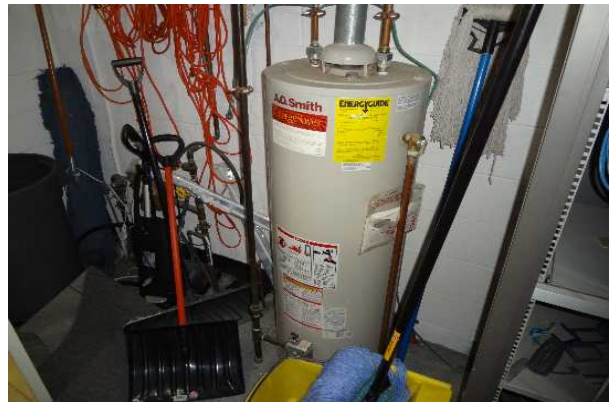
#22:

WATER HEATER, GAS

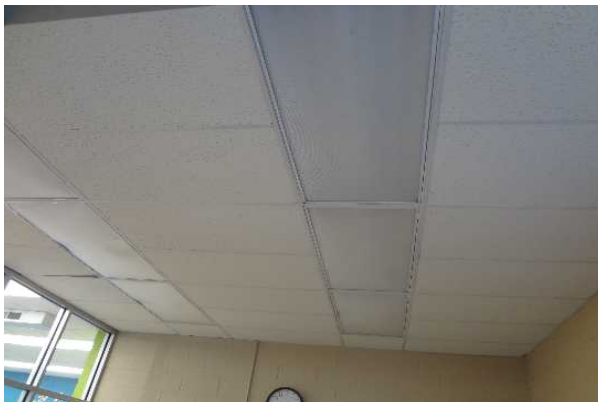
#23:

LIGHTING SYSTEM, INTERIOR

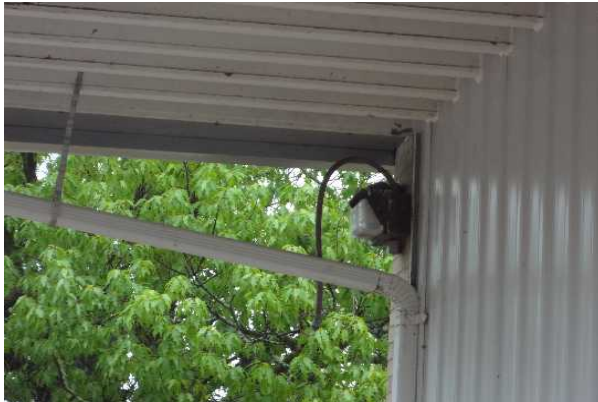
#25: HIGH PRESSURE SODIUM LIGHTING FIXTURE

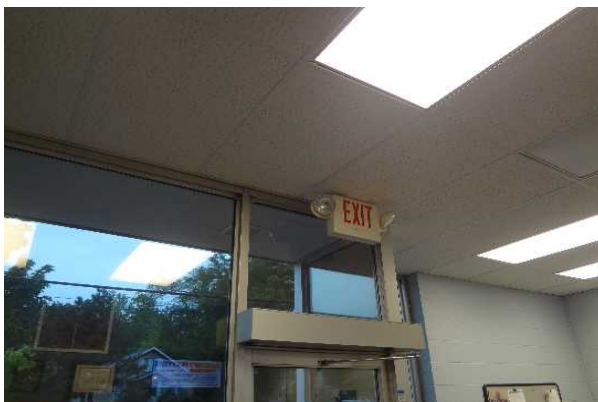
#29: EMERGENCY/EXIT COMBO

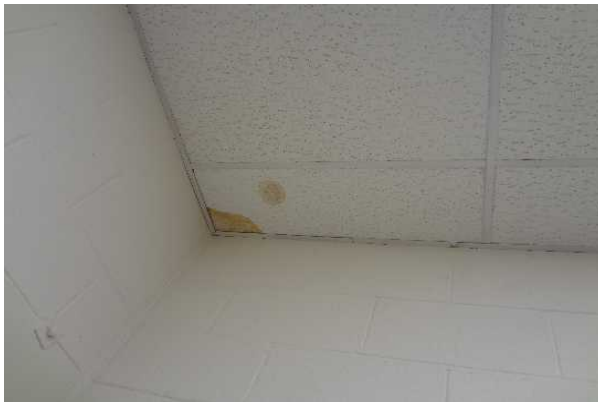
#39: STAINED ACOUSTICAL CEILING
TILE
