Title: Building Condition Reports 2017

Meeting and Date: Administration Committee - September 20, 2017

Synopsis: Discussion of the Preliminary Reports from the Building Condition Survey that
EMG performed on City-owned structures and facilities.

FACILITY CONDITION ASSESSMENT

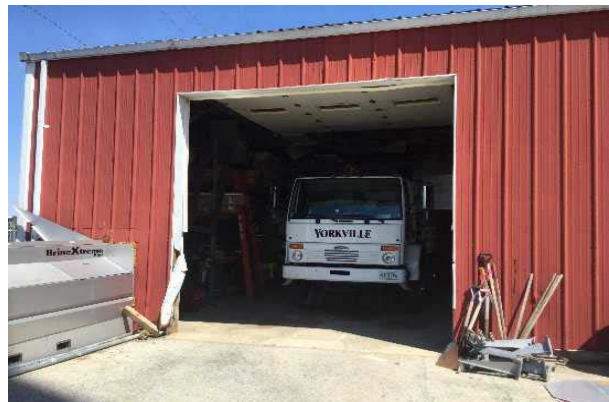
#11: EXTERIOR DOOR, STEEL
