United City of Yorkville

PUBLIC WORKS COMMITTEE MEETING

Tuesday, December 18, 2018 6:00 p.m.

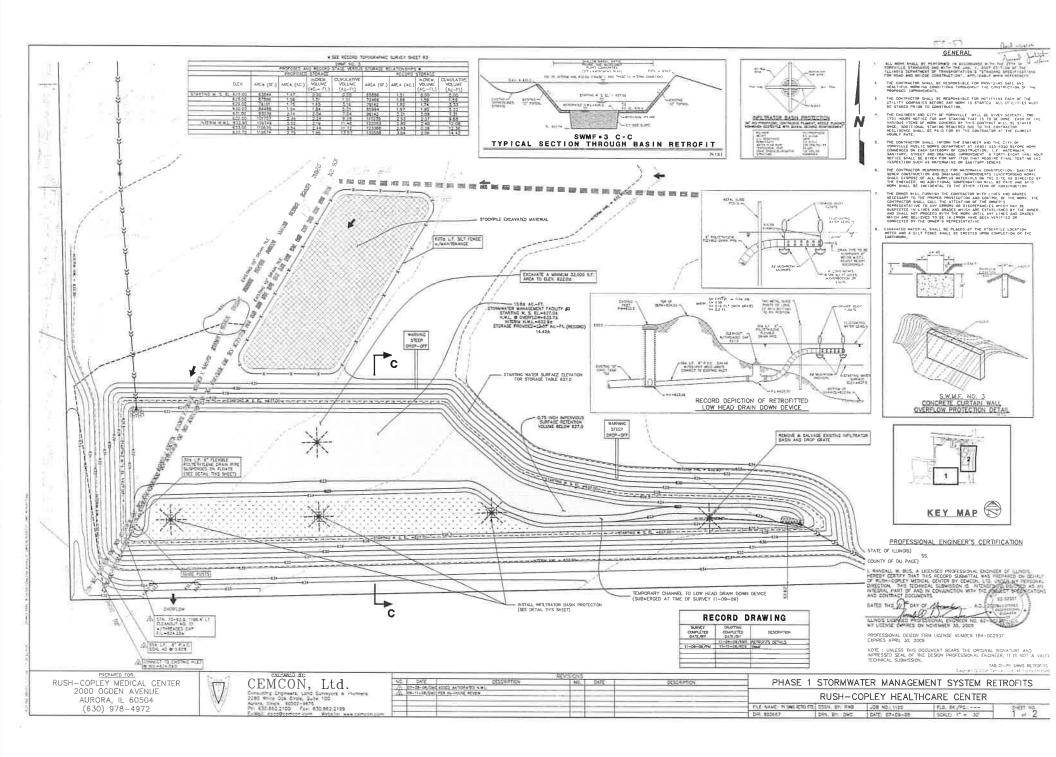
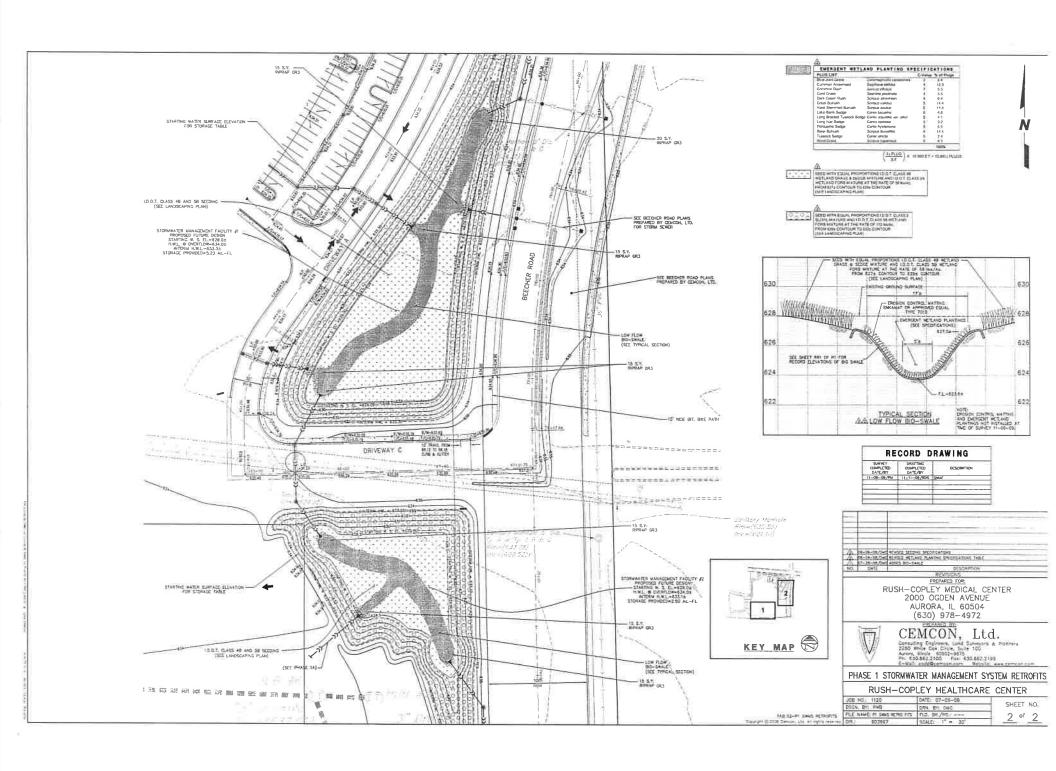
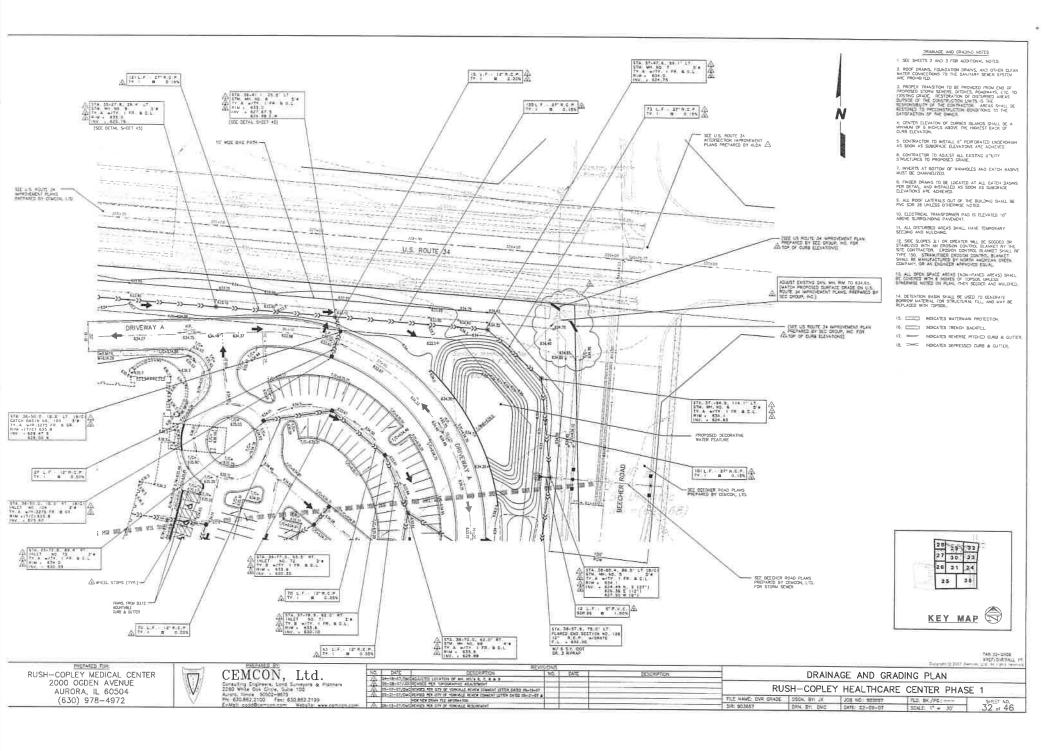
Black liner is exposed in many areas but overall the basin appears to be functioning normally.

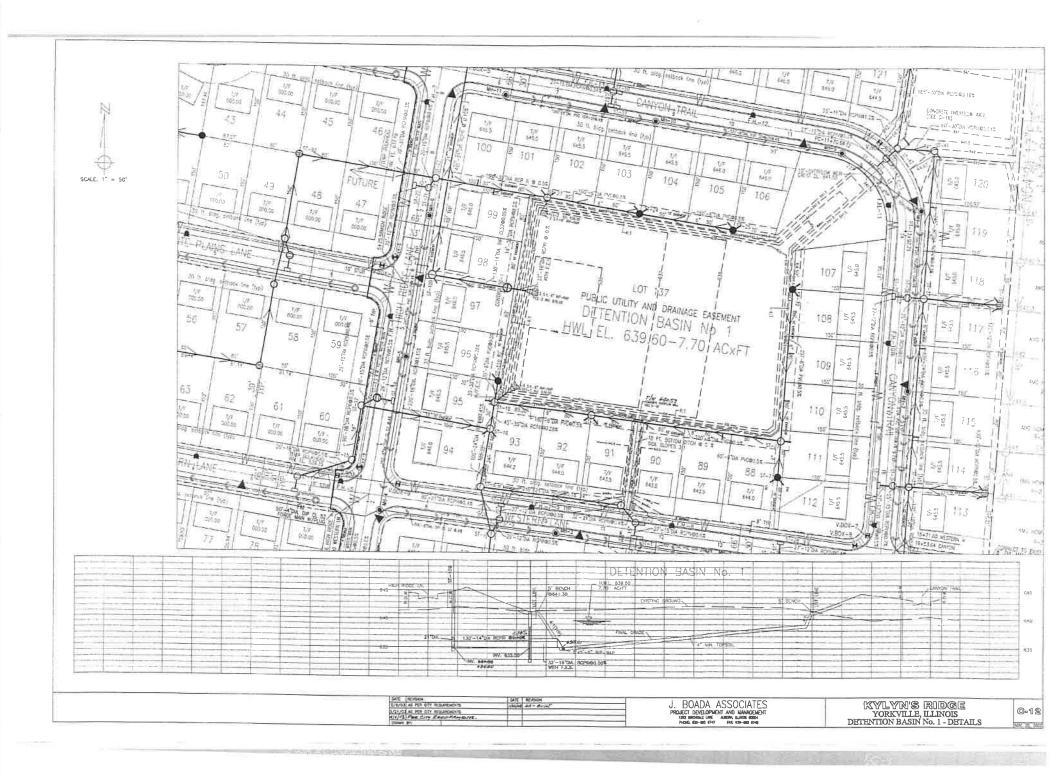
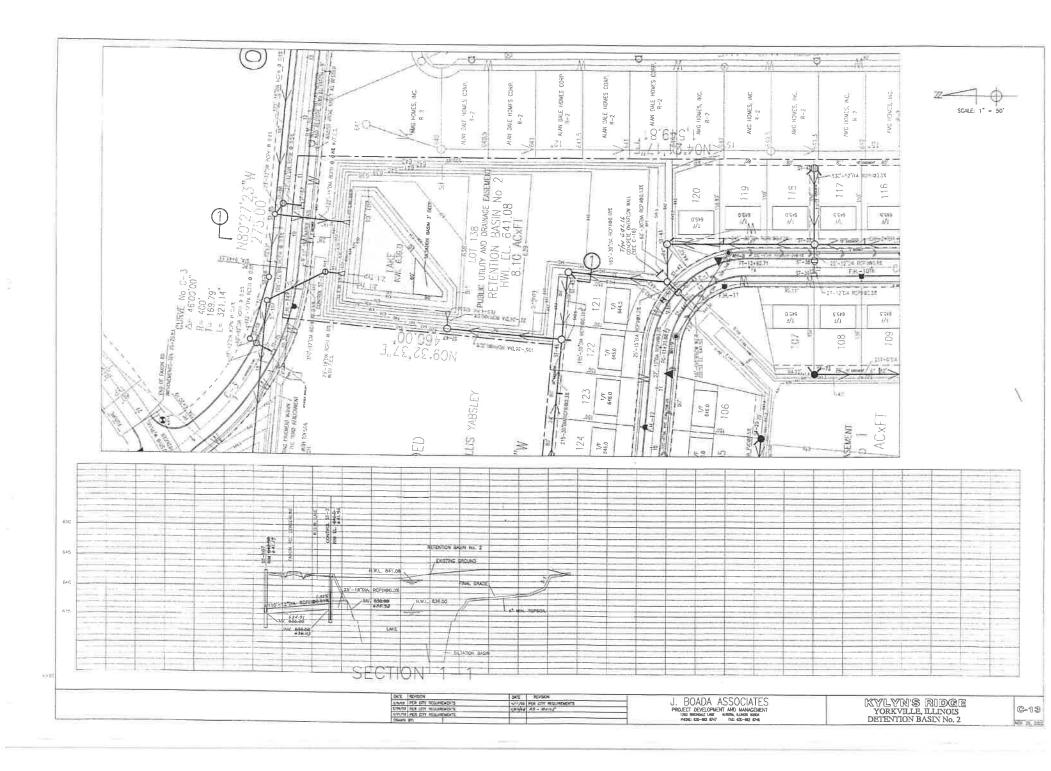
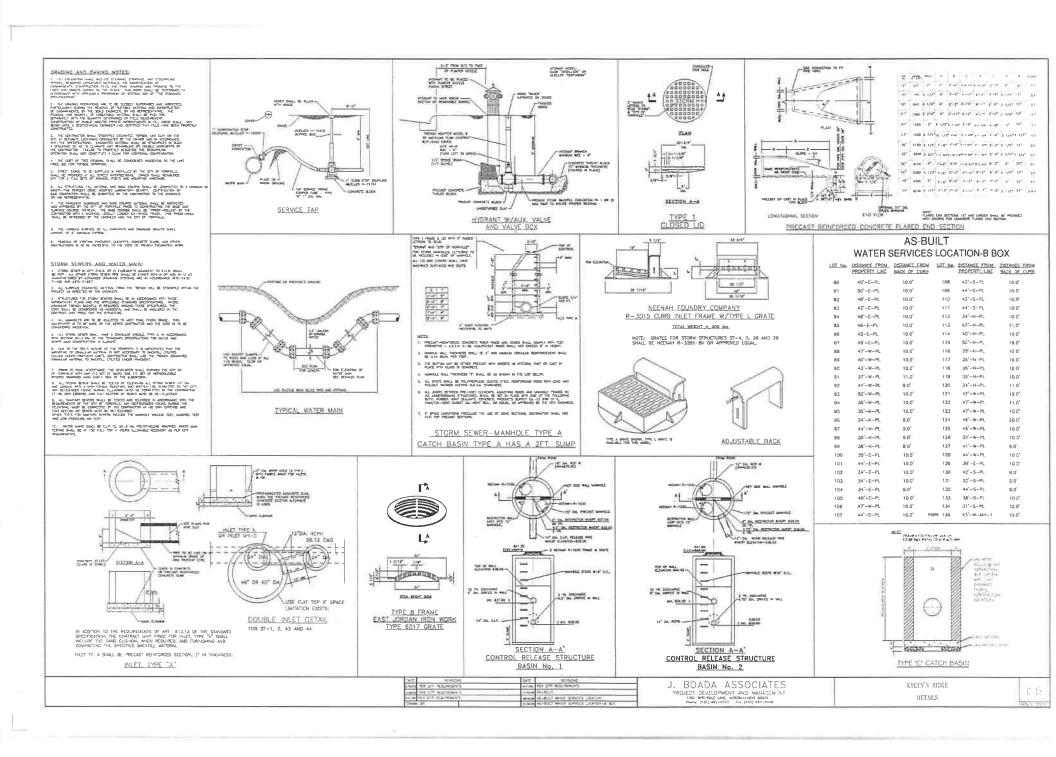
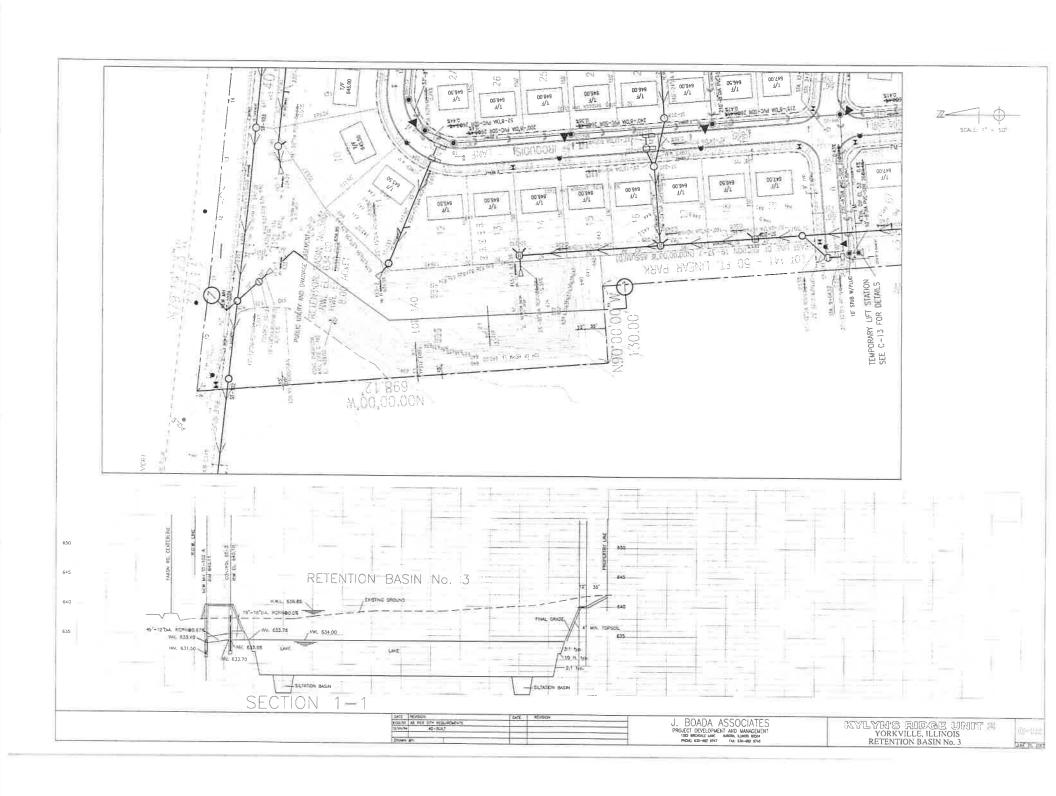
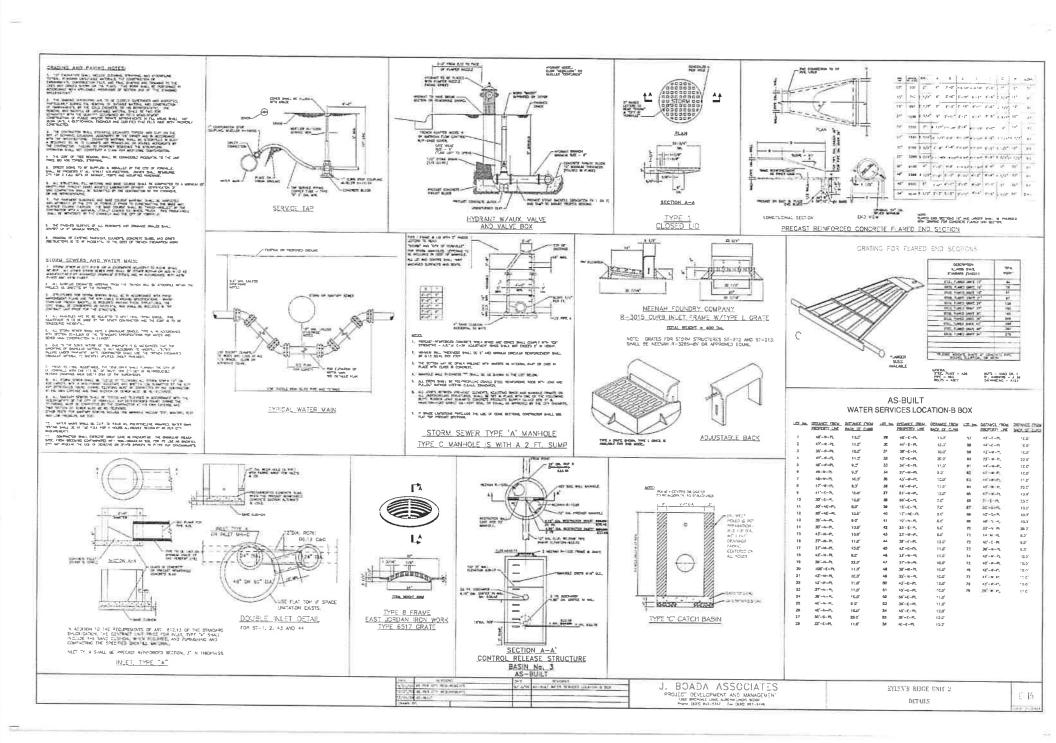
FES-1, FES-3, and FES-4 are heavily overgrown with woody vegetation and weeds.

- The missing grate on the northeast flared end section (FES-5) should be installed.
- The wall inside the restrictor manhole appears to be installed incorrectly and should be corrected to allow proper function.
- Areas caused by erosion and/or muskrat holes along the shore line should be stabilized.
- Areas where sinkholes are present along the shore line should be backfilled and stabilized.
- The tree growing in the northwest flared end section (FES-6) should be removed.
- All woody vegetation on the shore line and within the basin should be removed (Specialist required).

- All grass trimmings and leaves should be removed from the shoreline and sign installed stating "No Dumping of Yard Waste" should be installed.
- No movement of flow appeared to be occurring within the restrictor manhole. This could be due to possible blockage of the 2 year orifice or incorrect installation. The restrictor manhole should be investigated further and any necessary repairs should be made to allow proper function.
- The heavy vegetation causing blockage in and around the flared end sections should be removed.
- All woody vegetation on the shore line and within the basin should be removed (Specialist required).
- All invasive species/weeds should be removed. (Specialist required).

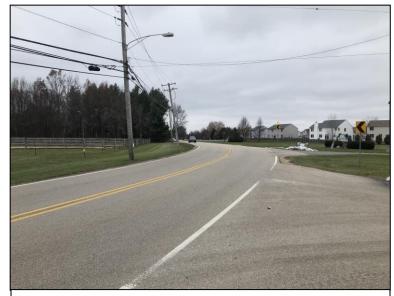
Westbound along Cannonball Trail at 350'-radius curve approximately ¼ mile west of IL 47.

Shoulder rumble strips are a relatively low-cost option for prevention of single vehicle, run-off-road fatal and injury crashes. Per NCHRP Report 641, Guidance for the Design and Application of Shoulder and Centerline Rumble Strips, shoulder rumble strips result in a 13% - 51% reduction in these types of crashes.

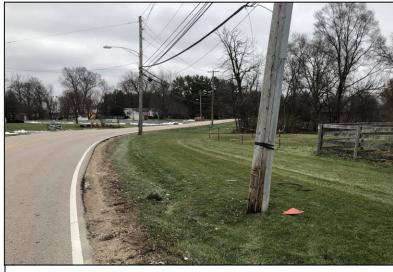
Power poles, signs, trees, and other roadside obstructions.

Increasing the clear zone (the unobstructed, traversable area beyond the edge of the travel lane for the recovery of errant vehicles) is one option. However, along the inside of the curve, this would involve relocation of Com Ed power poles and lines, among other roadside obstructions. Along the outside of the curve, there is a roadside ditch as well as power poles and trees and other obstructions.

Widening the paved shoulder to help give the driver more area to regain control of their vehicle and flattening the side slope also are roadside safety improvements to increase the clear zone

that could be considered. Widening the shoulders or flattening the ditch foreslopes would increase the clear zone area.

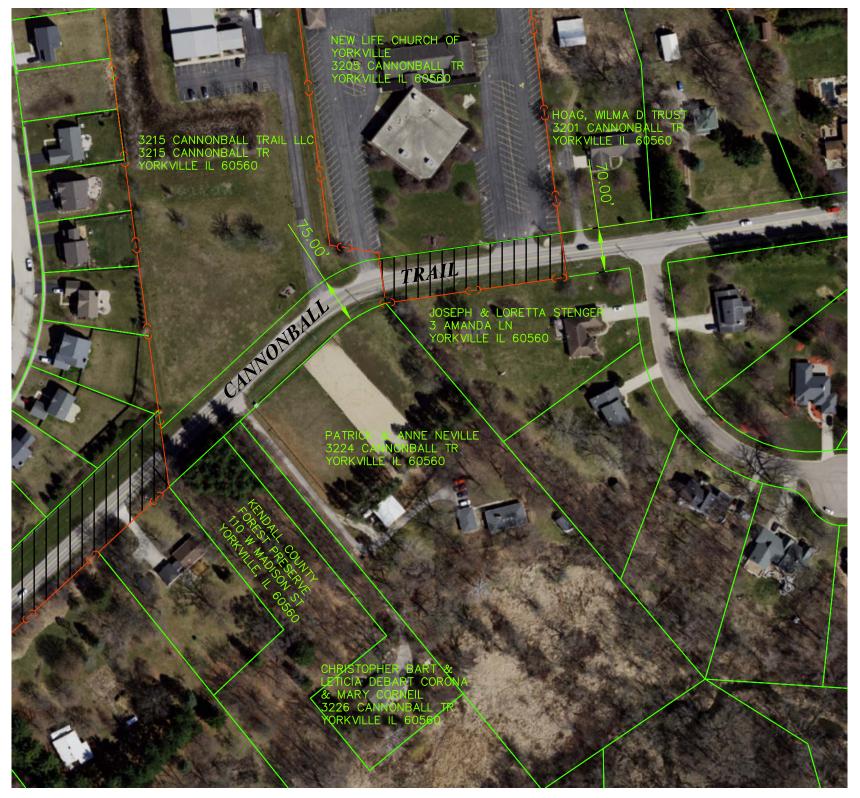
CANNONBALL TRAIL ROW AND JURISDICTION EXHIBIT

= UNITED CITY OF YORKVILLE JURISDICTION
