Title: Building Condition Reports 2017

Meeting and Date: Administration Committee - September 20, 2017

Synopsis: Discussion of the Preliminary Reports from the Building Condition Survey that
EMG performed on City-owned structures and facilities.

FACILITY CONDITION ASSESSMENT

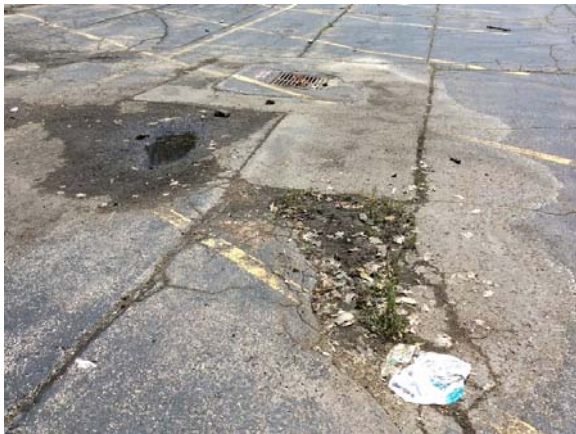
PHOTO #9: DAMAGED ASPHALT

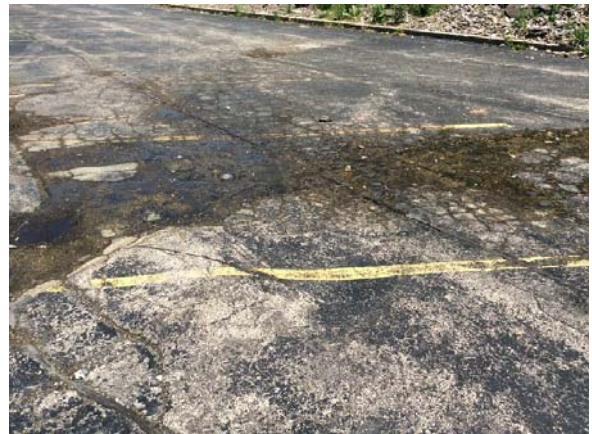
PHOTO #10: DAMAGED ASPHALT

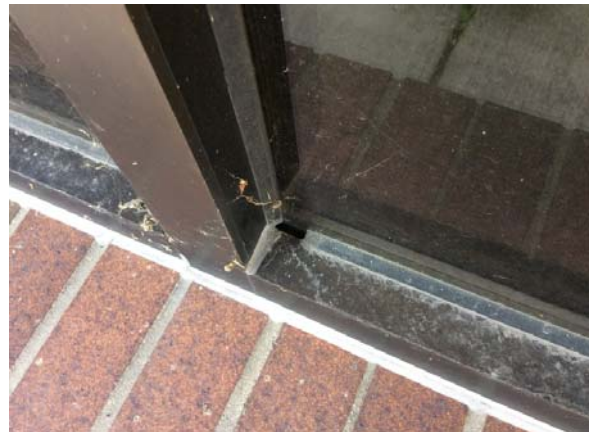
PHOTO #22: MISSING AREA OF WINDOW GASKET

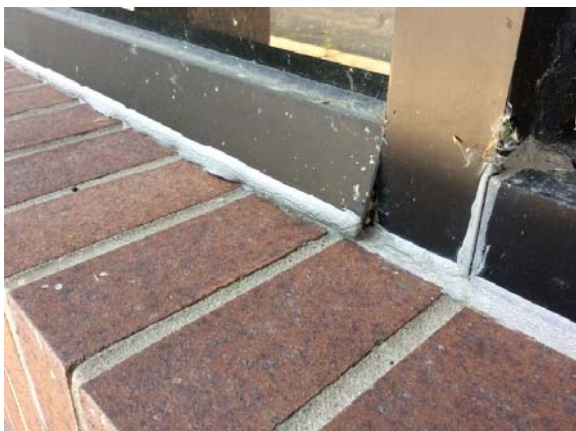
PHOTO #23: DAMAGED WINDOW FRAME

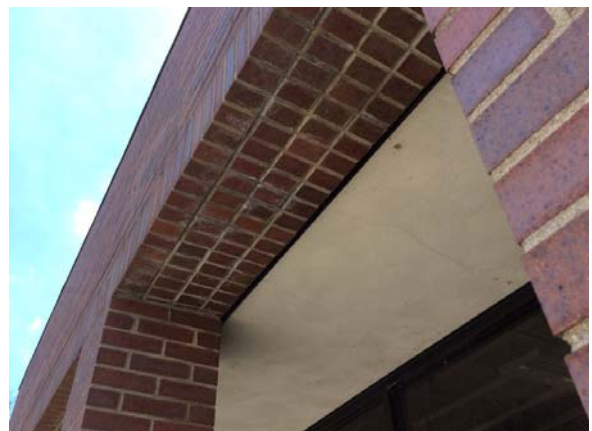
PHOTO #24: EFFLORESCENCE ON BRICK

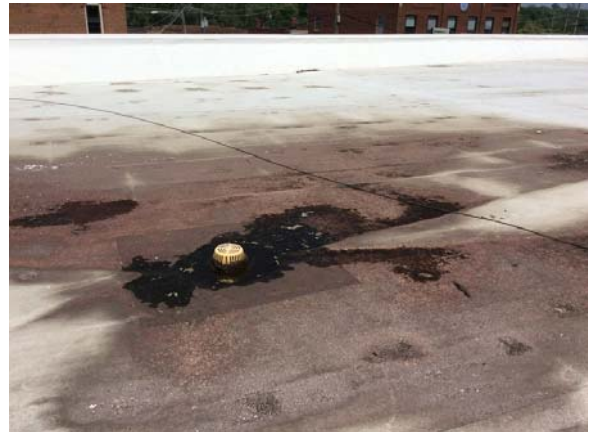
PHOTO #26: ROOF, WATER STAINING

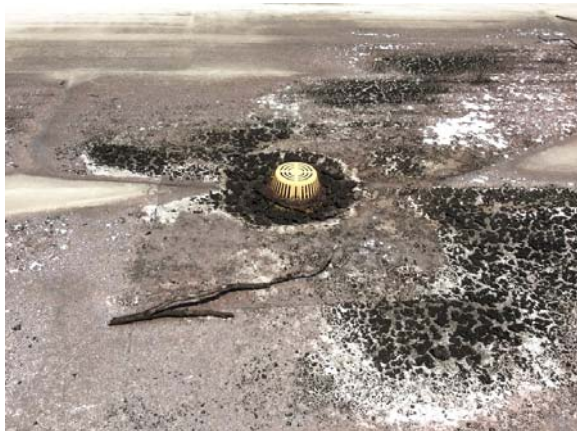
PHOTO #27: ROOF, CLOGGED DRAIN

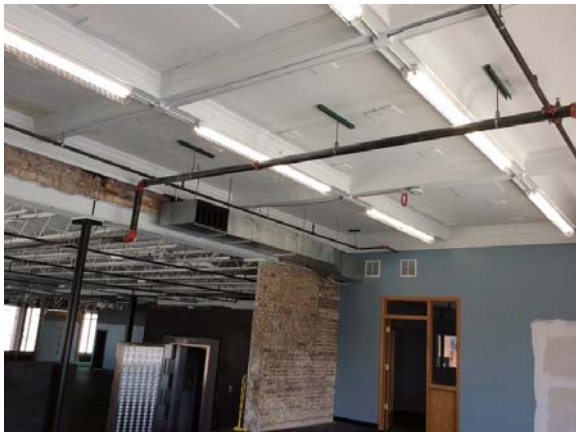
PHOTO #44: WATER STAIN ADJACENT TO EAST WALL

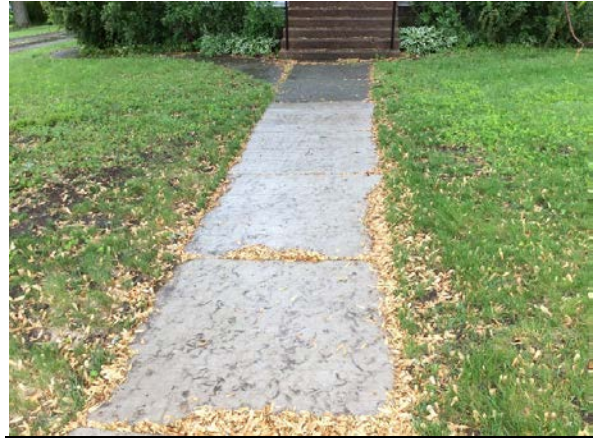
PHOTO #8: *SIDEWALK*

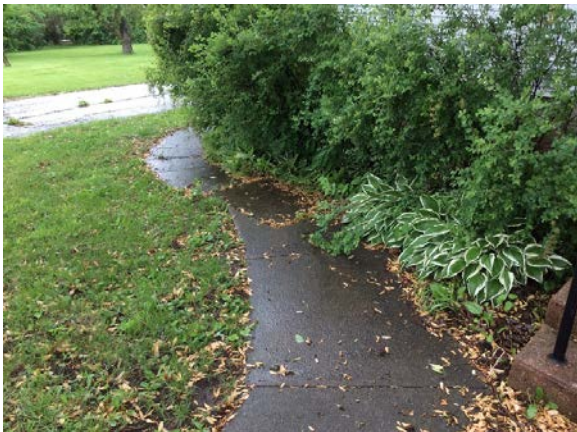
PHOTO #9: *SIDEWALK*

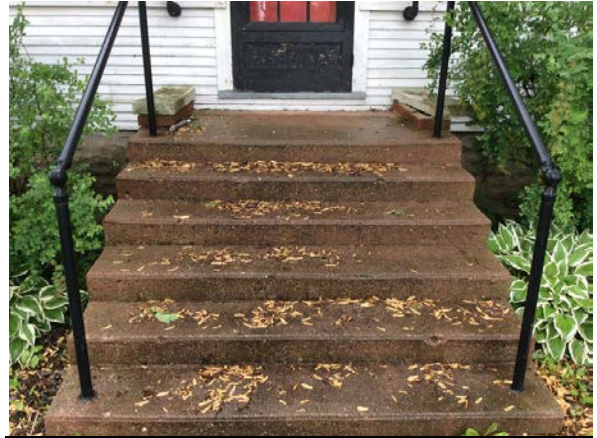
PHOTO #13: ENTRY STEPS

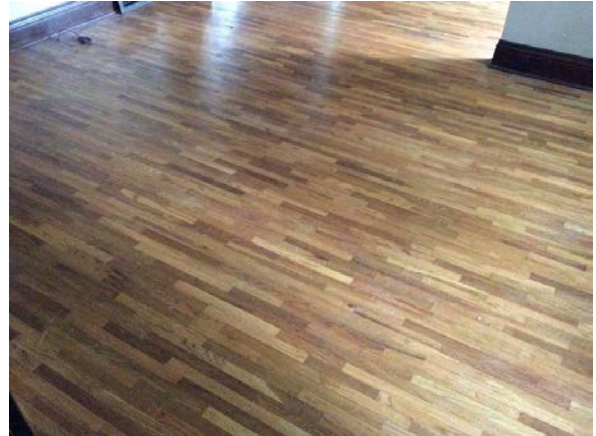
PHOTO
#37: WOOD FLOORING

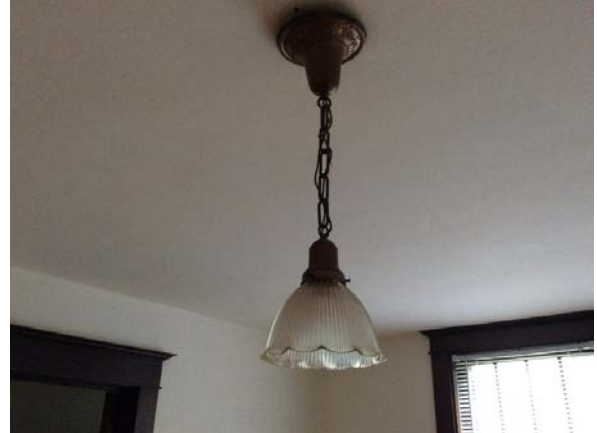
PHOTO
#49: LIGHT FIXTURE

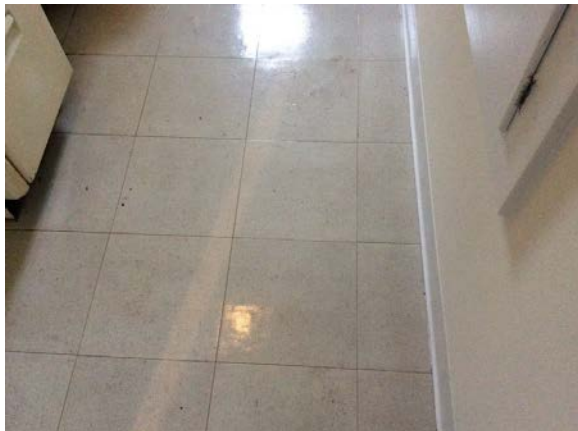
PHOTO
#52: BATHROOM, SECOND FLOOR

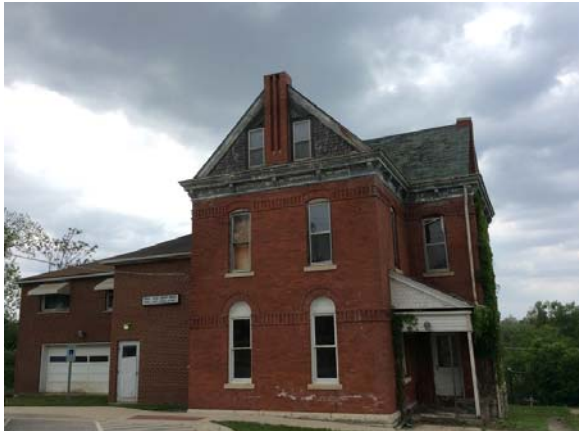
PHOTO #1: FRONT ELEVATION

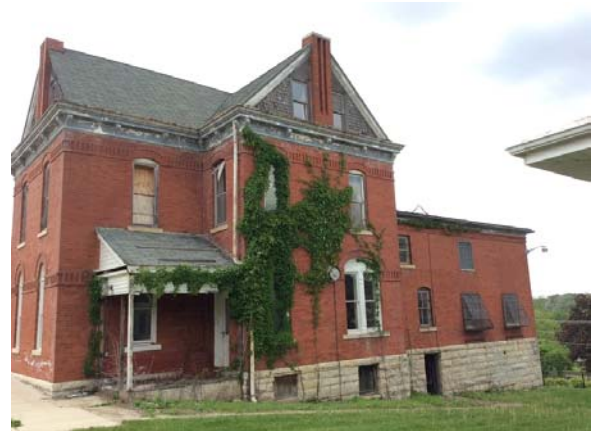
PHOTO #2: EAST ELEVATION

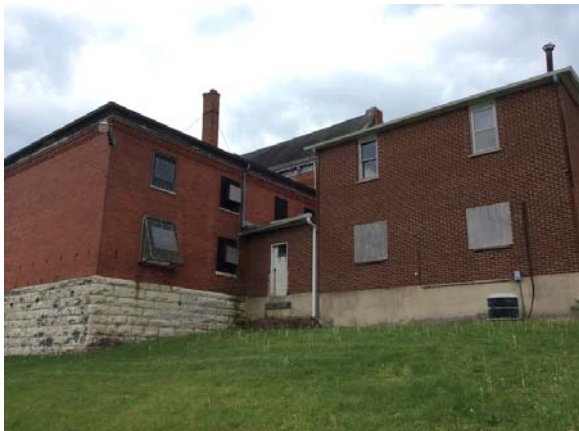
PHOTO #3: NORTH ELEVATION

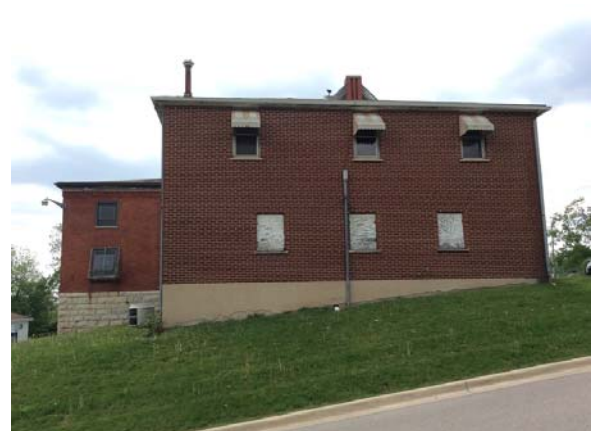
PHOTO #4: WEST ELEVATION

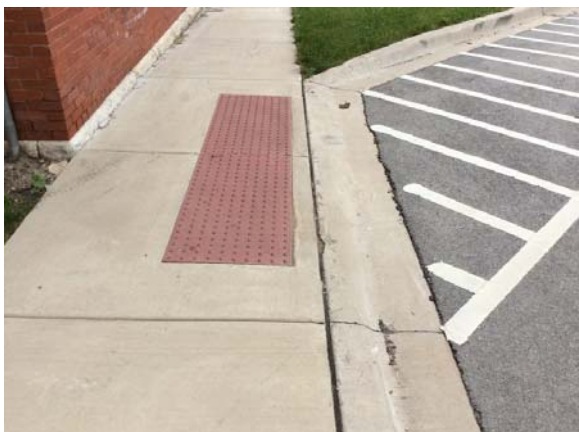
PHOTO #5: CURB CUTAWAY

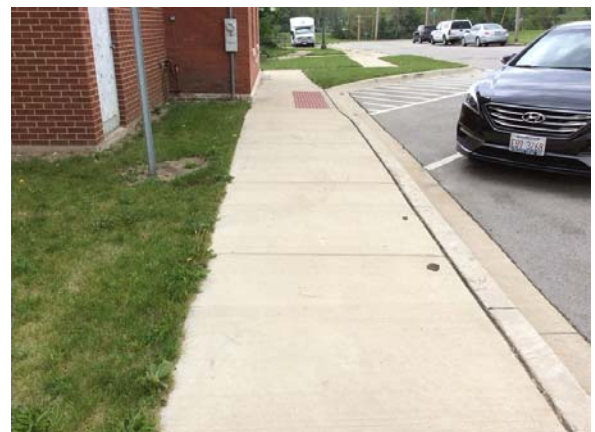
PHOTO #6: SIDEWALK

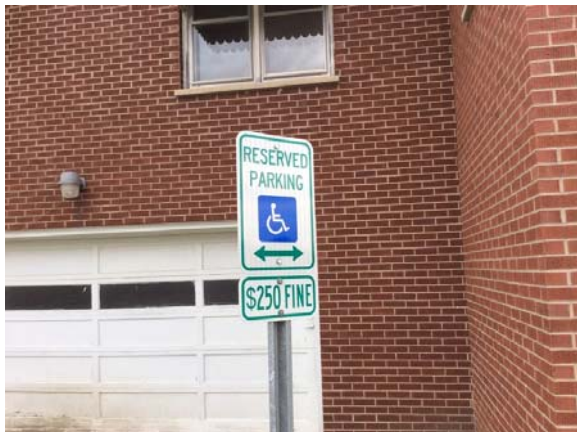
PHOTO #7: ACCESSIBLE PARKING SPACE

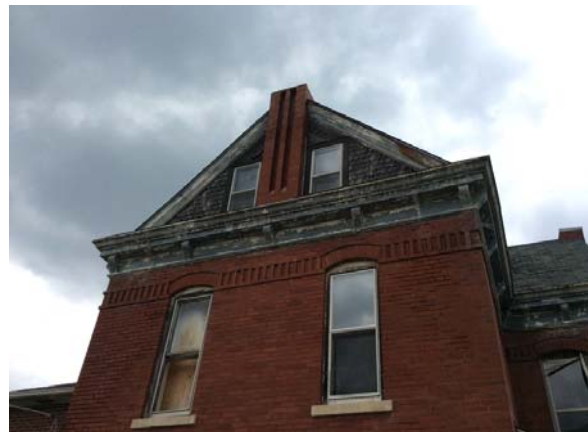
PHOTO #8: CORNICE AND SHINGLES

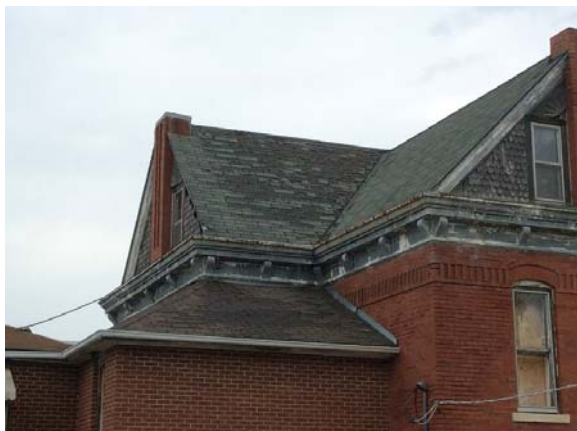
PHOTO #9: ASPHALT SHINGLE ROOF, DETERIORATING

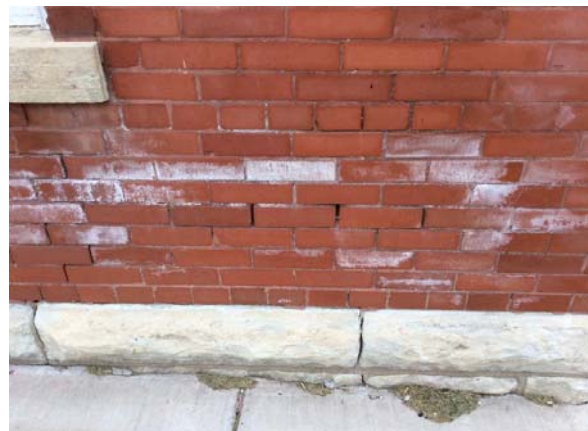
PHOTO #10: EFFLORESCENCE AND DETERIORATED MORTAR

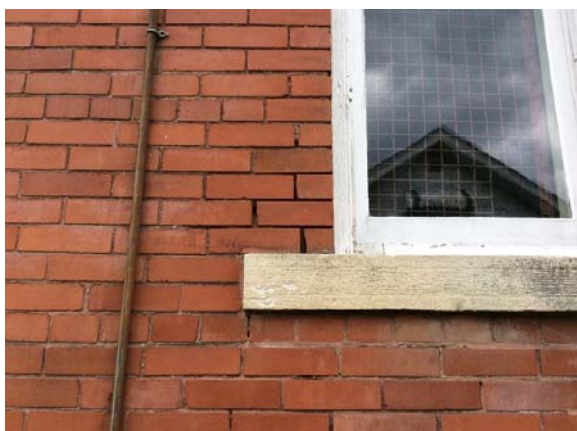
PHOTO #11: MISSING MORTAR

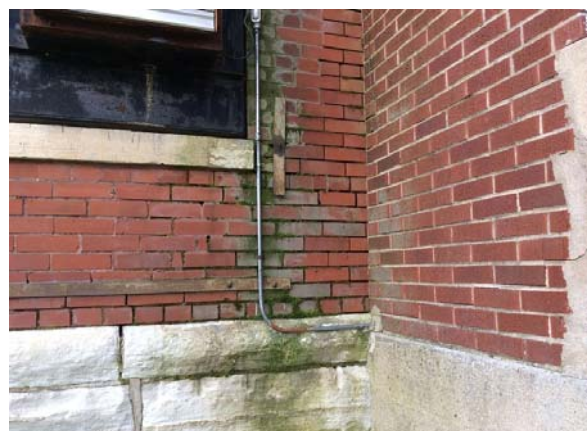
PHOTO #12: MISSING MORTAR

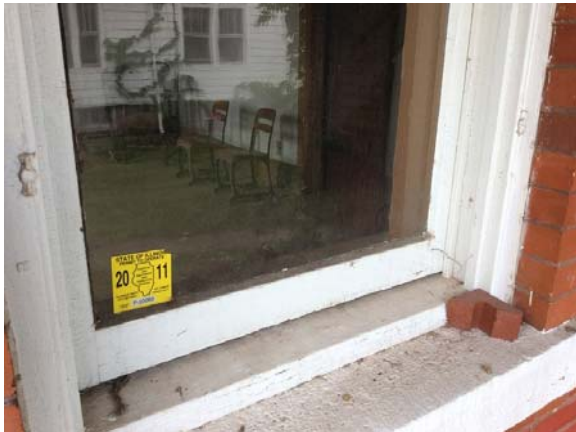
PHOTO #13: WINDOW, WOOD FRAME, SINGLE PANE

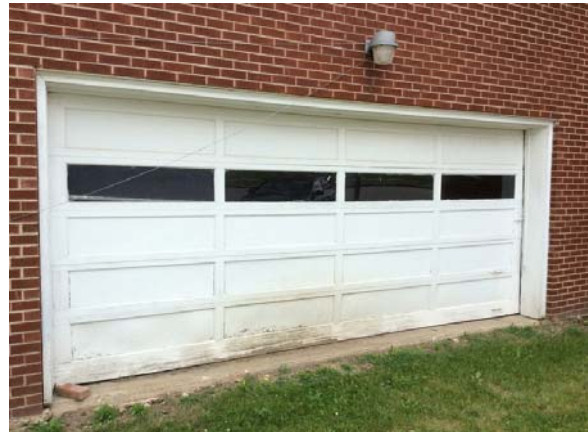
PHOTO #14: GARAGE DOOR, WOOD

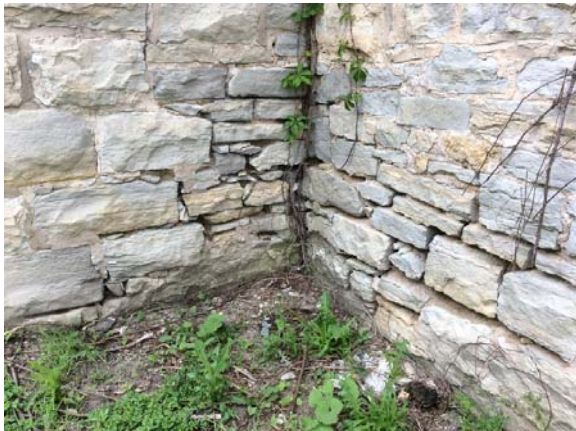
PHOTO #15: FOUNDATION WALL, MISSING MORTAR, LOOSE STONES

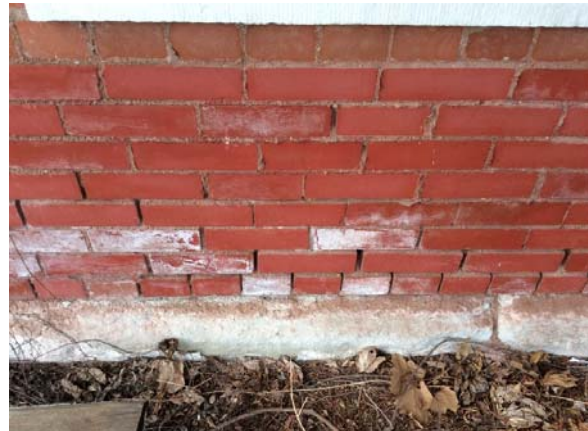
PHOTO #16: EFFLORESCENCE AND MISSING MORTAR

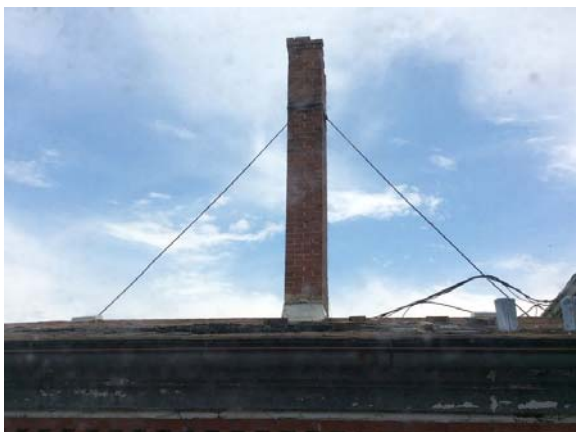
PHOTO #17: CHIMNEY, DETERIORATING

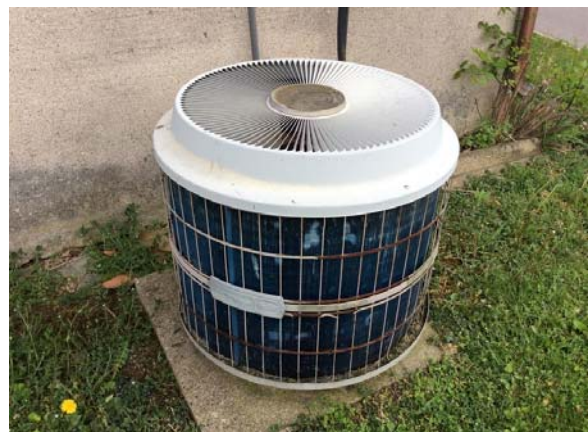
PHOTO #18: CONDENSING UNIT

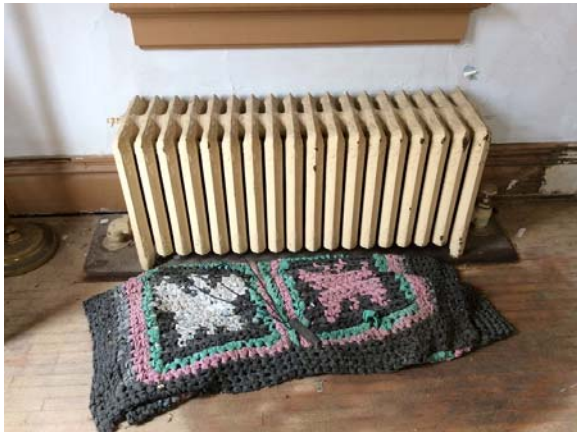
PHOTO #19: RADIATOR

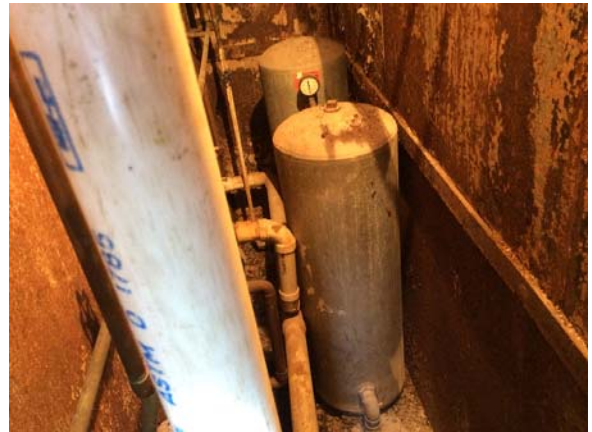
PHOTO #20: EXPANSION TANKS, JAIL AREA

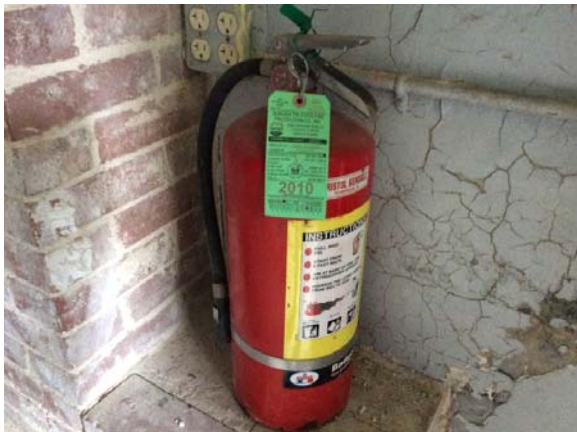
PHOTO #21: EXTINGUISHER

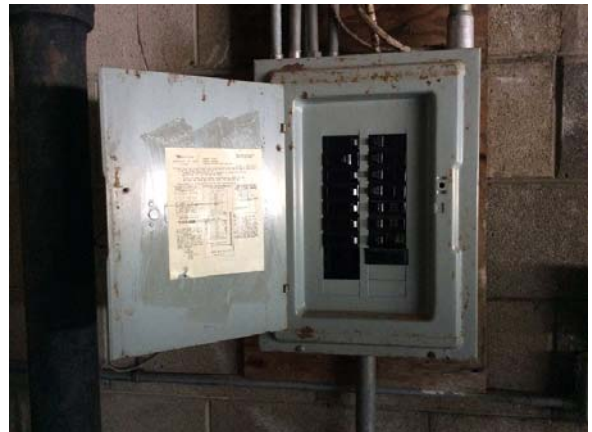
PHOTO #22: LOAD CENTER

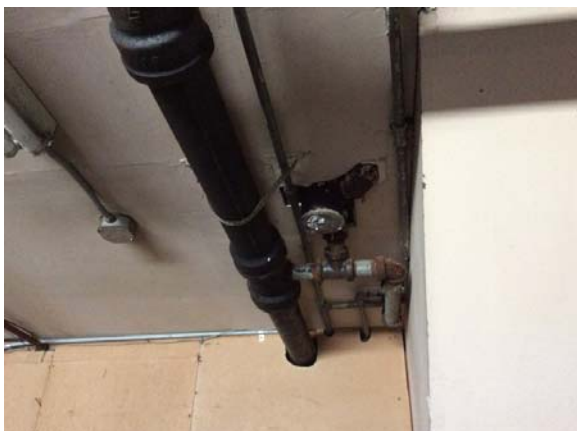
PHOTO #23: SANITARY PIPING

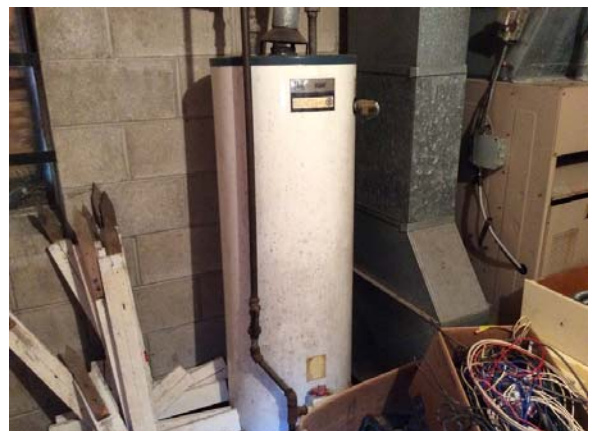
PHOTO #24: DOMESTIC WATER HEATER

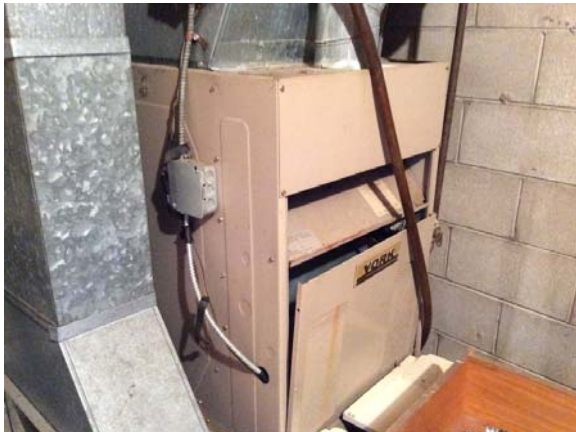
PHOTO #25: FURNACE

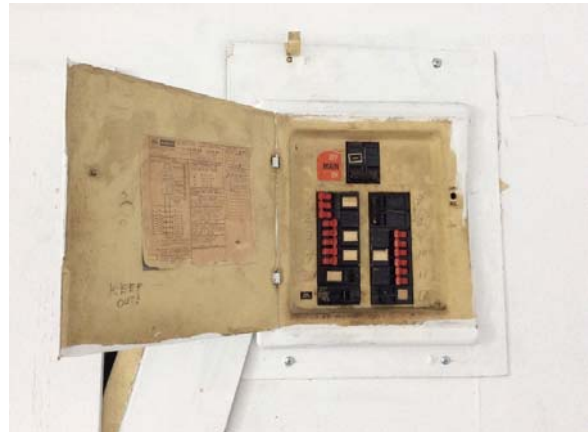
PHOTO #26: CIRCUIT BREAKER

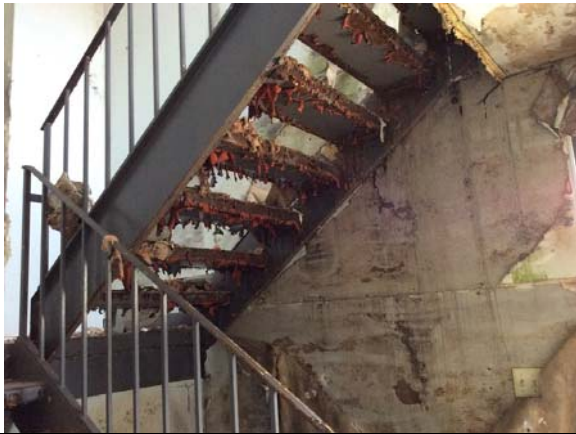
PHOTO #36: WATER DAMAGE, CENTRAL HALLWAY

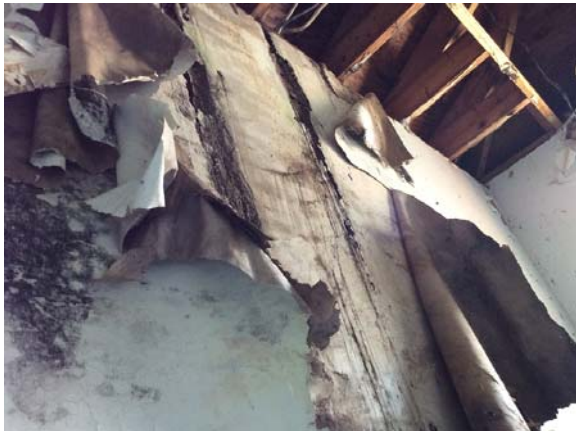
PHOTO
#38: WATER DAMAGE, SECOND FLOOR,
SOUTH STAIRS

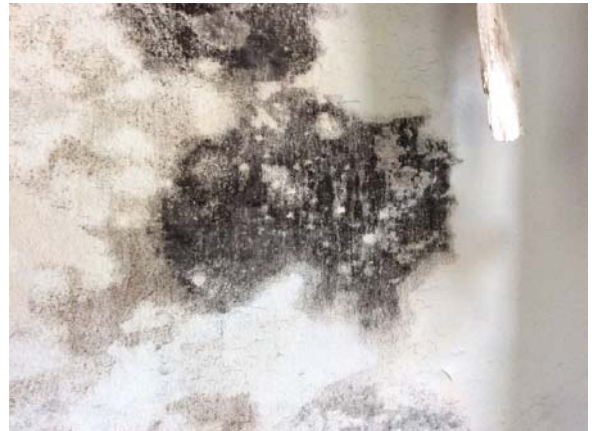
PHOTO
#39: WATER DAMAGE

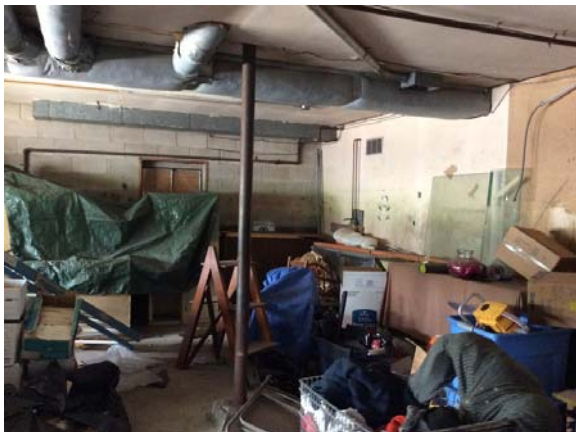
PHOTO
#40: FUNGAL GROWTH

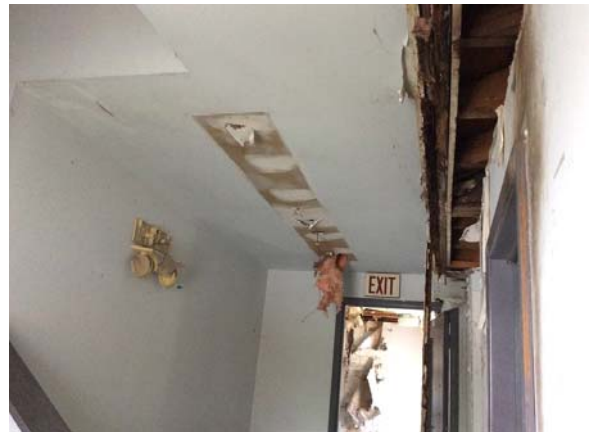
PHOTO #45: SECOND FLOOR CENTRAL HALLWAY, MOSS GROWING FROM CARPET

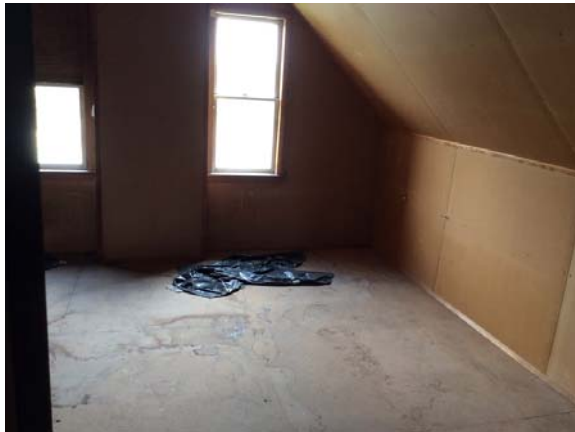
PHOTO #54: FUNGAL GROWTH

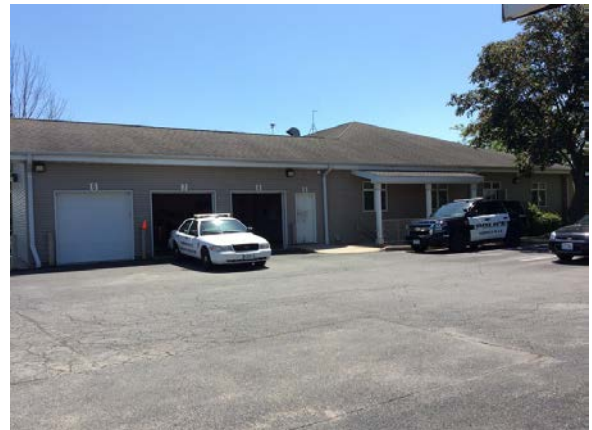
PHOTO #4: NORTH ELEVATION

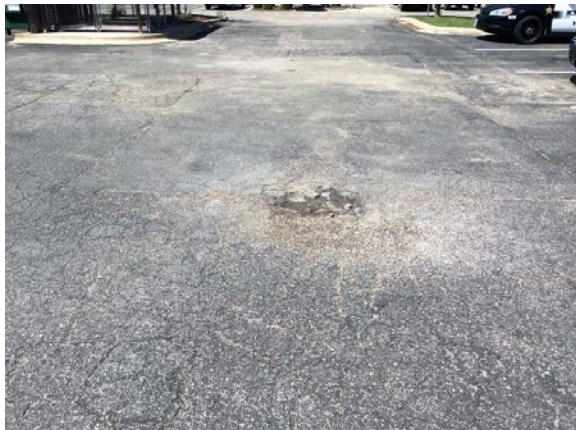
PHOTO #14: FRONT LOT, CRACKING AND DETERIORATED

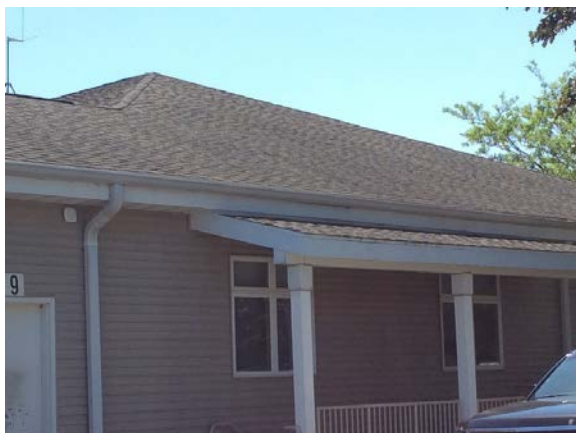
PHOTO #26: ROOF, CURLING

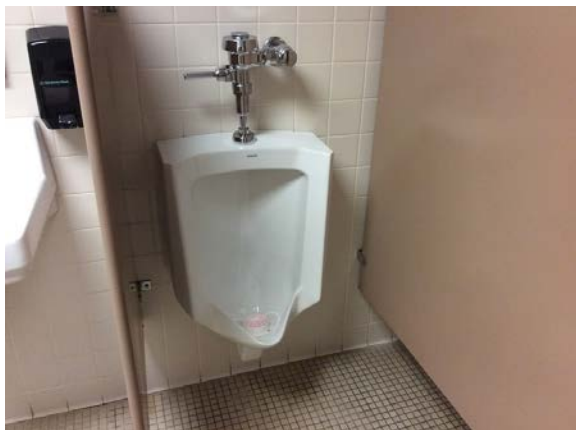
PHOTO #44: RESTROOM

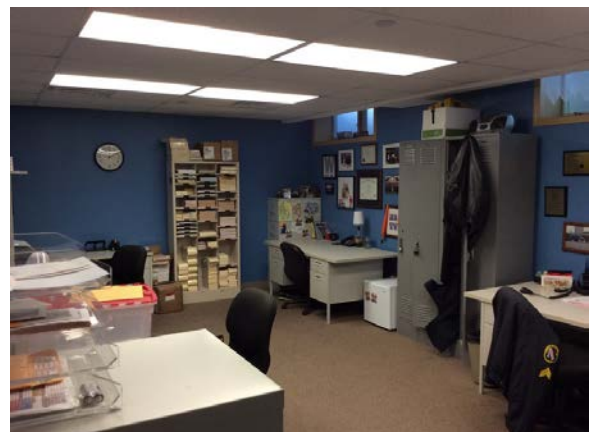
PHOTO #63: OFFICE, POLICE AREA

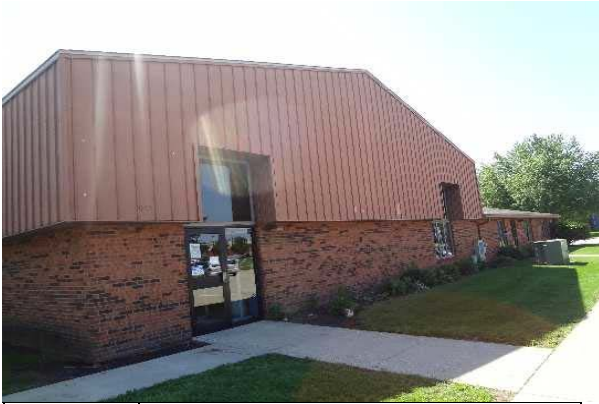
#1: FRONT ELEVATION

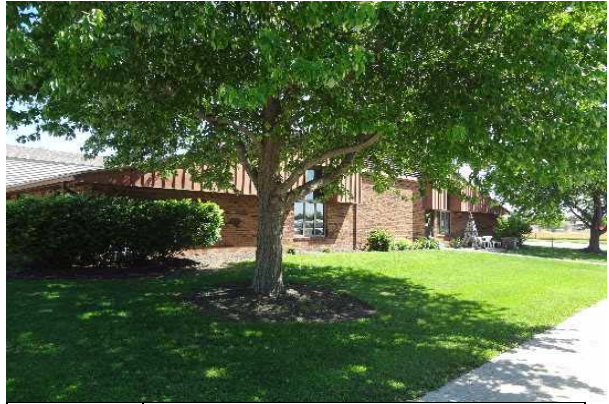
#2: RIGHT ELEVATION

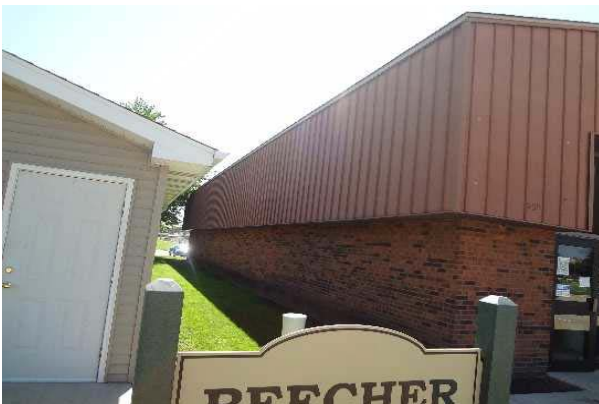
#3: LEFT ELEVATION

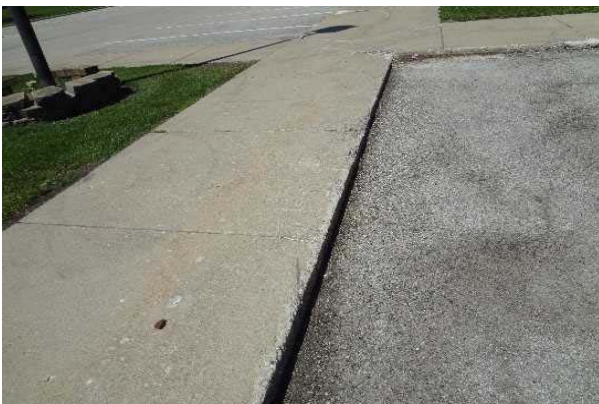
#5: SIDEWALK

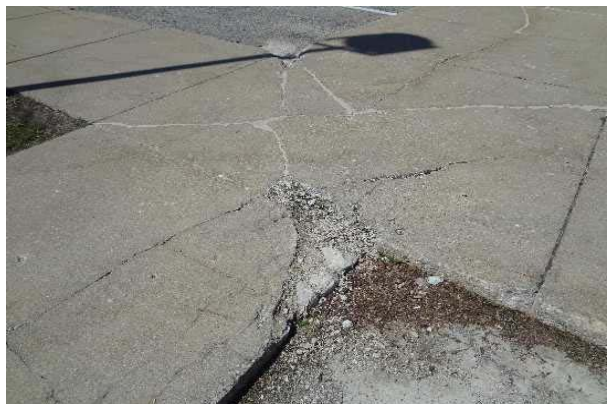
#6: DETERIORATING SIDEWALK
AND REPAIRED CRACKS

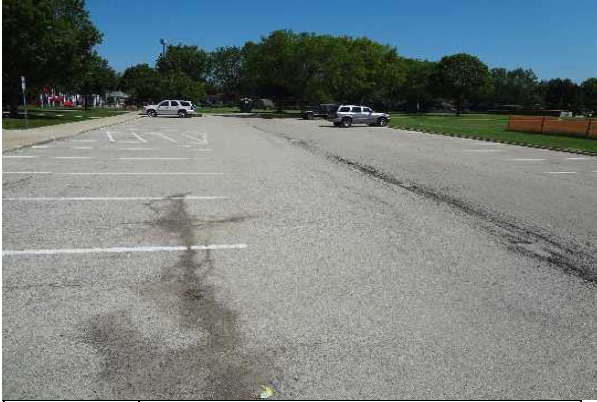
#7:

PARKING LOTS, ASPHALT
PAVEMENT

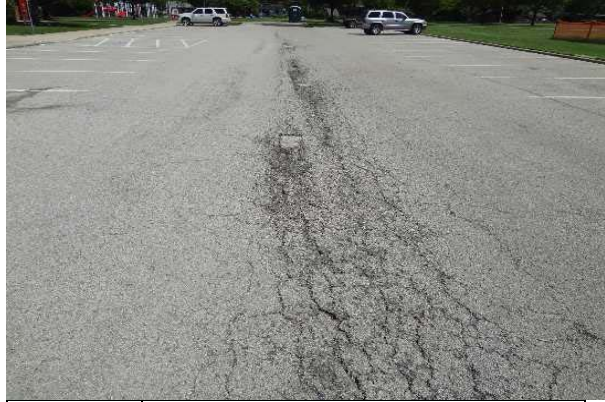
#8:

SIGNIFICANT CRACKING AND
DETERIORATION OF PARKING
LOT

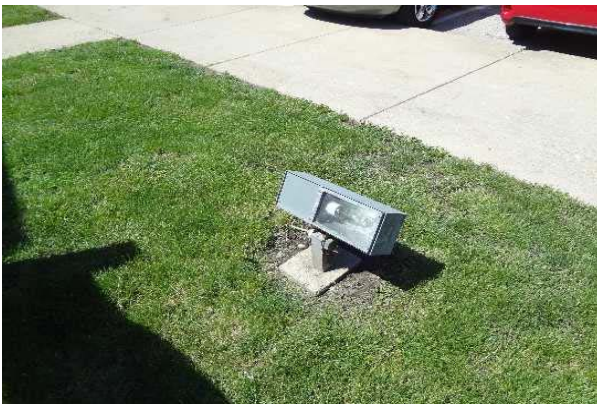
#9:

HIGH PRESSURE SODIUM
LIGHTING FIXTURE

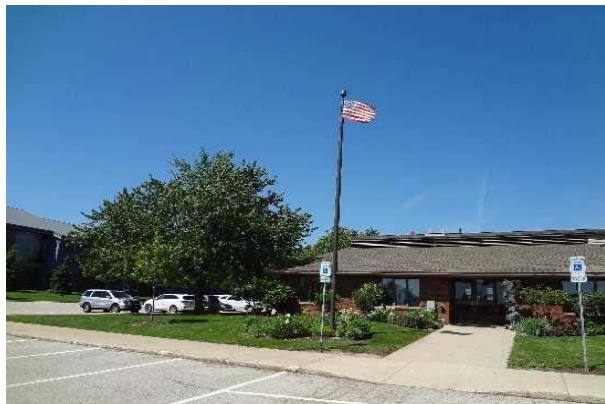
#10:

FLAGPOLE

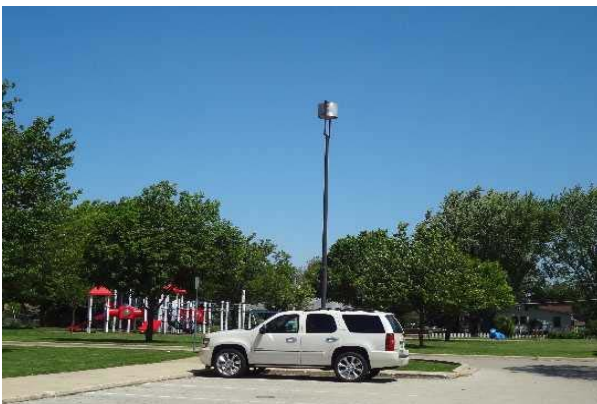
#11:

POLE LIGHT

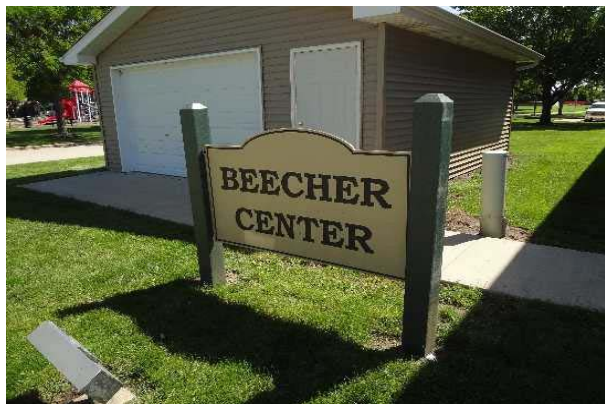
#12:

SIGNAGE

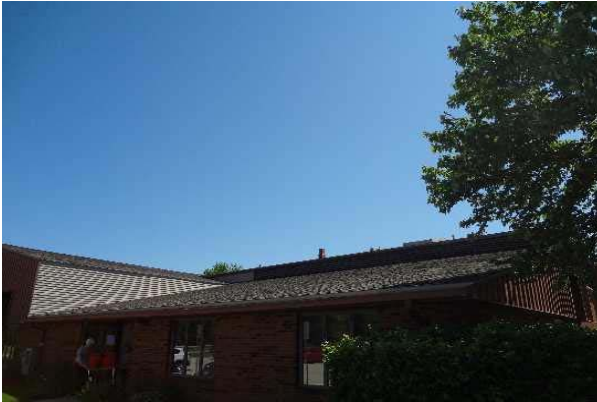
#13: ROOF, ASPHALT SHINGLE

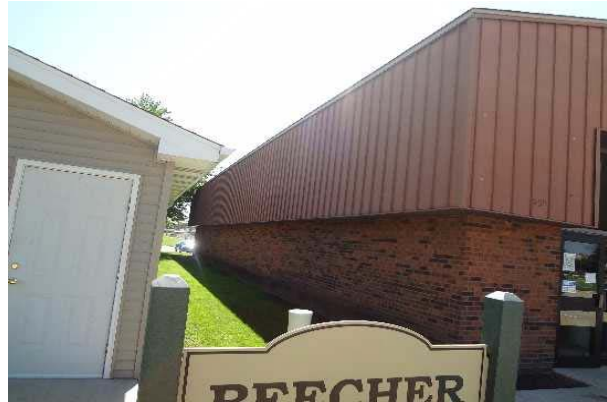
#14: EXTERIOR WALL, ALUMINUM SIDING

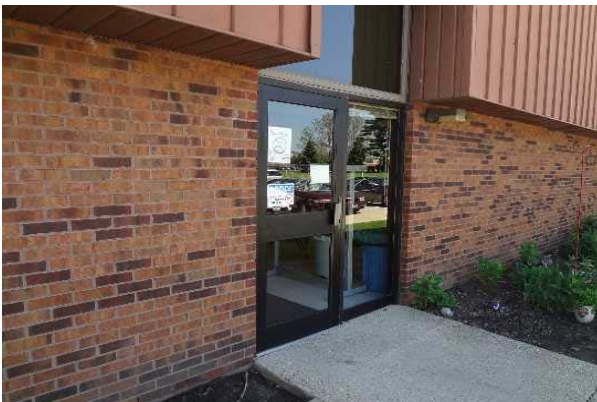
#15: EXTERIOR DOOR, FULLY-GLAZED ALUMINUM-FRAMED SWINGING

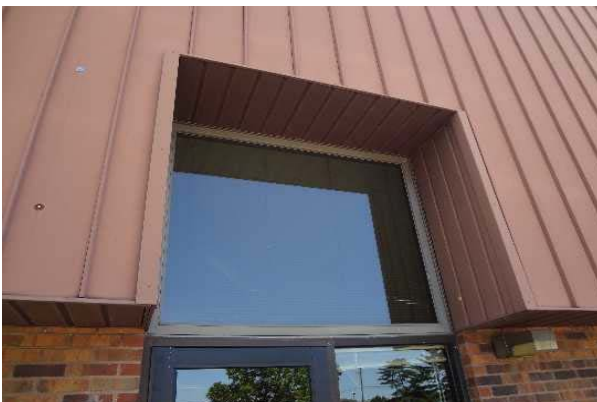
#16: WINDOW, ALUMINUM DOUBLE-GLAZED OPERABLE

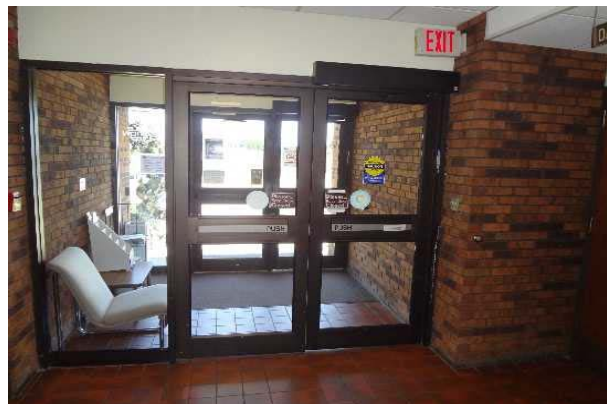
#47: INTERIOR WALL FINISH

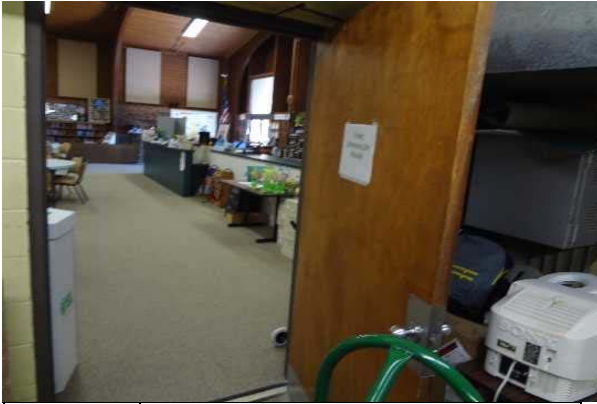
#48: INTERIOR DOOR, FULLY-
GLAZED ALUMINUM-FRAMED
SWINGING

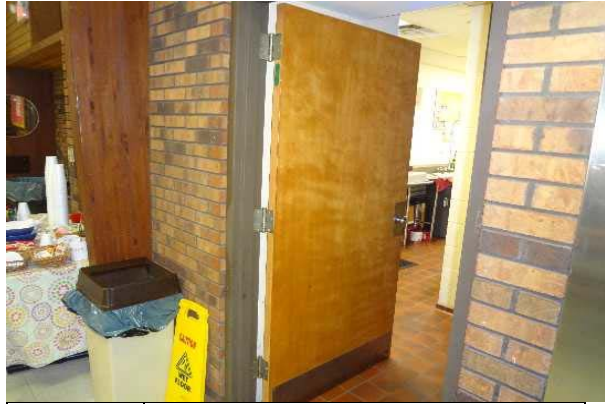
#49: INTERIOR DOOR, WOOD SOLID-CORE

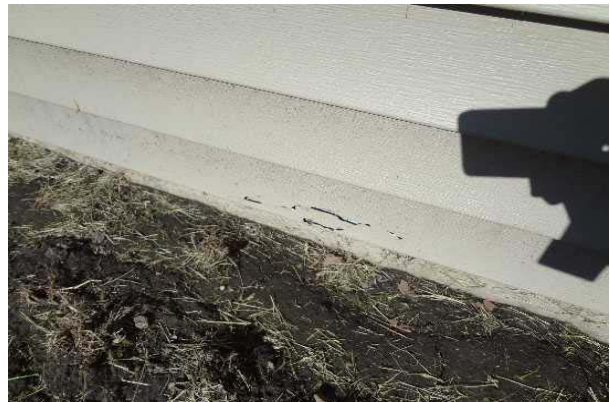
#10:

DAMAGED VINYL SIDING,
LOWER REAR ELEVATION

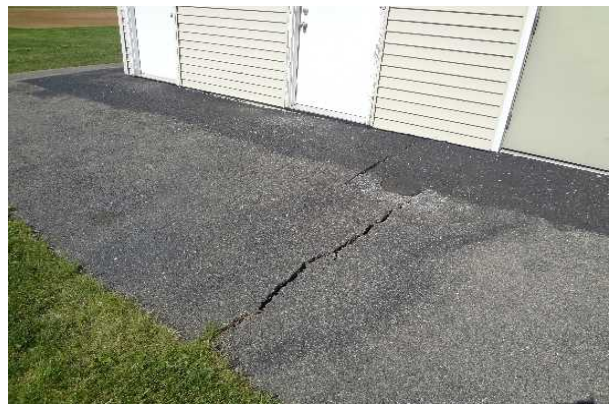
#6: PEDESTRIAN PAVEMENT,
SIDEWALK, CRACKING

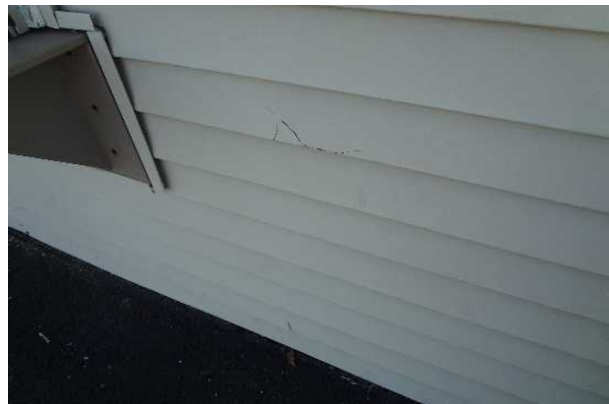
#10: DAMAGED VINYL SIDING

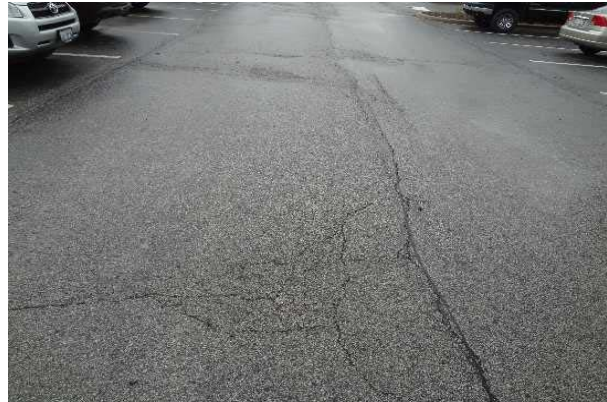
#8:

PARKING LOTS, MINOR
CRACKING

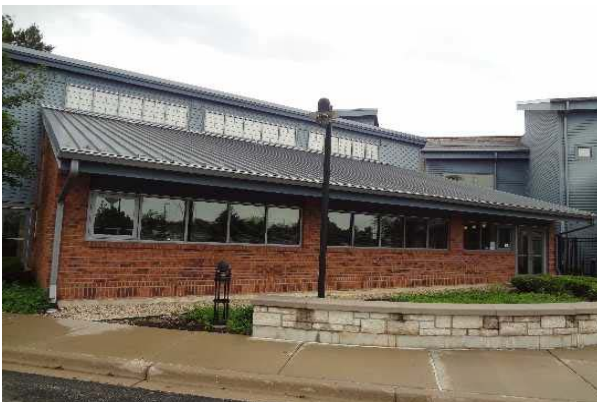
#11:

POLE LIGHT, EXTERIOR,
DECORATIVE

Public Library	5.5	613168	Pole Light, Exterior, Decorative, Replace	20	10	10	4	EA	\$4,630.42	\$18,522											\$18,522											\$18,522	
Public Library	5.5	613161	Pole Light, Exterior, 135 to 1000 W HID (Fixture Only), Replace	20	10	10	5	EA	\$4,630.42	\$23,152											\$23,152											\$23,152	
Public Library	5.5	613162	Pole Light, Exterior, 135 to 1000 W HID (Double Fixture, with Metal Pole), Replace	20	10	10	2	EA	\$8,523.34	\$17,047											\$17,047											\$17,047	
Public Library	5.5	613163	Walkway Bollard Light, 70 to 150 W HID, Replace	20	10	10	12	EA	\$1,494.12	\$17,929											\$17,929											\$17,929	
Public Library	6.3	613205	Roof, Single-Ply EPDM Membrane, Replace	20	10	10	4745	SF	\$10.52	\$49,917											\$49,917											\$49,917	
Public Library	6.4	614552	Exterior Wall, Painted Surface, Prep & Paint	10	5	5	12675	SF	\$2.87	\$36,386						\$36,386										\$36,386							\$72,772

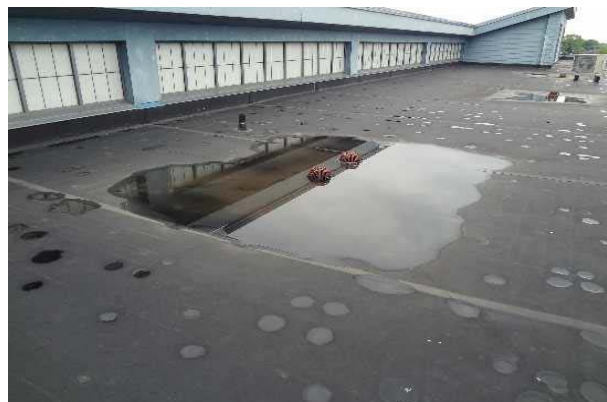
#18:

PONDING AT DRAINS

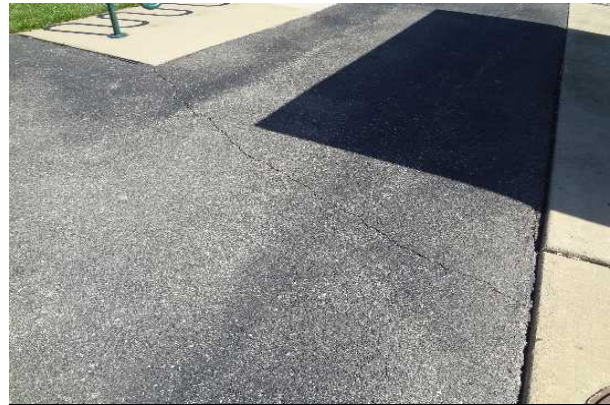
#4: SIDEWALK, MINOR CRACKING

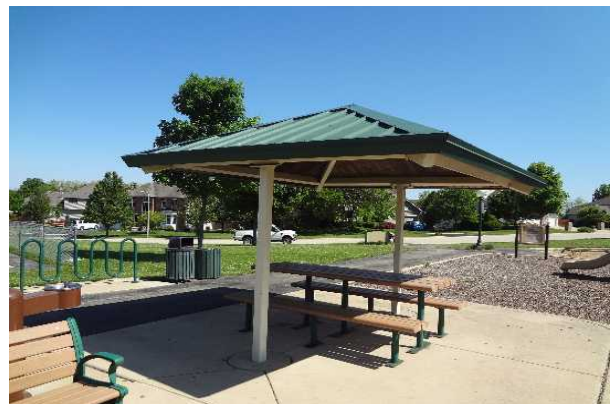
#18: ROOF, METAL

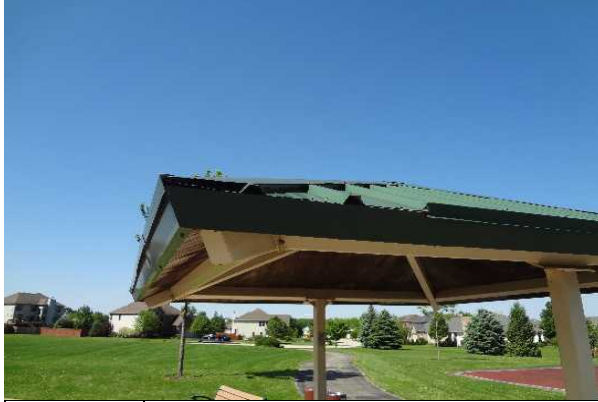
#19:

ROOF, MISSING EDGE

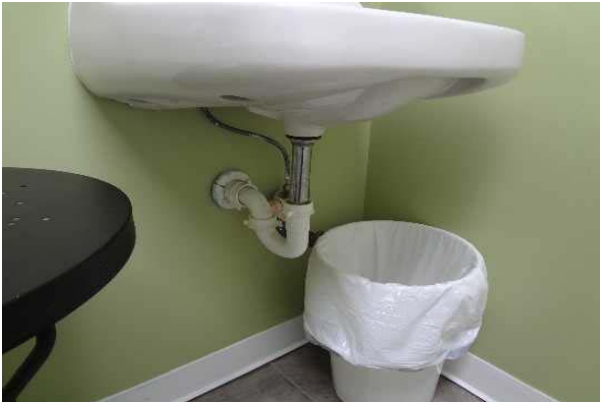
#7:

ADA, RESTROOM, LAVATORY
PIPE WRAPS

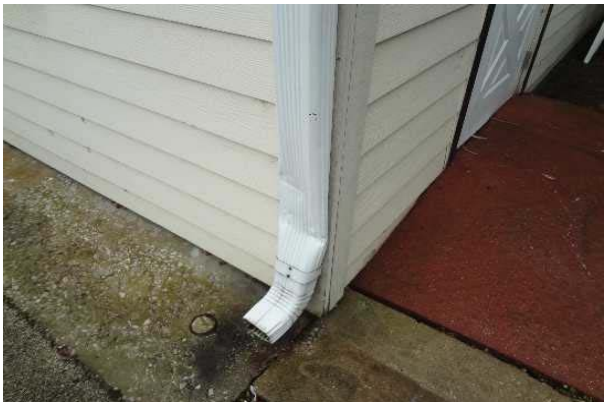
#10:

DAMAGED DOWNSPOUT

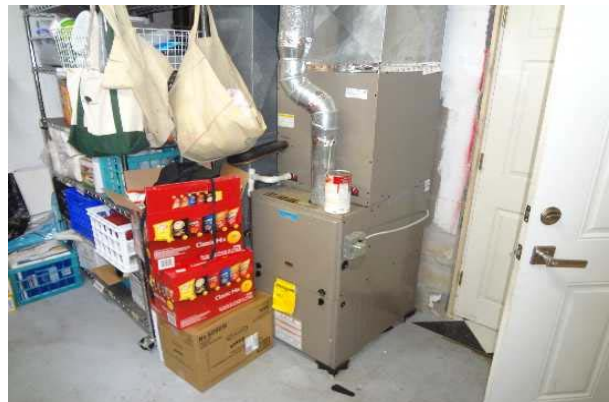
#24: FURNACE, GAS - FOXY'S ICE CREAM

- Replacement of furnace
- Replacement of water heater
- Installation of a complete fire suppression system
- Installation of a complete fire alarm system

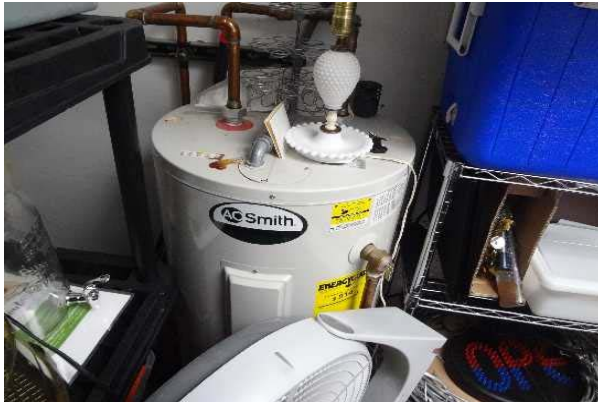
#25: WATER HEATER, ELECTRIC - GINGER + SOUL

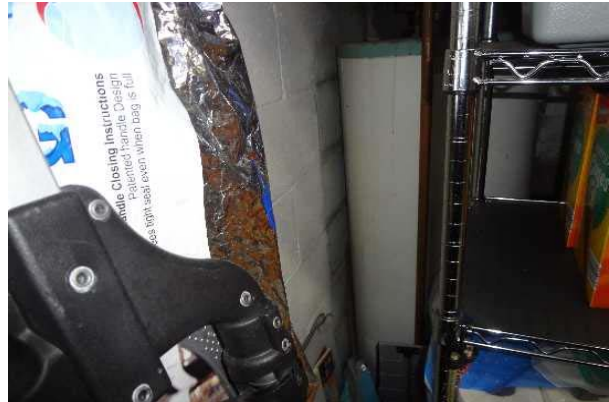
#26: WATER HEATER, ELECTRIC - FOXY'S ICE CREAM

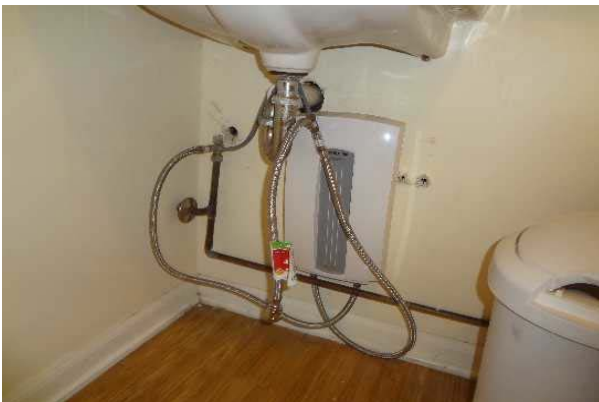
#5: ADA, MISSING LAVATORY PIPE WRAPS

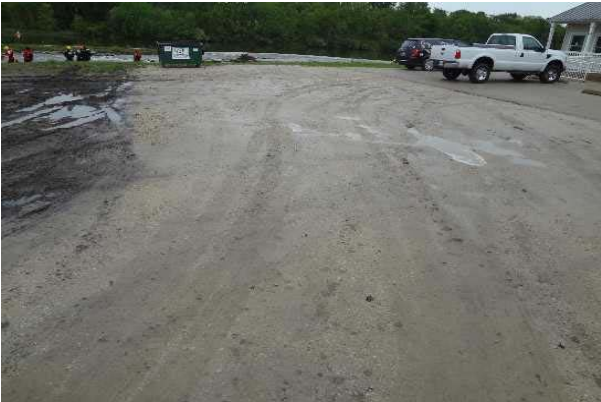
- Full replacement of gravel parking areas

#7:	PARKING LOT, GRAVEL
-----	---------------------

- Full replacement of gravel parking areas
- Installation of a complete fire suppression and alarm system

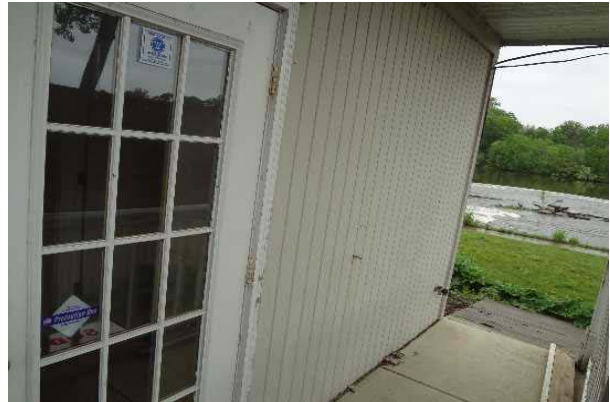
#14:	EXTERIOR WALL, WOOD CLAPBOARD
------	-------------------------------

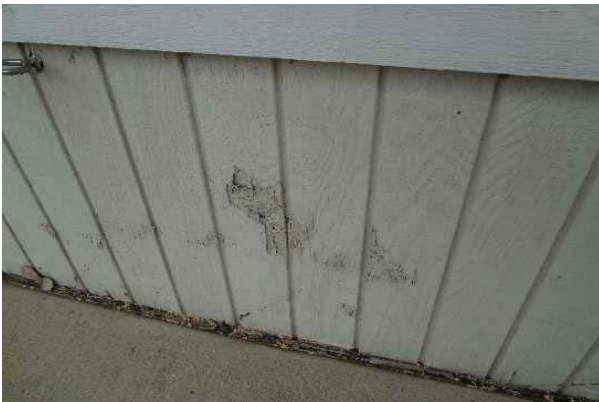
#15:	EXTERIOR WALL, DAMAGED CLAPBOARD
------	----------------------------------

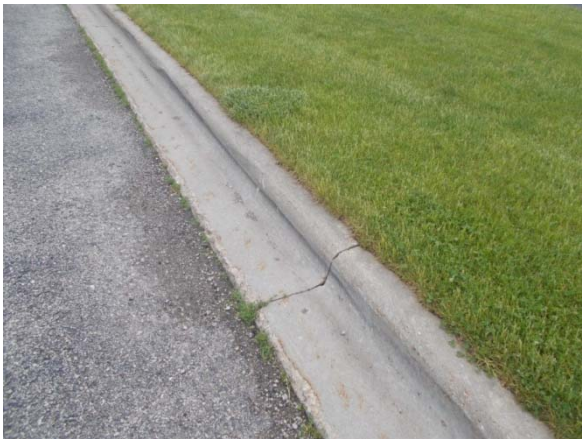
PHOTO #6: CONCRETE CURB
