Title: Building Condition Reports 2017

Meeting and Date: Administration Committee - September 20, 2017

Synopsis: Discussion of the Preliminary Reports from the Building Condition Survey that
EMG performed on City-owned structures and facilities.

FACILITY CONDITION ASSESSMENT

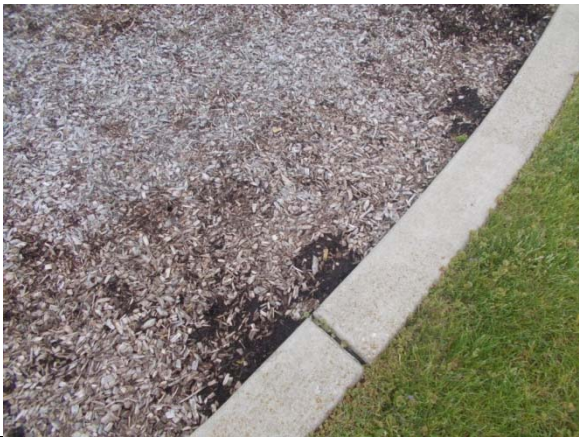
PHOTO #7: CHIP MULCH AND CONCRETE CURB

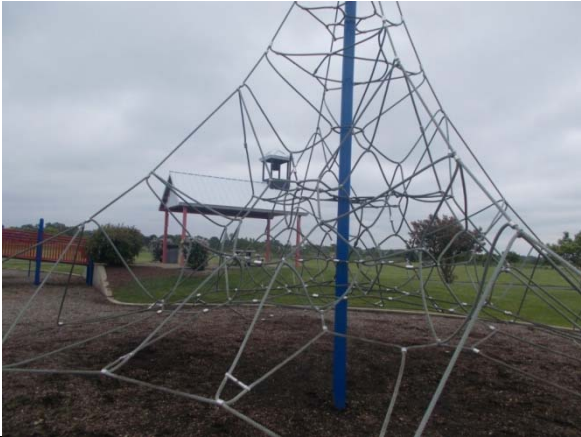
PHOTO #8: CLIMBING APPARATUS

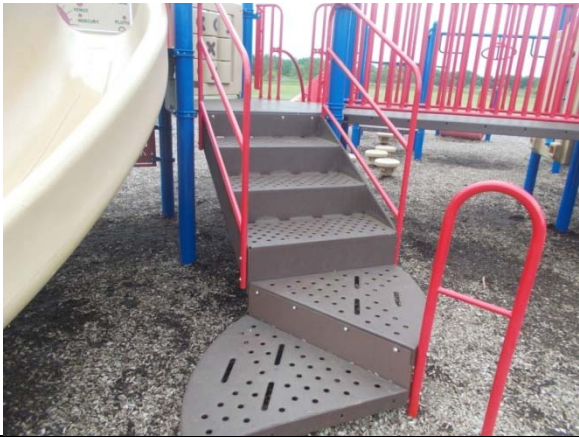
PHOTO #9: STEEL STAIRS

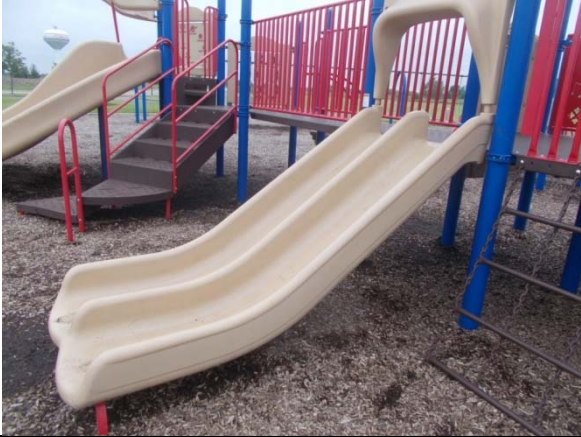
PHOTO #10: PLASTIC SLIDES

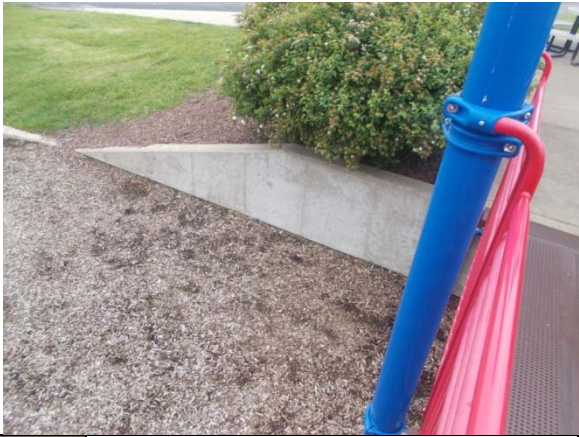
PHOTO #11: CONCRETE RETAINING WALL

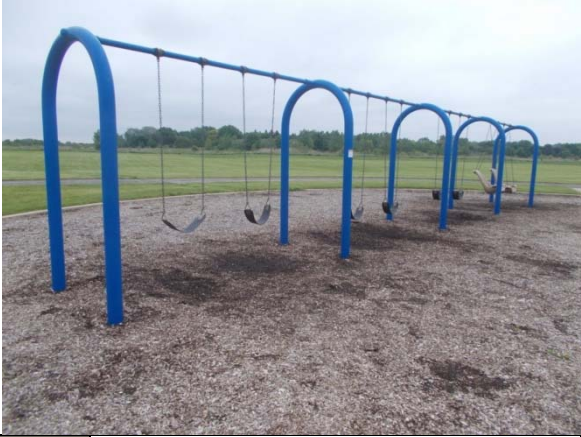
PHOTO #12: SWINGS

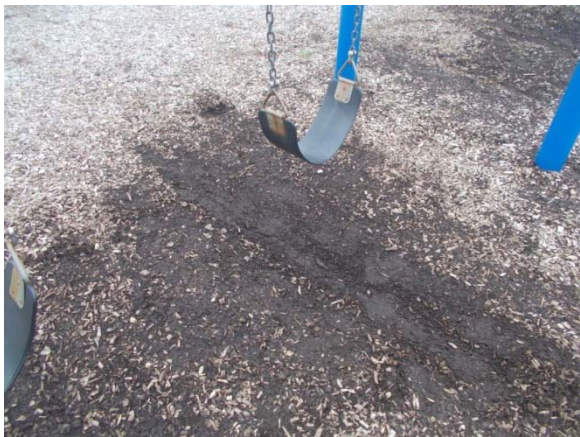
PHOTO #13: MULCH UNDER SWING

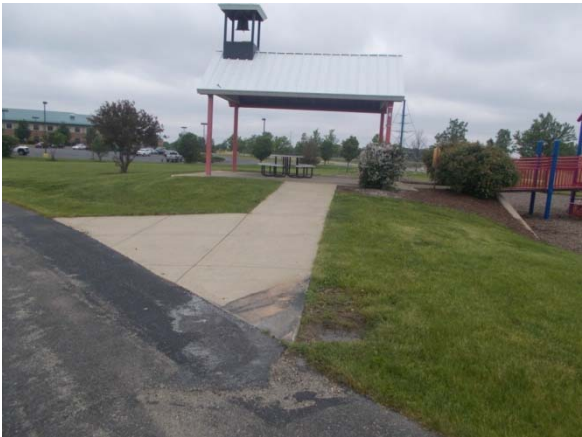
PHOTO #14: ASPHALT AND CONCRETE WALKWAY

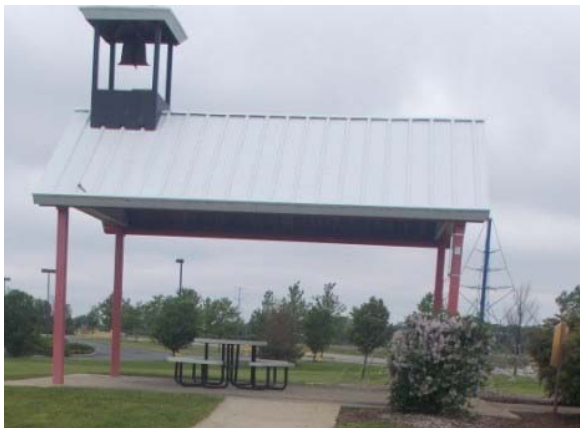
PHOTO #15: FRONT ELEVATIONS - SHELTER

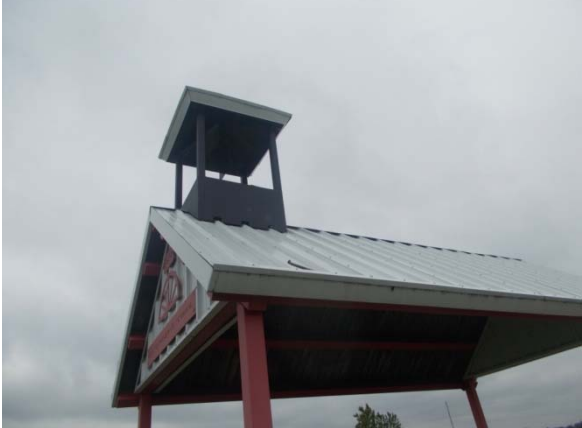
PHOTO #16: STEEL ROOF OF SHELTER

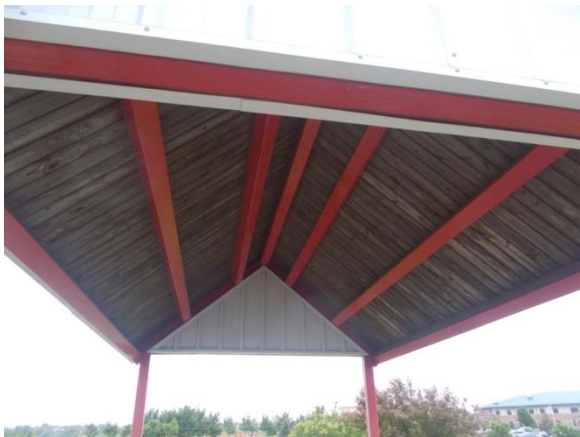
PHOTO #17: CEILING OF SHELTER

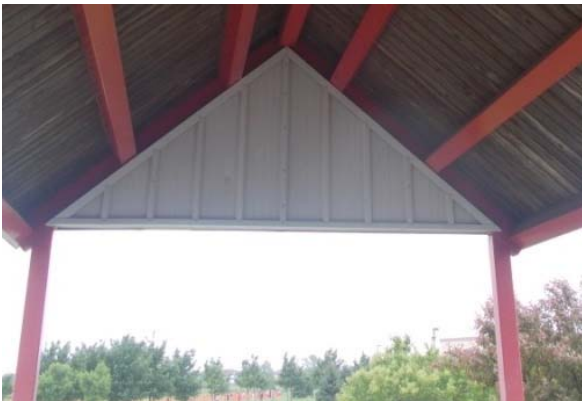
PHOTO #18: PAINTED STEEL WALL OF SHELTER

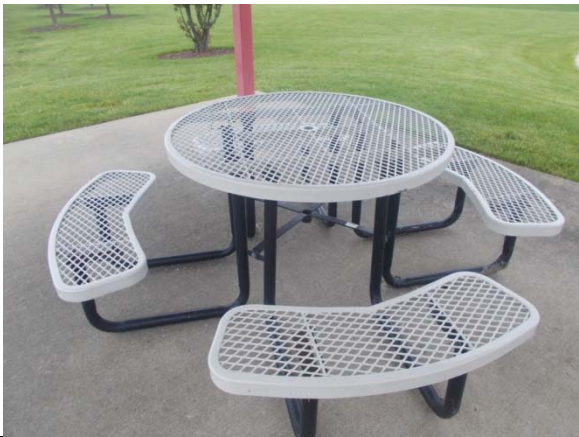
PHOTO #19: PARK BENCH

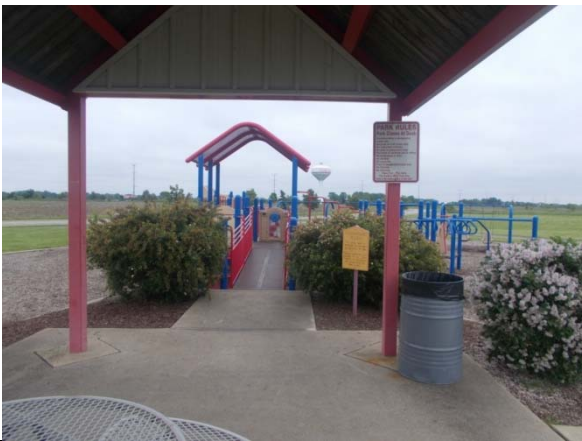
PHOTO #20: CONCRETE FLOOR AT SHELTER

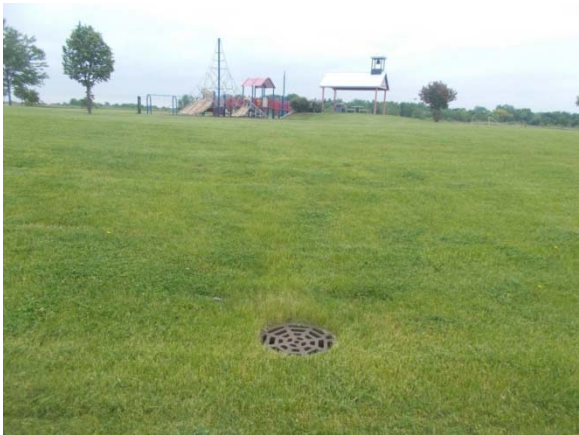
PHOTO #21: DRAINAGE AND LANDSCAPING

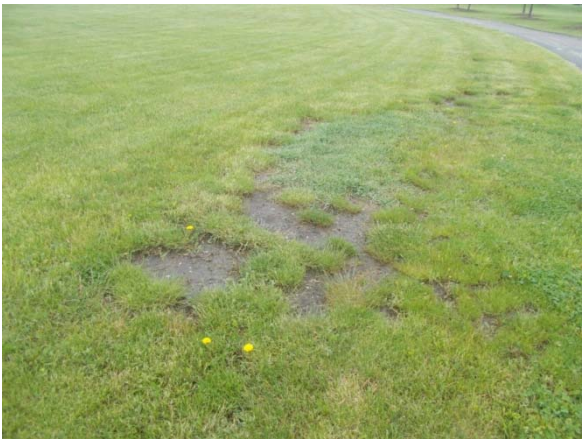
PHOTO #22: LANDSCAPING

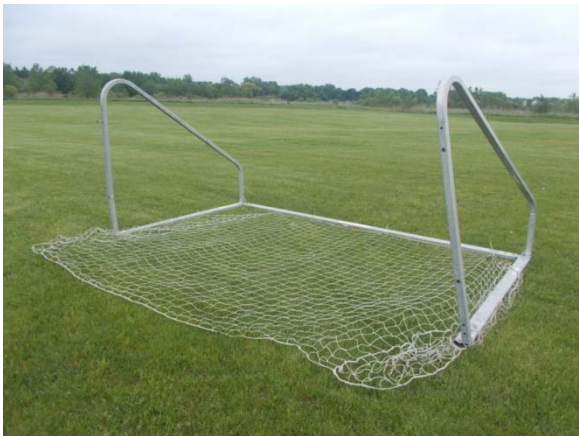
PHOTO #23: SOCCER GOAL

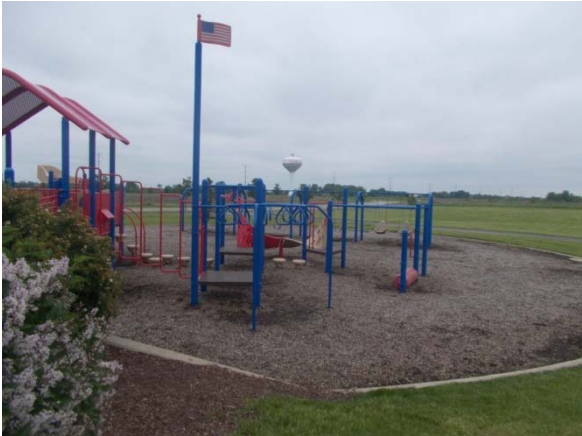
PHOTO #24: PLAY AREA

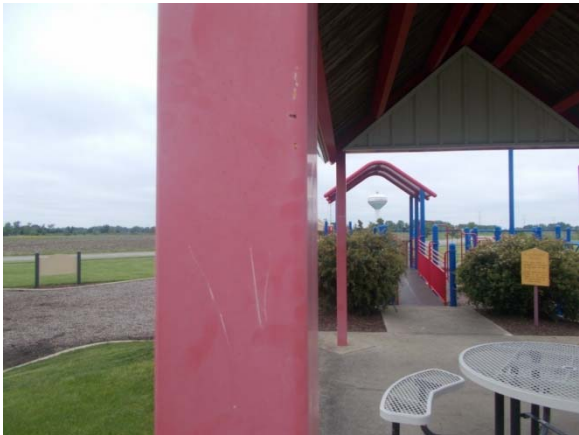
PHOTO #25: PAINTED STEEL POST

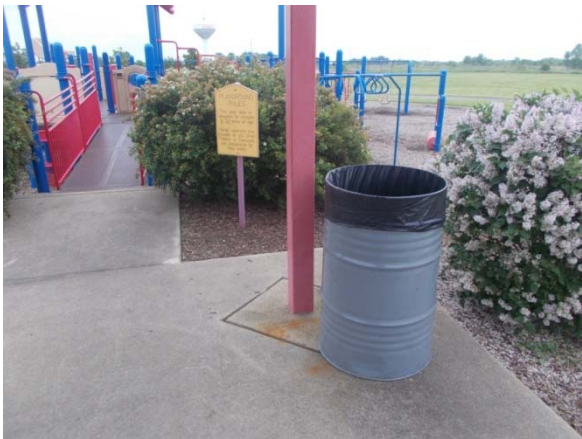
PHOTO #26: WASTE COLLECTION

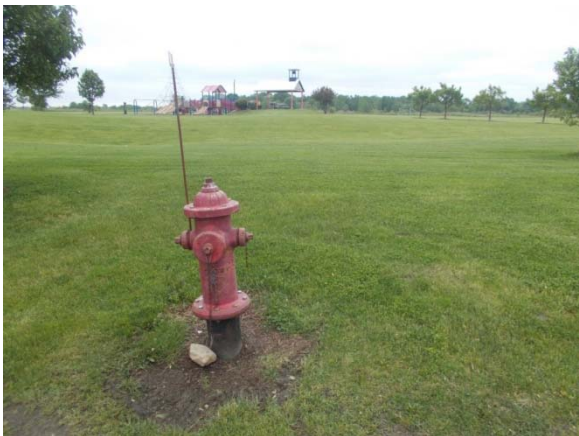
PHOTO #27: HYDRANT

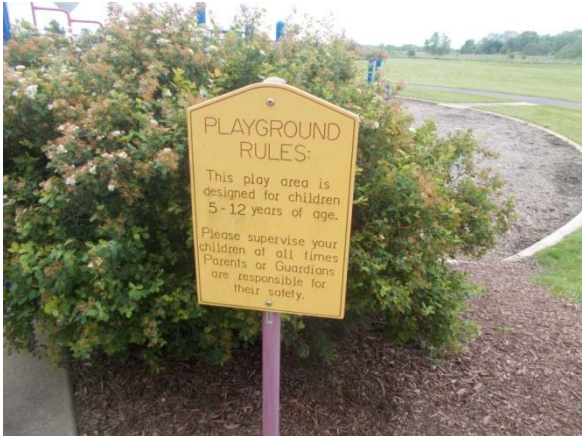
PHOTO #28: INSTRUCTION SIGN

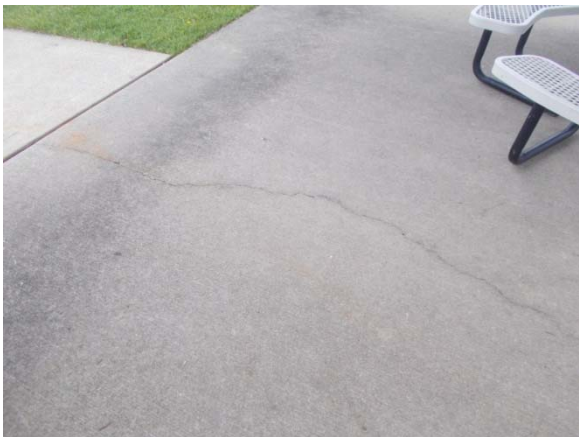
PHOTO #29: CRACKED CONCRETE

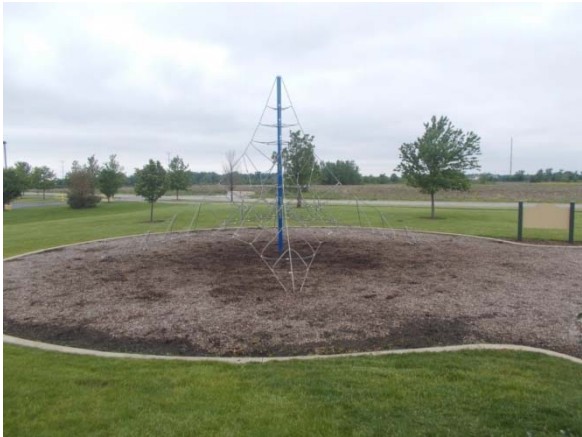
PHOTO #30: MULCH AND CLIMBING APPARATUS

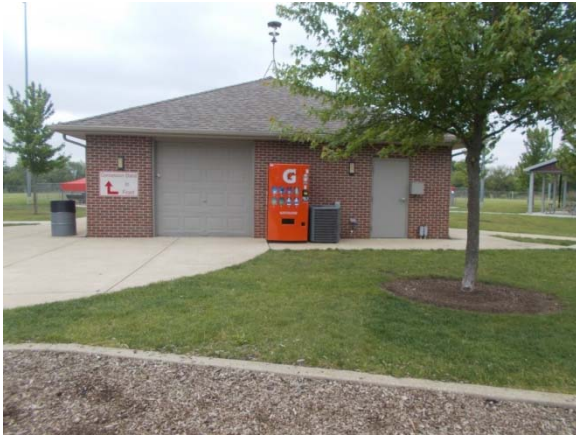
PHOTO #1: FRONT ELEVATION

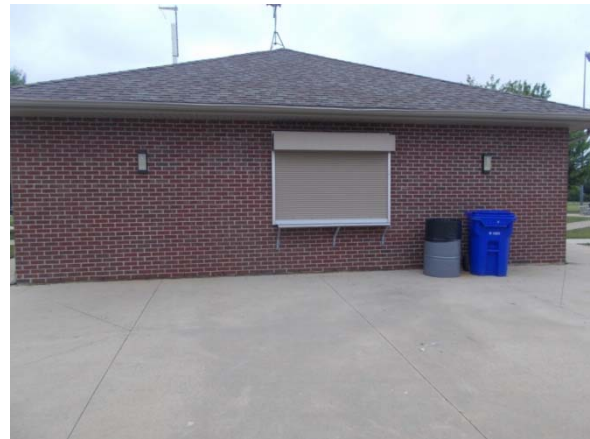
PHOTO #2: REAR ELEVATION

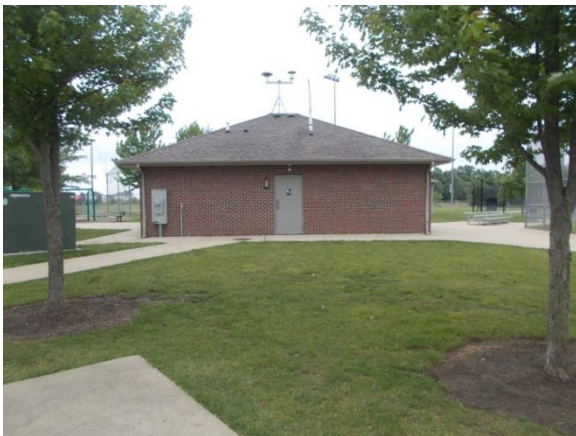
PHOTO #3: EAST ELEVATION

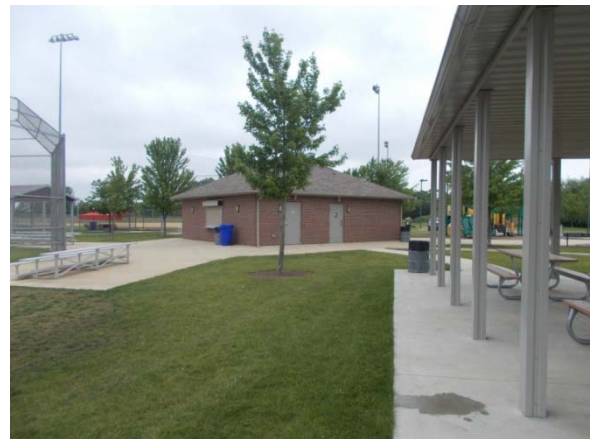
PHOTO #4: WEST ELEVATION

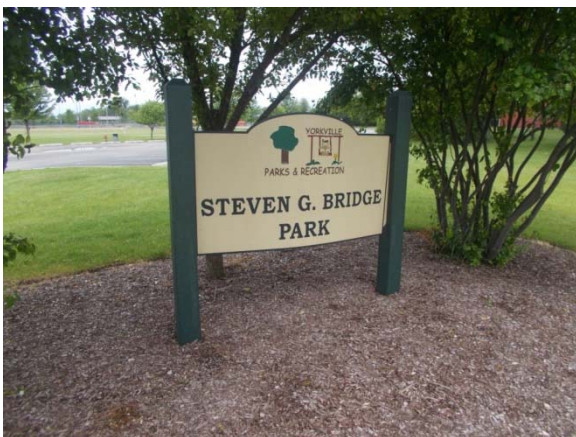
PHOTO #5: PARK SIGN

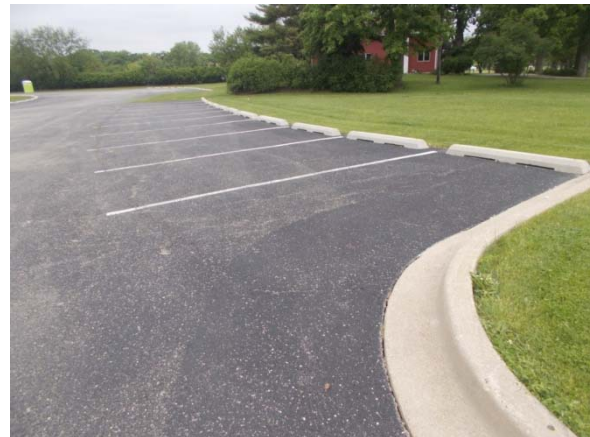
PHOTO #6: PARKING – ASPHALT AND CURB

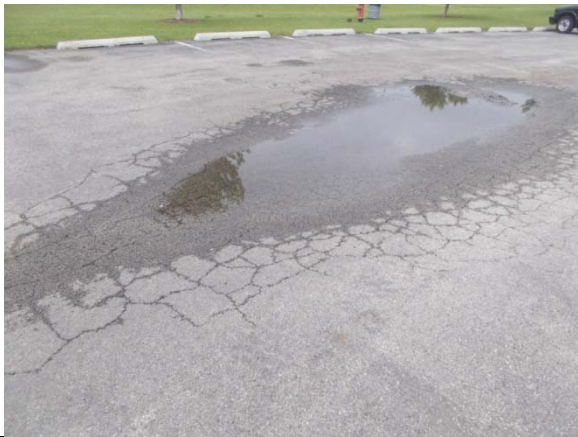
PHOTO #7: *DETERIORATED ASPHALT*

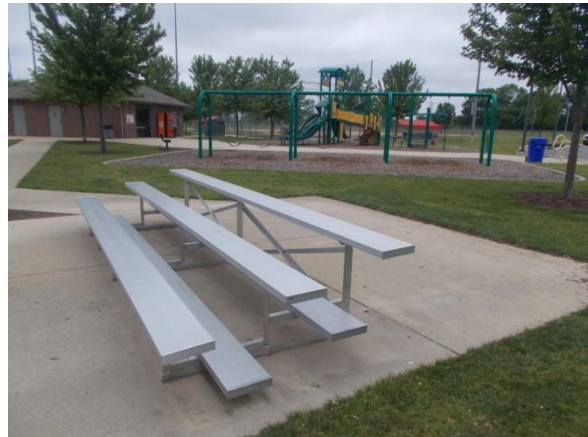
PHOTO #8: *BLEACHER*

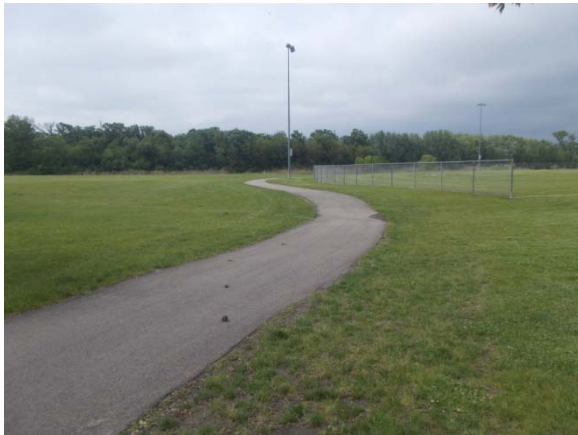
PHOTO #9: *SITE ASPHALT WALKWAY*

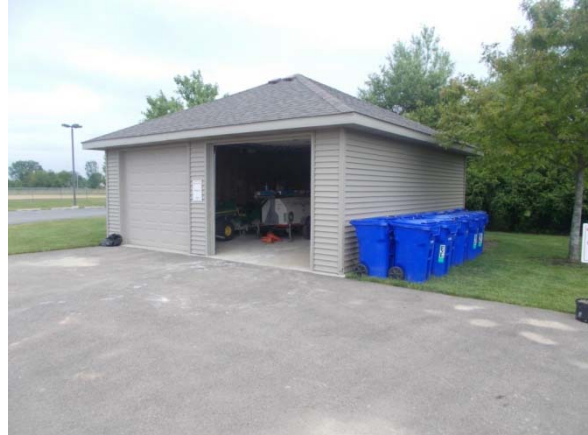
PHOTO #10: *GARAGE*

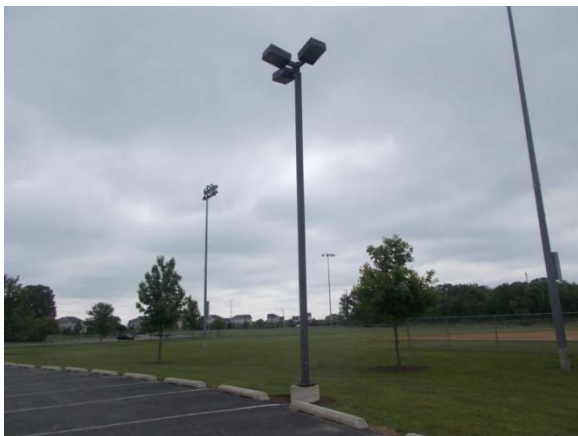
PHOTO #11: *SITE PARKING LIGHTING*

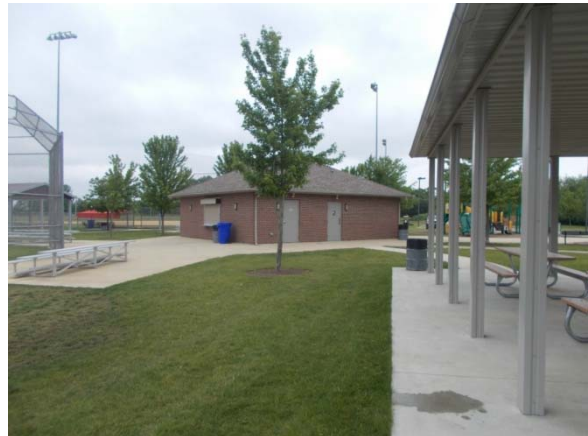
PHOTO #12: *LANDSCAPING*

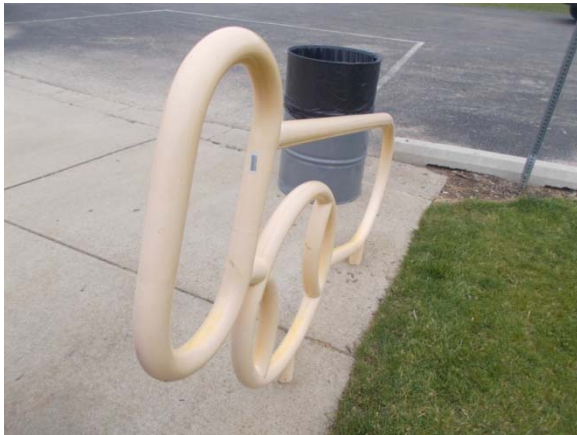
PHOTO #13: BICYCLE RACK

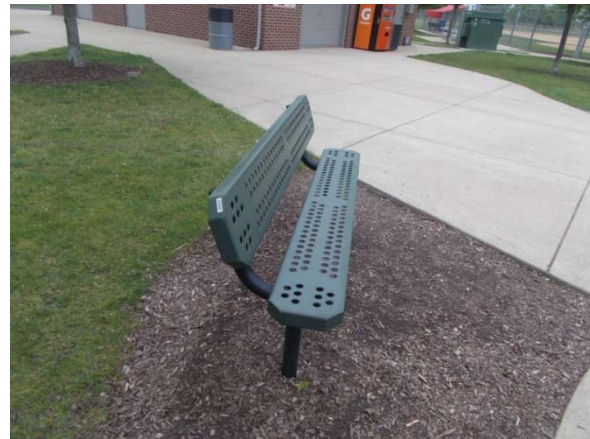
PHOTO #14: STEEL BENCH

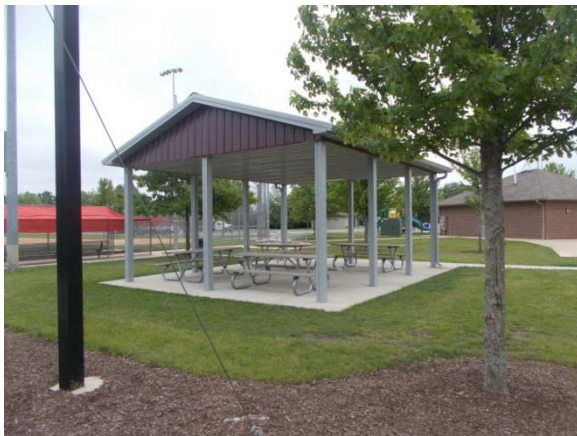
PHOTO #15: SHELTER

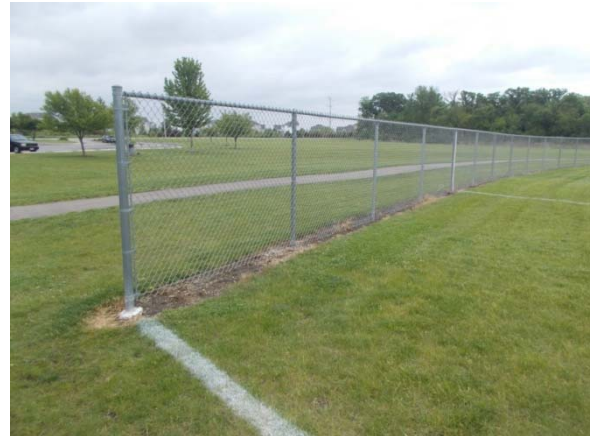
PHOTO #16: SITE FENCING

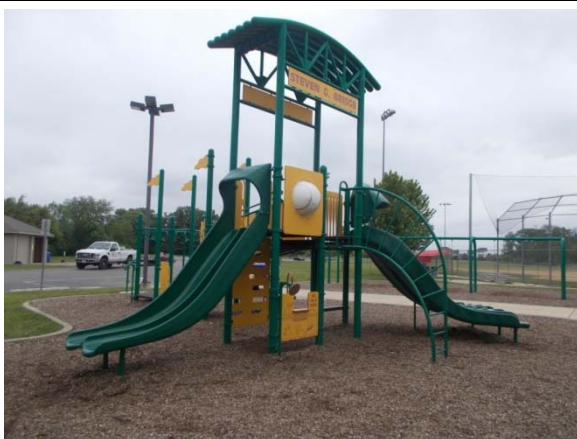
PHOTO #17: PLAY STRUCTURE

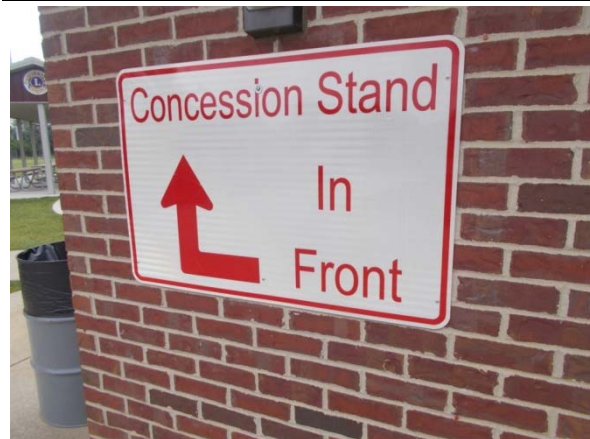
PHOTO #18: BUILDING SIGN

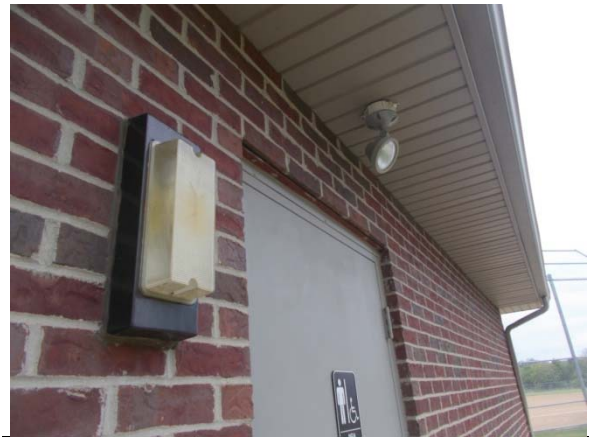
PHOTO
#20: EXTERIOR LIGHTS

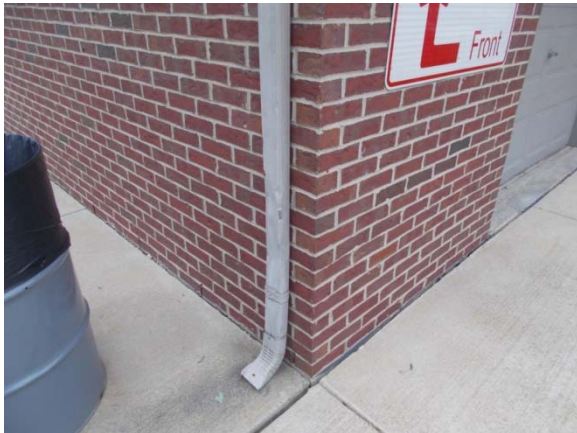
PHOTO
#21: DOWNSPOUT - GUTTER

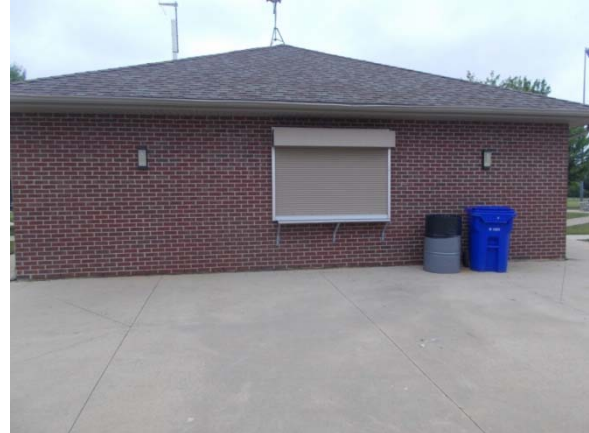
PHOTO
#22: ROOF AND GUTTERS

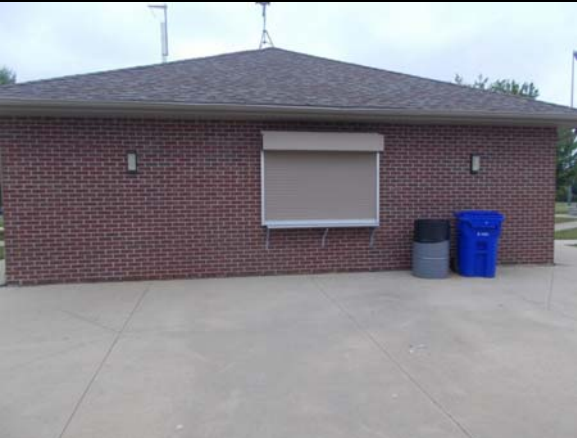
PHOTO
#23: MASONRY

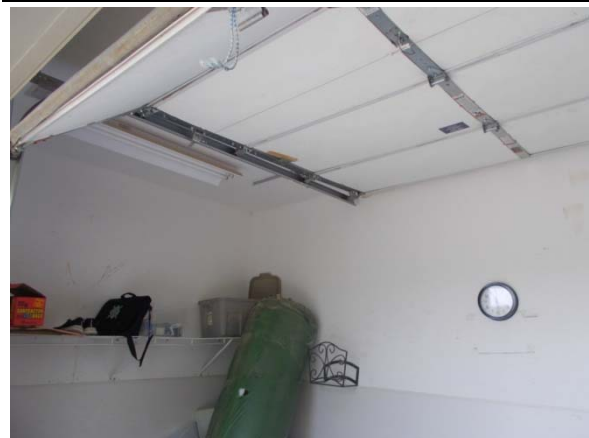
PHOTO
#24: OVERHEAD DOOR

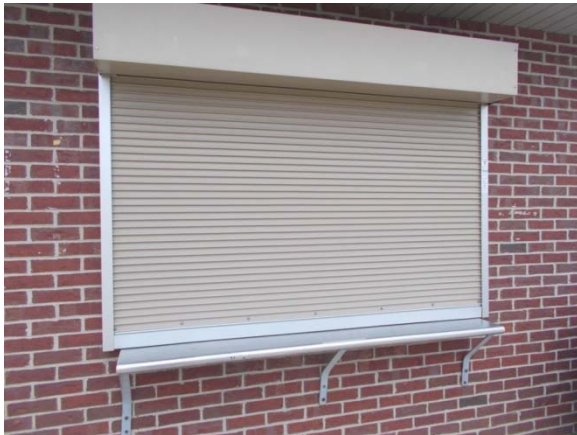
PHOTO #25: EXTERIOR ROLL-UP WINDOW

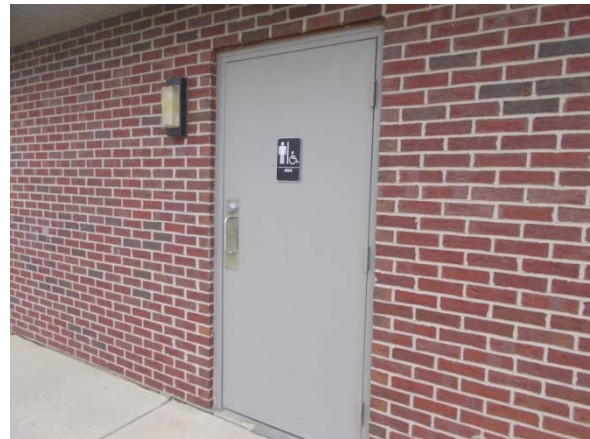
PHOTO #26: EXTERIOR DOOR

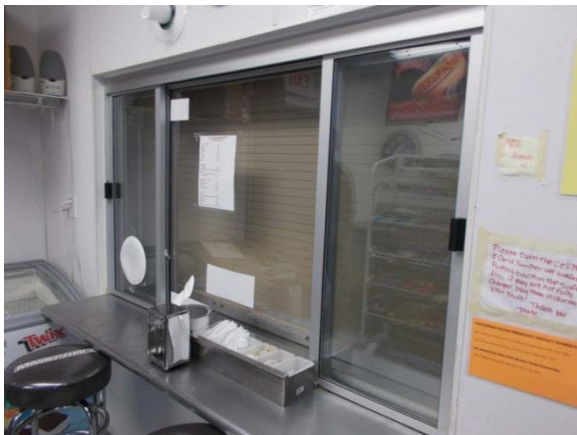
PHOTO #27: SLIDING ALUMINUM WINDOW

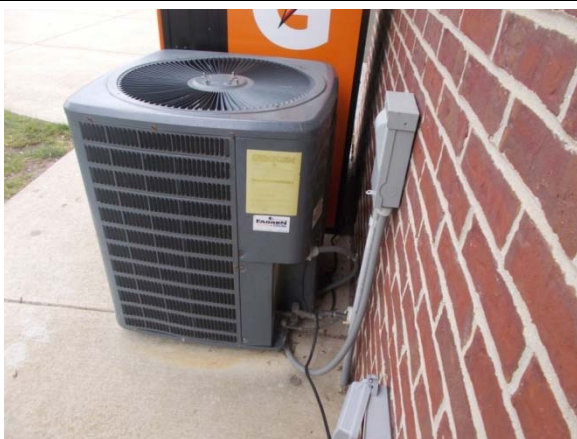
PHOTO #29: CONDENSING UNIT

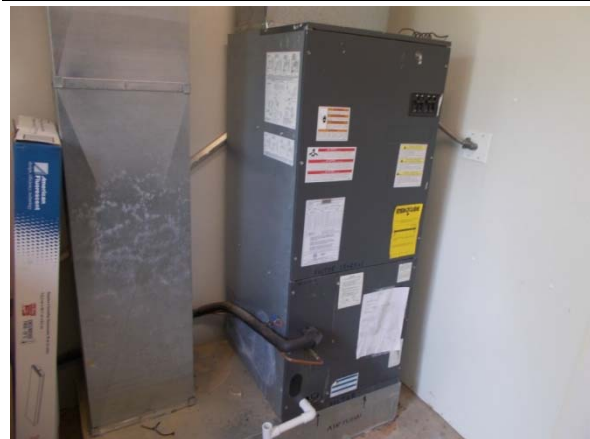
PHOTO #30: FURNACE

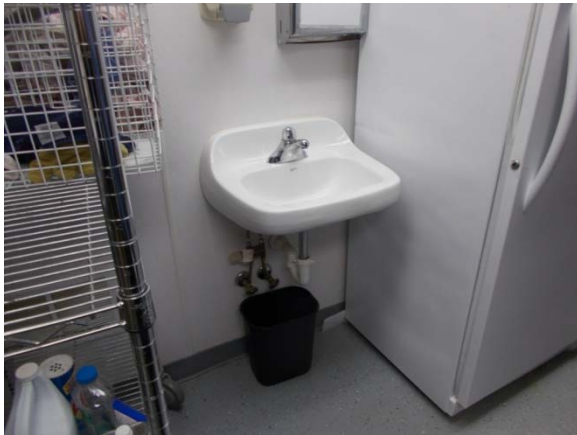
PHOTO #31: KITCHEN SINK

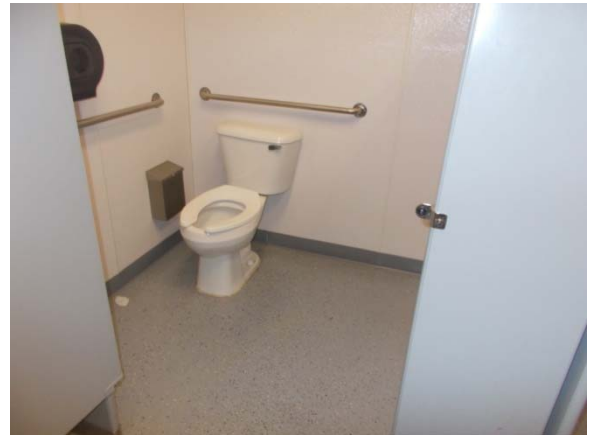
PHOTO #32: RESTROOM TOILET

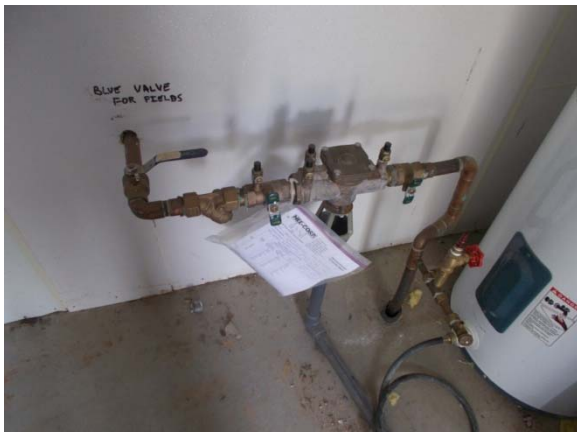
PHOTO #33: BACKFLOW PREVENTER

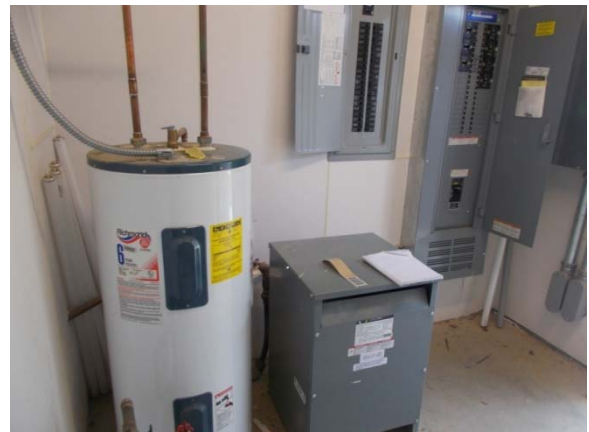
PHOTO #34: ELECTRIC WATER HEATER

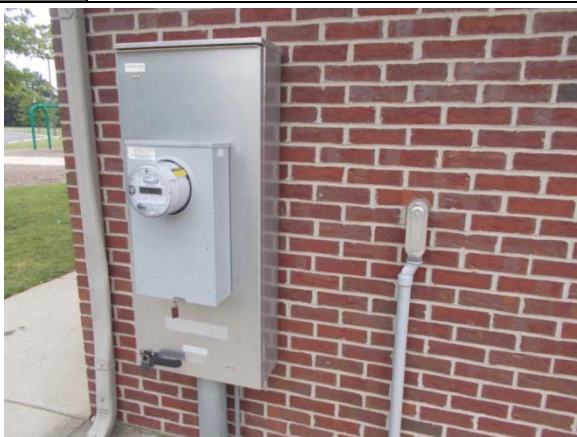
PHOTO #35: ELECTRICAL SERVICE AND METER

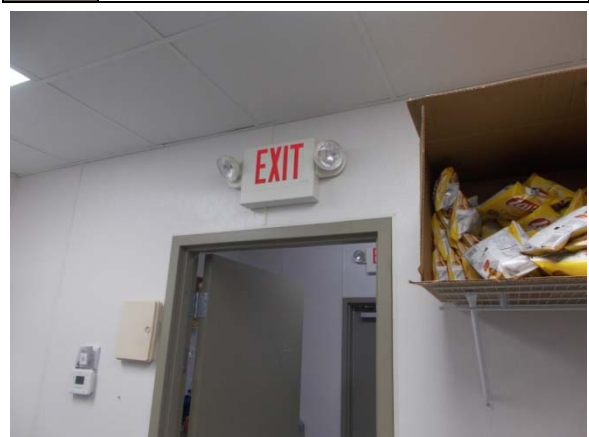
PHOTO #36: EXIT-EMERGENCY LIGHT

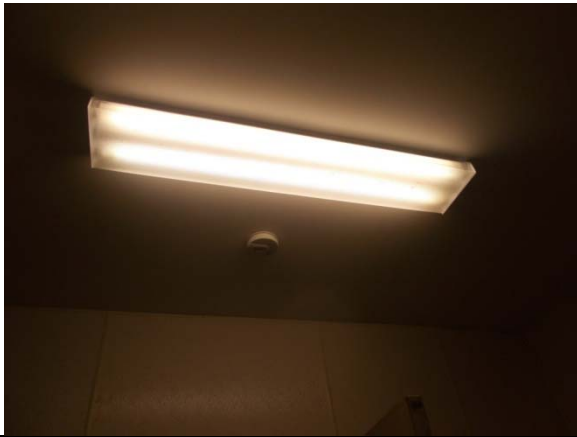
PHOTO #37: INTERIOR T-8 LIGHT

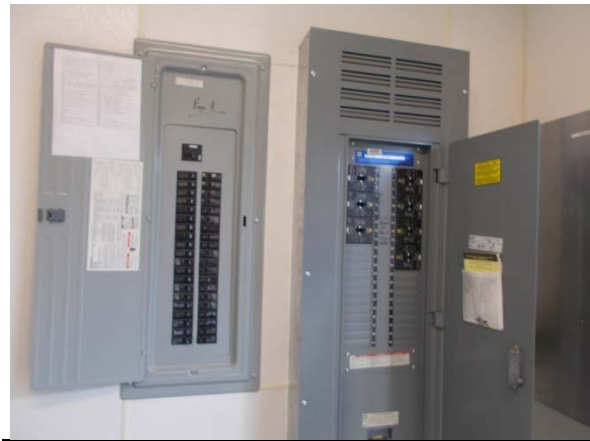
PHOTO #38: ELECTRICAL PANELS

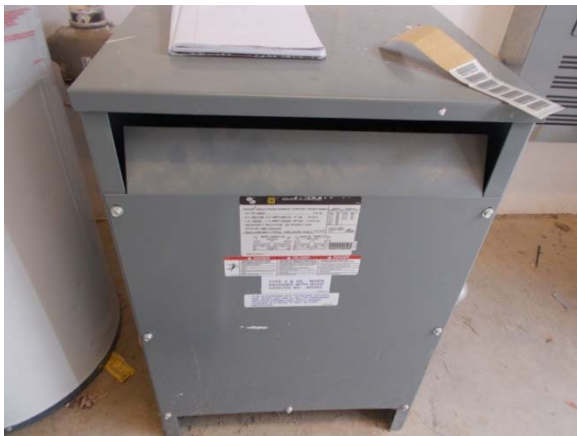
PHOTO #39: STEP DOWN TRANSFORMER

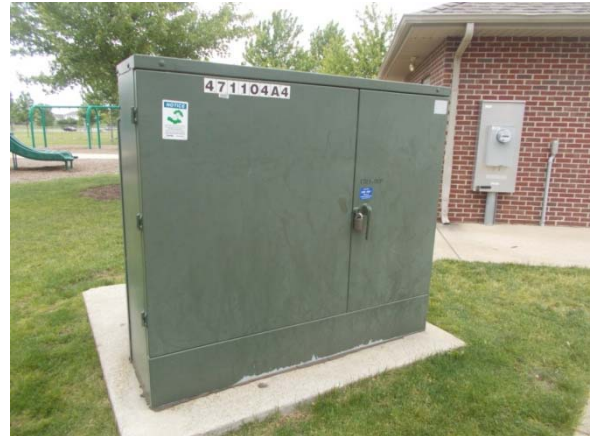
PHOTO #40: MAIN TRANSFORMER

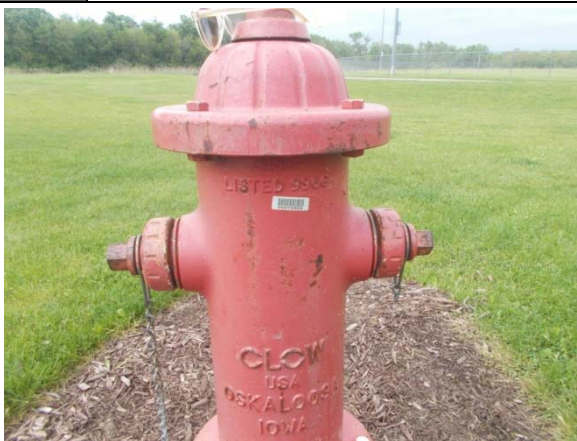
PHOTO #41: HYDRANT

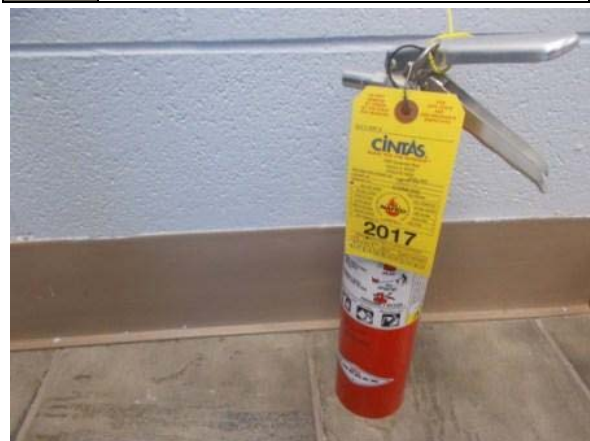
PHOTO #42: FIRE EXTINGUISHER

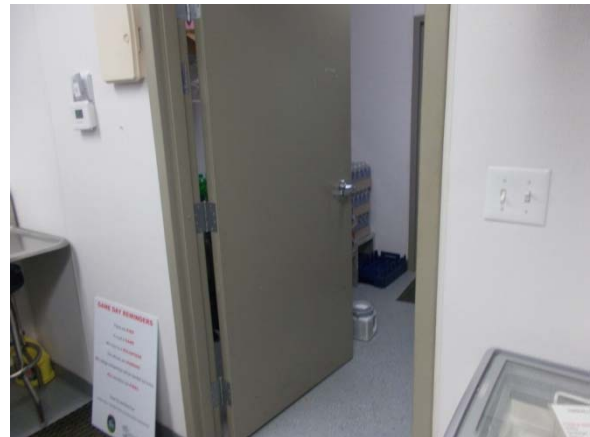
PHOTO #44: INTERIOR DOOR

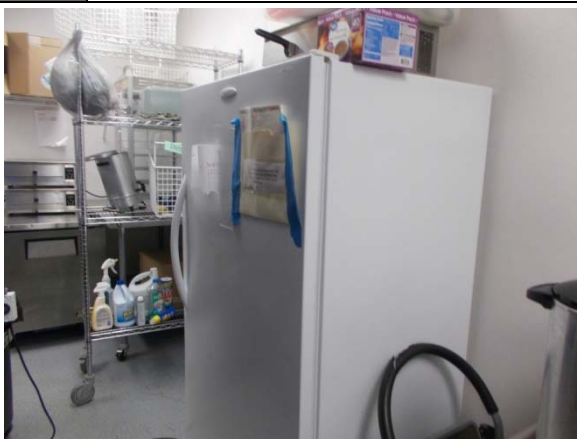
PHOTO #47: REFRIGERATOR

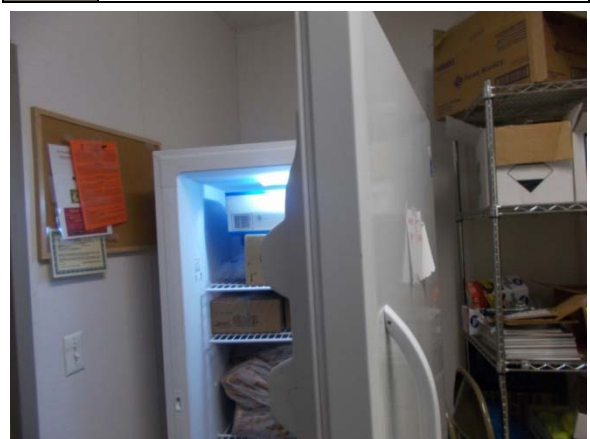
PHOTO #48: FREEZER

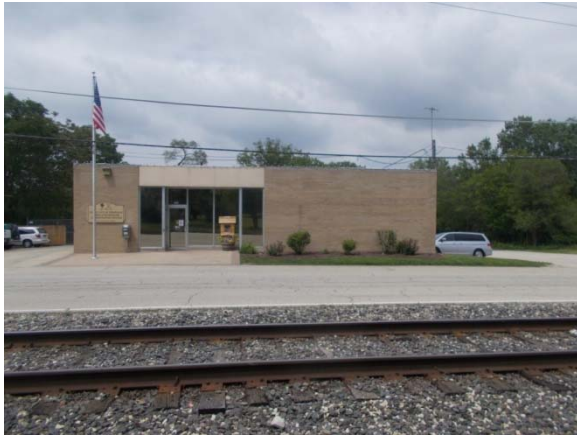
PHOTO #1: LOCATION OF PARKS STORAGE SHED

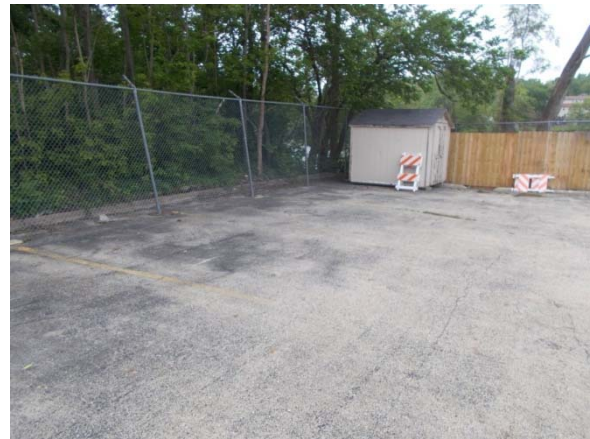
PHOTO #2: SITE AND SHED

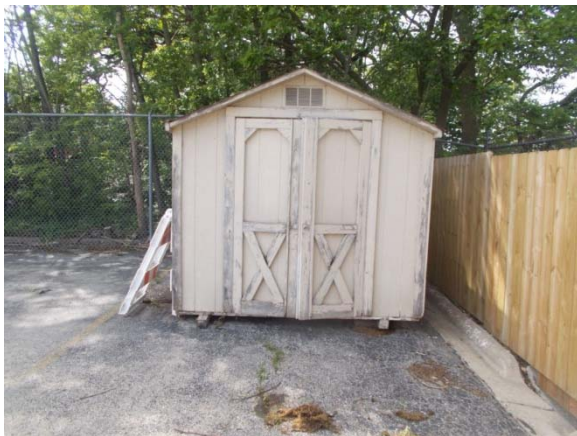
PHOTO #3: FRONT ELEVATION

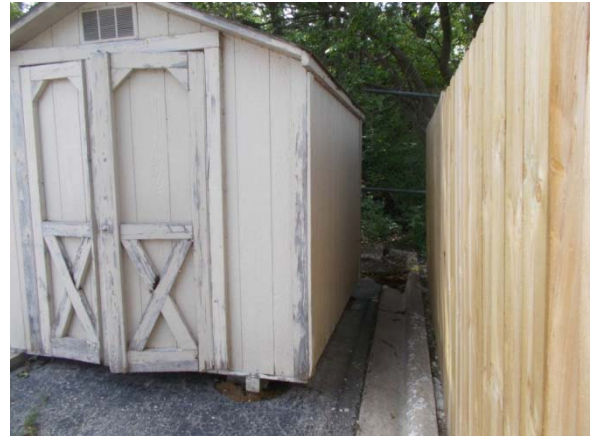
PHOTO #4: VIEW SHOWING RIGHT SIDE ELEVATION

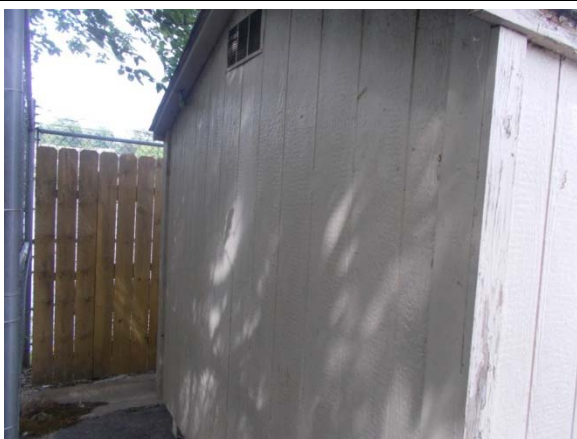
PHOTO #5: VIEW SHOWING REAR VIEW OF SHED

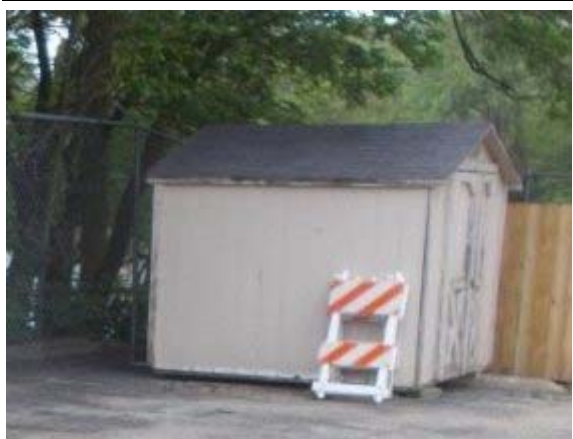
PHOTO #6: LEFT ELEVATION

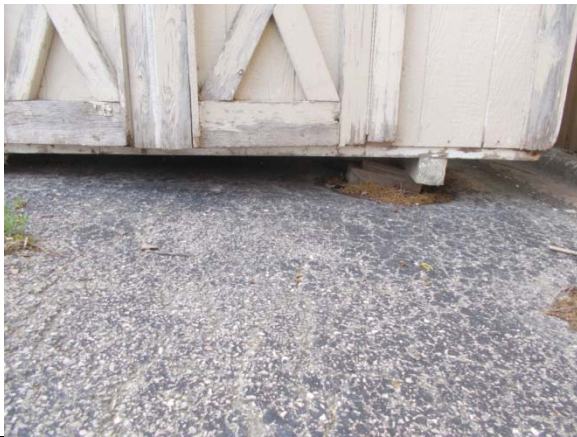
PHOTO #7: FOOTING (SUPPORT) OF SHED

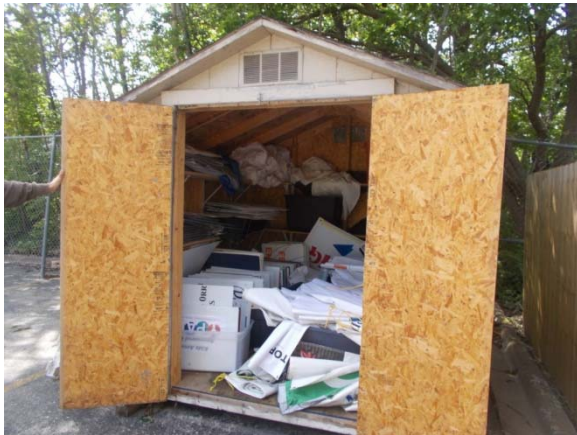
PHOTO #9: SHED WITH OPENED DOORS

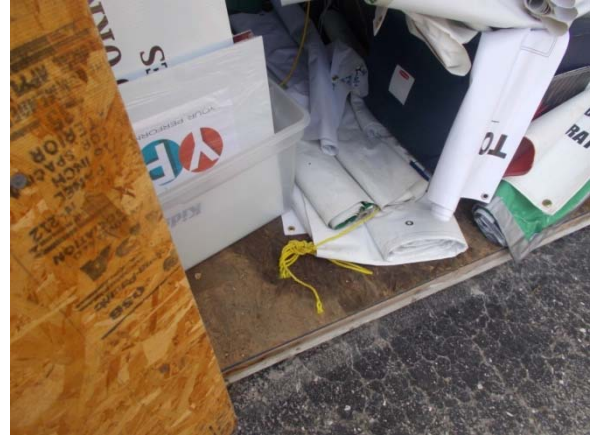
PHOTO #10: SHED PLYWOOD FLOOR DETAIL

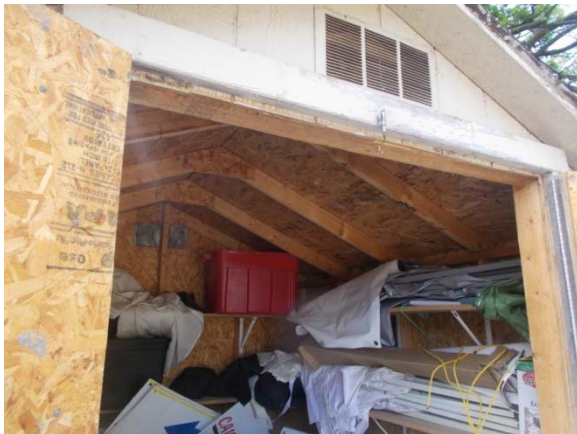
PHOTO #11: SHED CEILING DETAIL

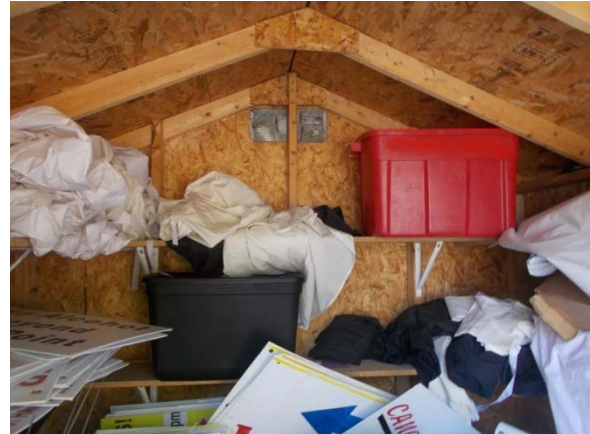
PHOTO #12: SHED FAR WALL VIEW, VENT

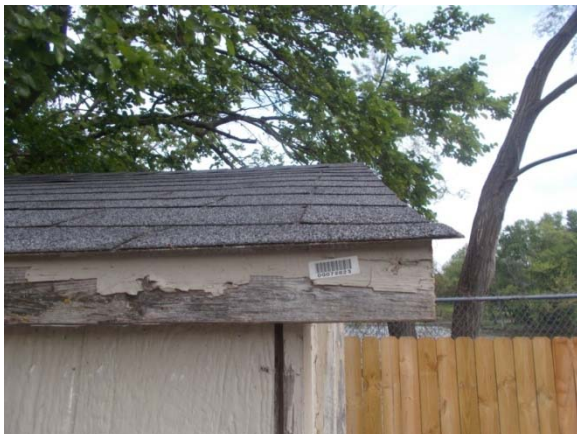
PHOTO #15: SHED ROOF DETAIL

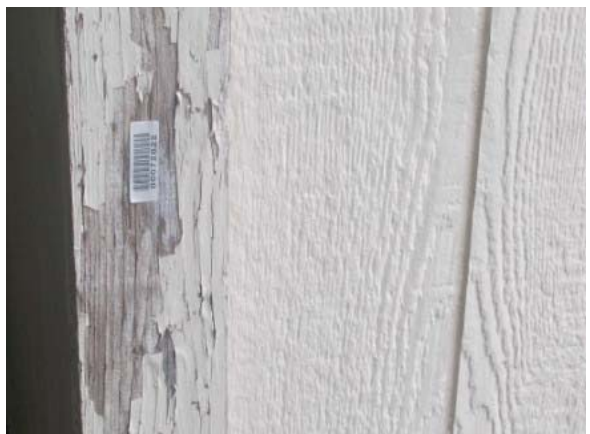
PHOTO #16: SIDING DETAIL

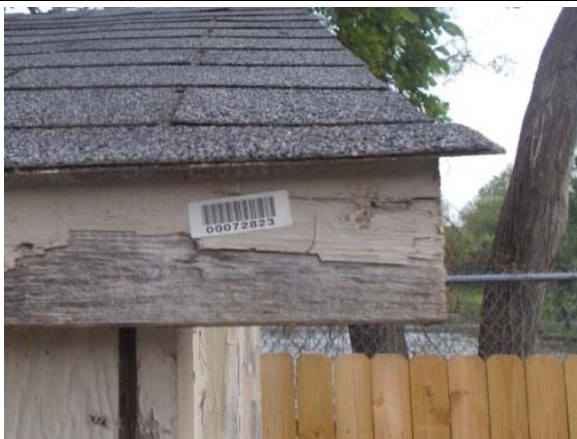
PHOTO #17: SHED FACIA

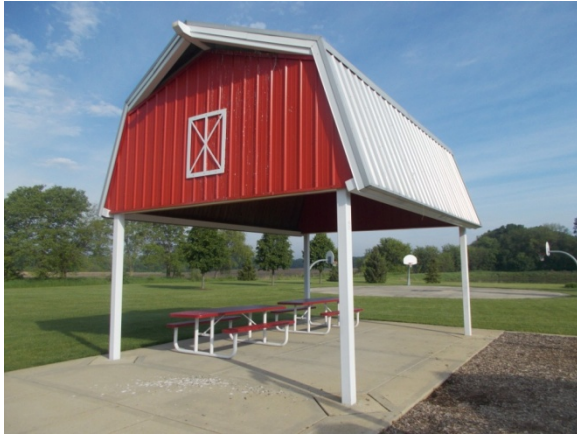
PHOTO #1: METAL PARK SHELTER

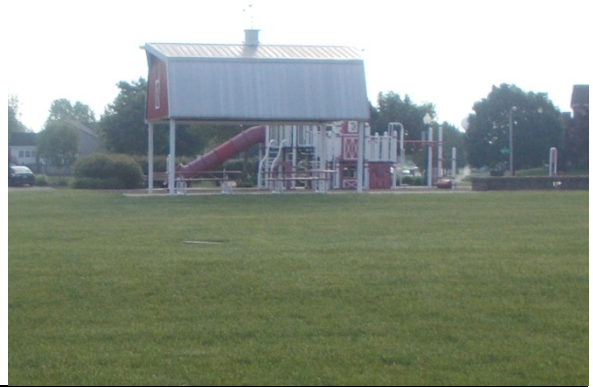
PHOTO #2: SIDE VIEW OF SHELTER

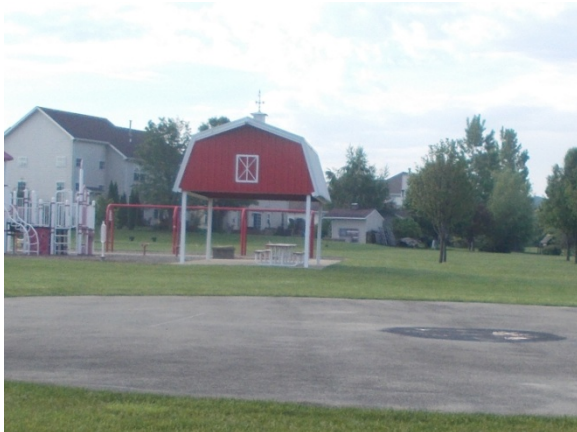
PHOTO #3: END VIEW OF SHELTER

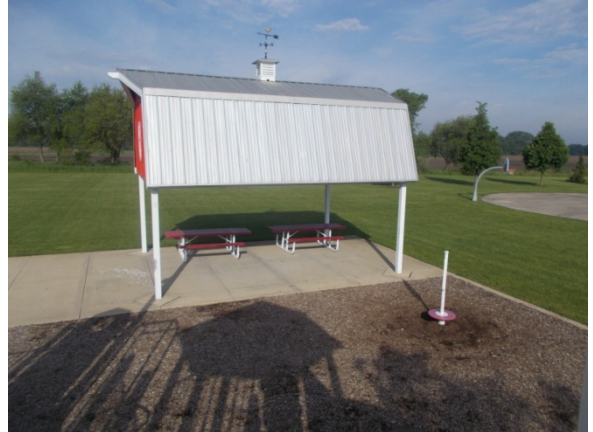
PHOTO #4: CONCRETE UNDER SHELTER

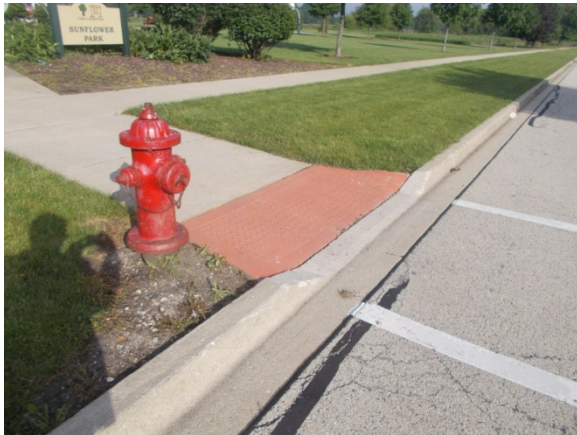
PHOTO #7: ADA ACCESSIBLE ENTRANCE

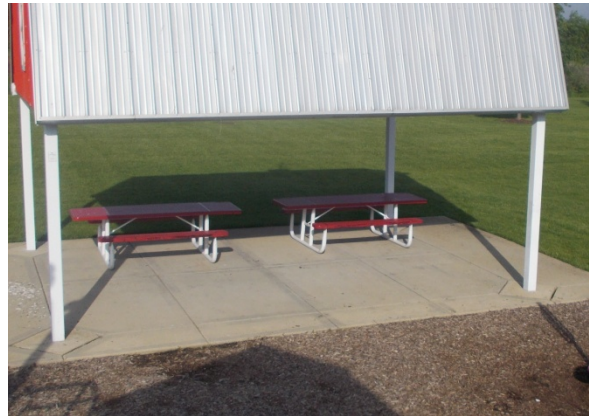
PHOTO #8: INSIDE VIEW OF SHELTER

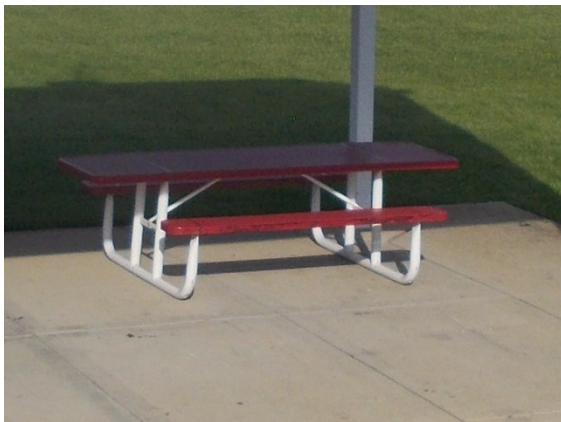
PHOTO #9: BENCH

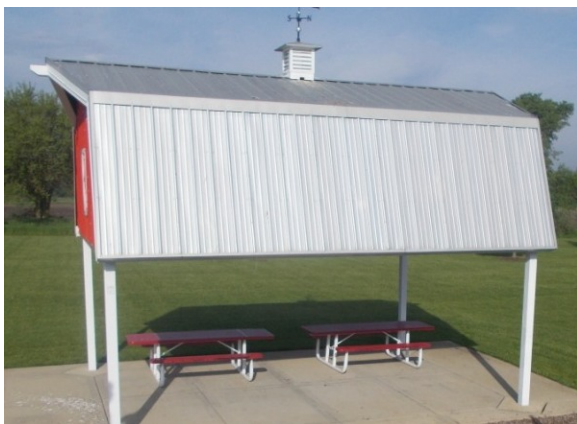
PHOTO #11: METAL ROOF
