Title: Building Condition Reports 2017

Meeting and Date: Administration Committee - September 20, 2017

Synopsis: Discussion of the Preliminary Reports from the Building Condition Survey that
EMG performed on City-owned structures and facilities.

FACILITY CONDITION ASSESSMENT

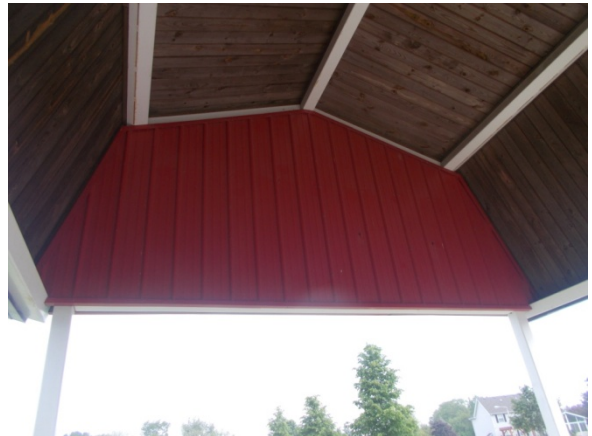
PHOTO #12: CEILING AND INTERIOR WALL DETAIL

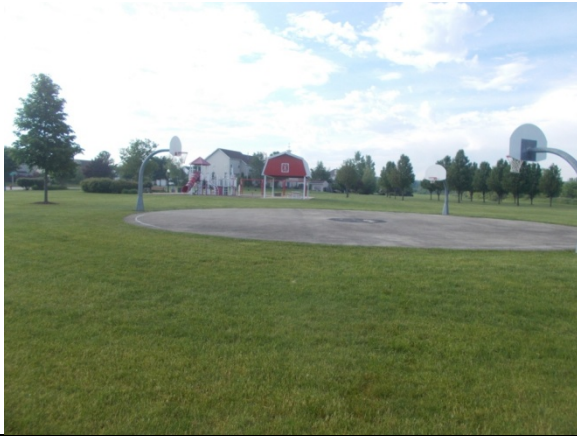
PHOTO #13: LANDSCAPING

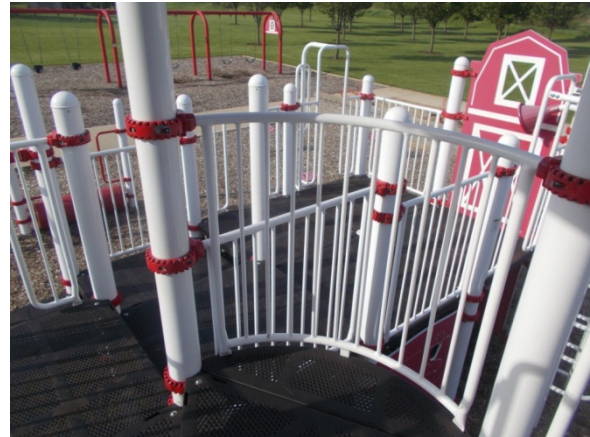
PHOTO #14: METAL RAILING

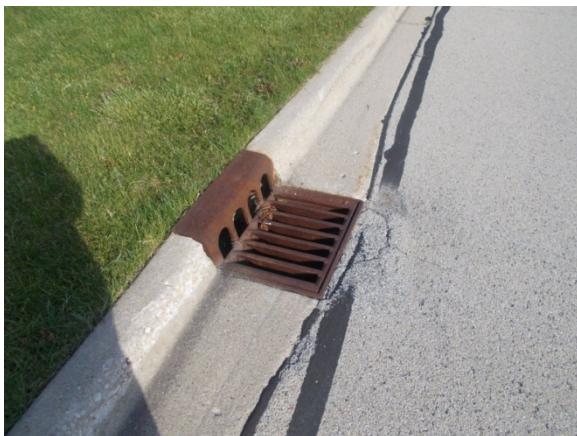
PHOTO #15: STORM DRAIN

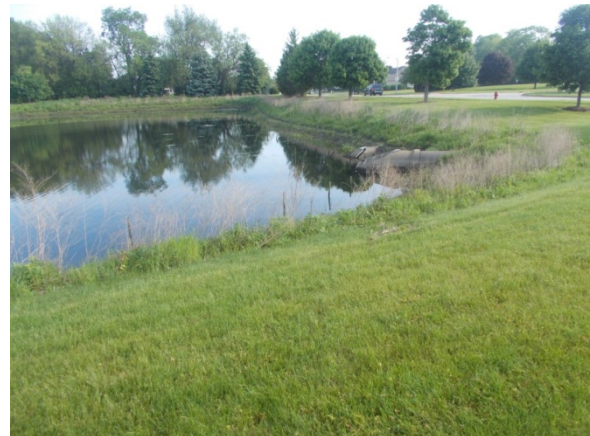
PHOTO #16: LANDSCAPING

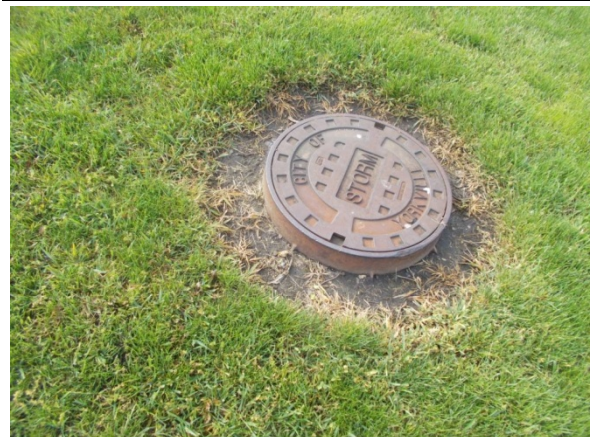
PHOTO #18: STORM SEWER DRAIN

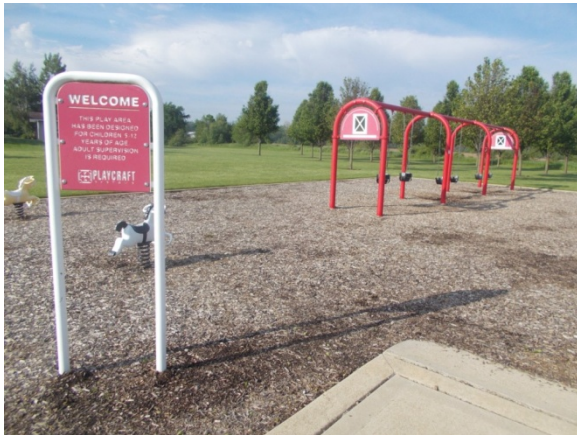
PHOTO #19: SWING SET

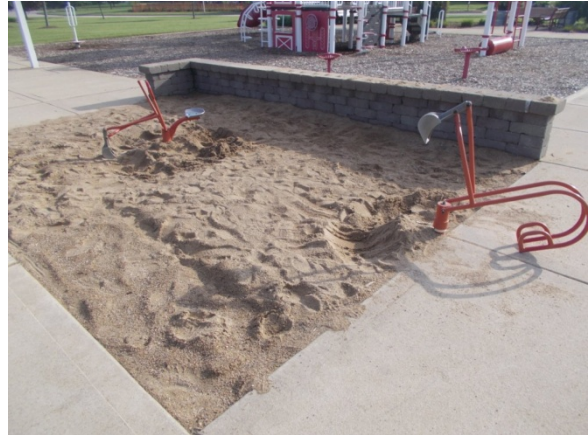
PHOTO #20: SAND PLAY AREA

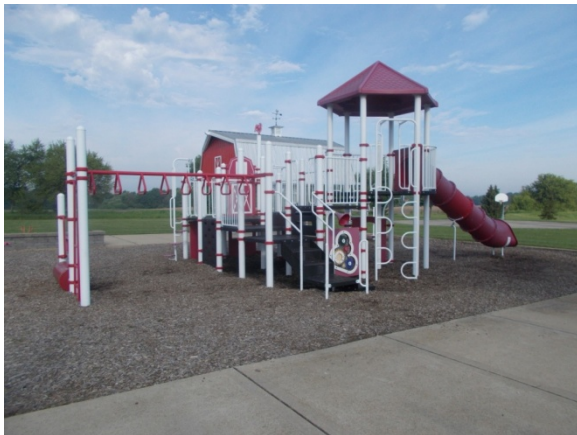
PHOTO #21: PLAY STRUCTURE

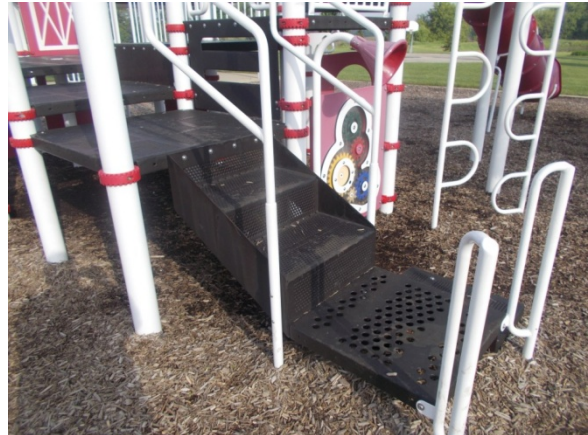
PHOTO #22: METAL STAIRS

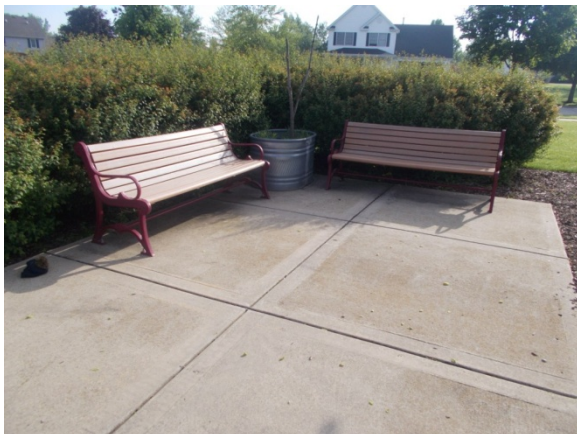
PHOTO #23: PARK BENCHES

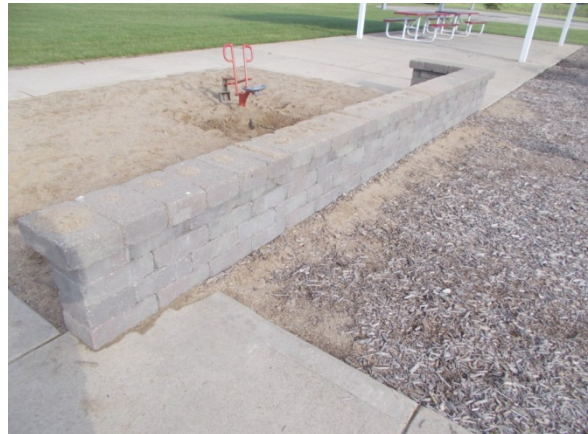
PHOTO #24: CMU RETAINING WALL

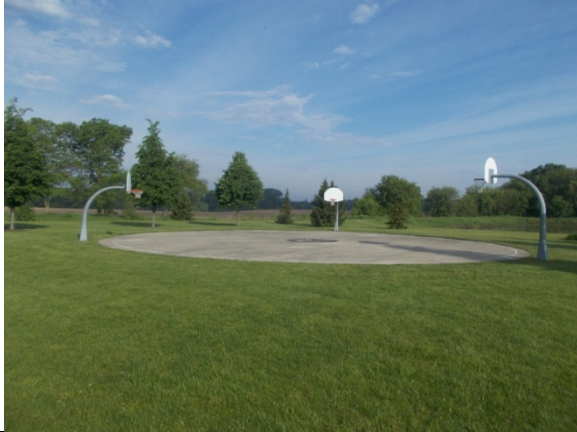
PHOTO #25: BASKETBALL COURT

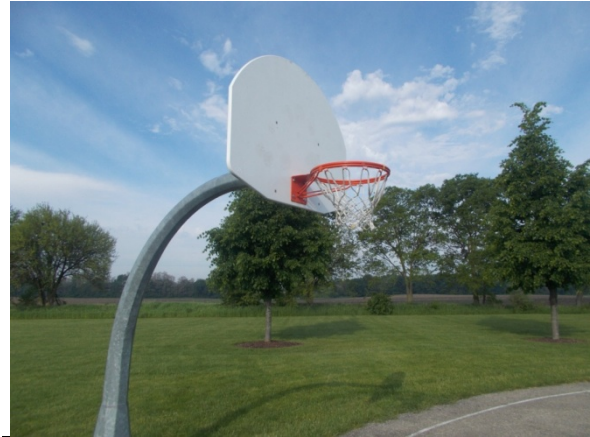
PHOTO #26: BASKETBALL BACKSTOP

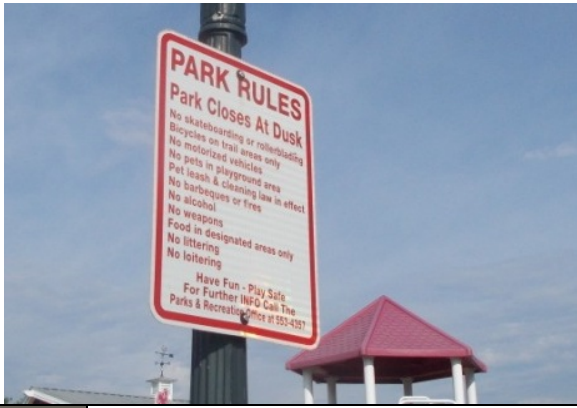
PHOTO #27: INSTRUCTION SIGN

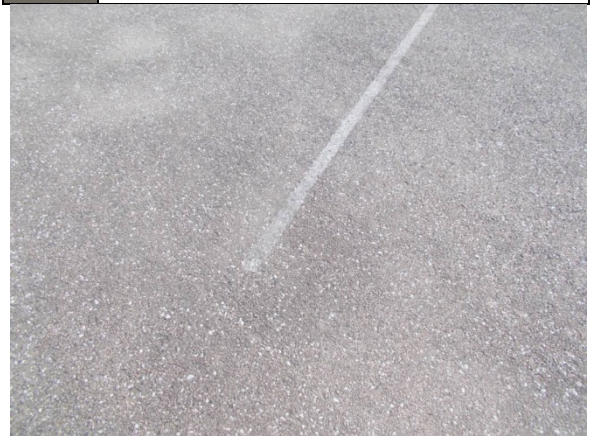
PHOTO #28: ASPHALT STRIPING

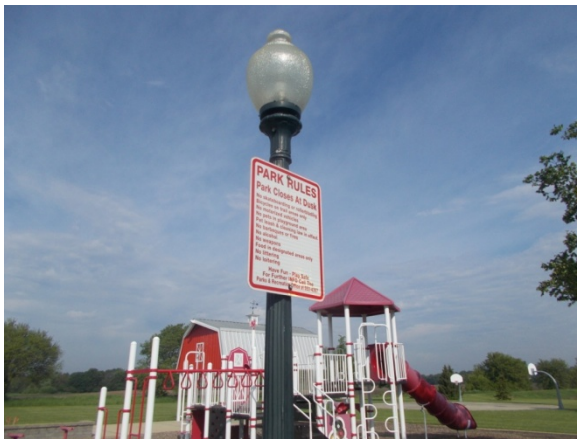
PHOTO #29: LAMP

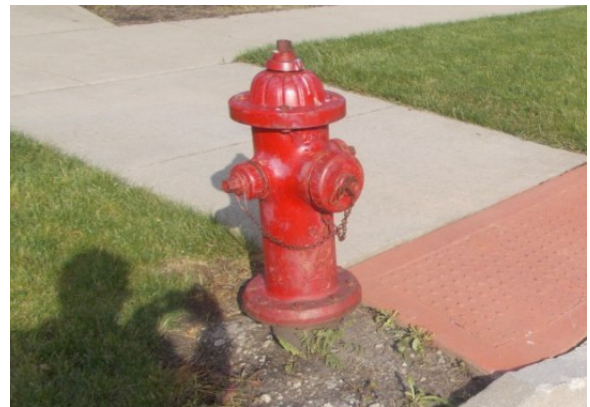
PHOTO #30: HYDRANT

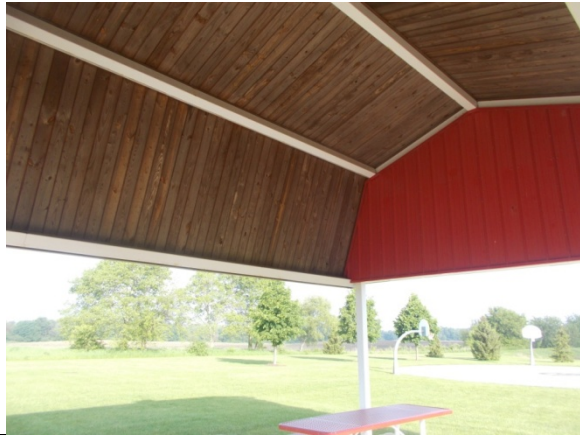
PHOTO
#31:

INTERIOR PAINTED SURFACE

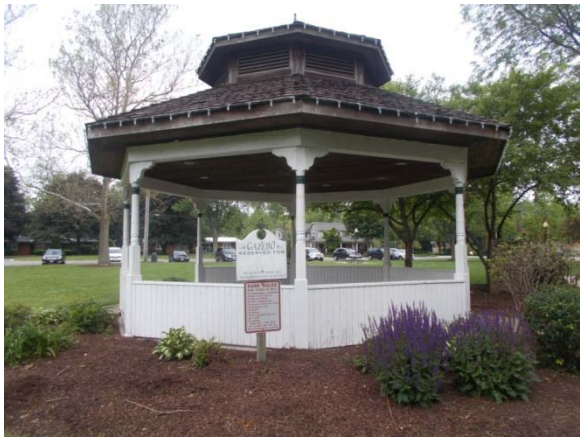
PHOTO #1: FRONT ELEVATION

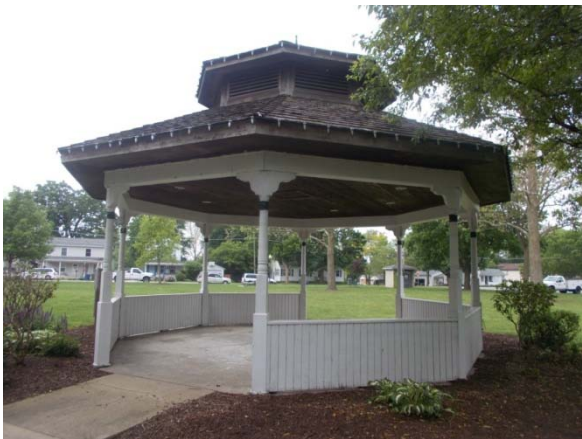
PHOTO #2: RIGHT SIDE ELEVATION

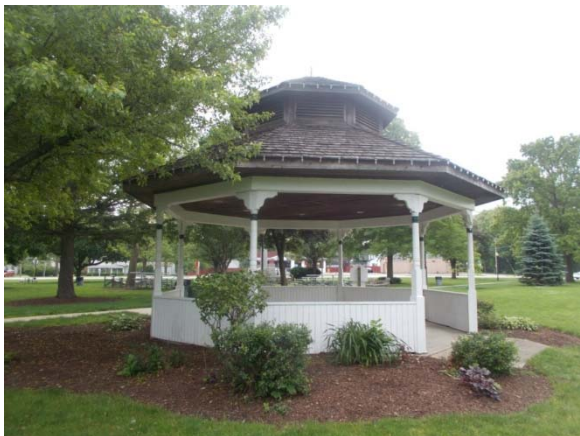
PHOTO #3: REAR ELEVATION

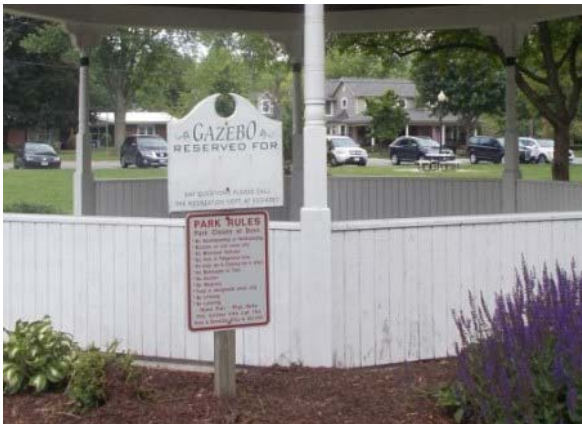
PHOTO #4: BUILDING SIGN

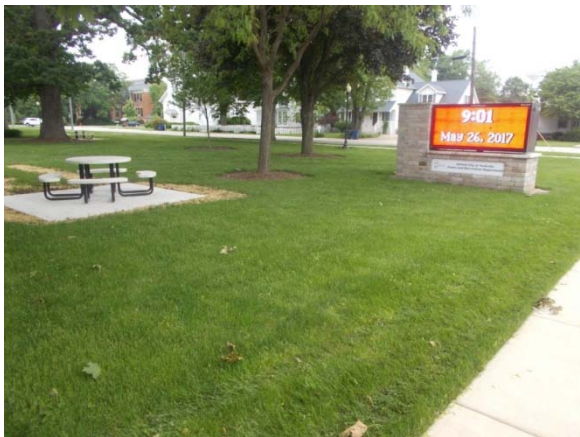
PHOTO #5: PARK SITE

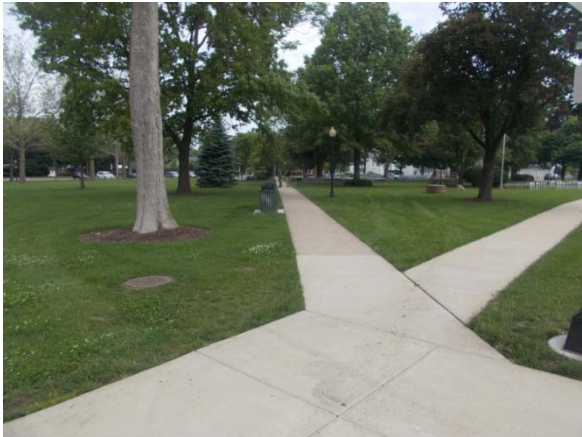
PHOTO #6: CONCRETE SIDEWALKS

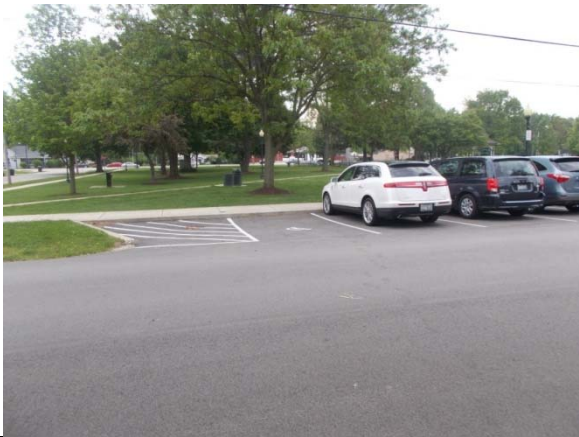
PHOTO #7: PARKING

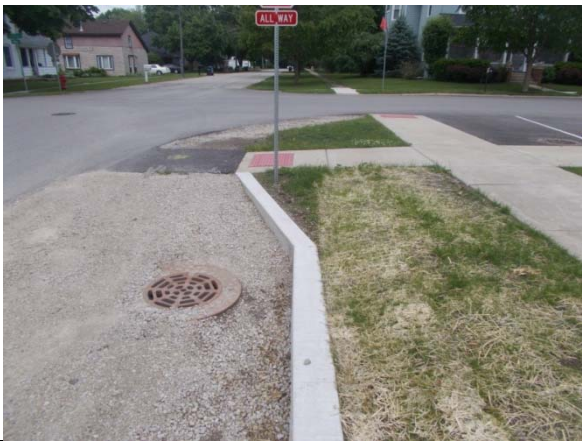
PHOTO #8: DRAINAGE SYSTEM

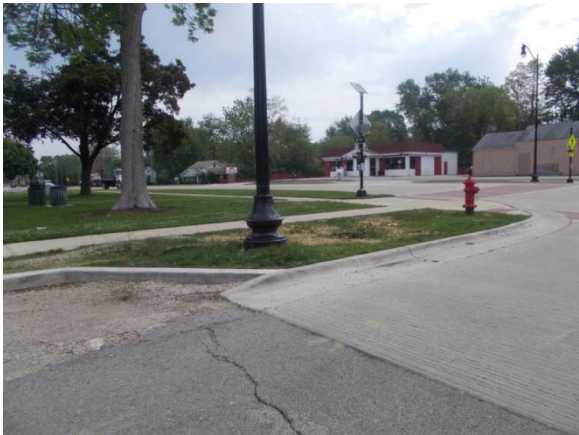
PHOTO #9: CURB

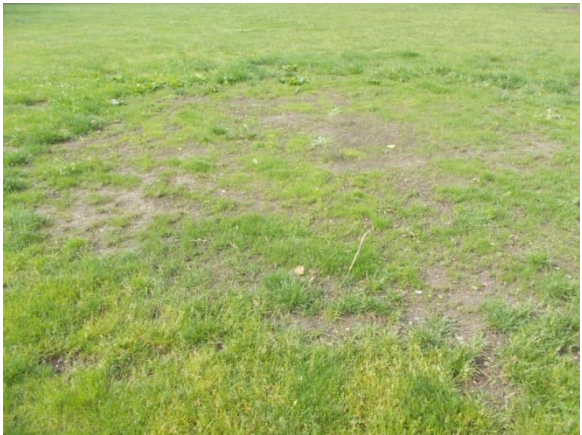
PHOTO #10: LANDSCAPING

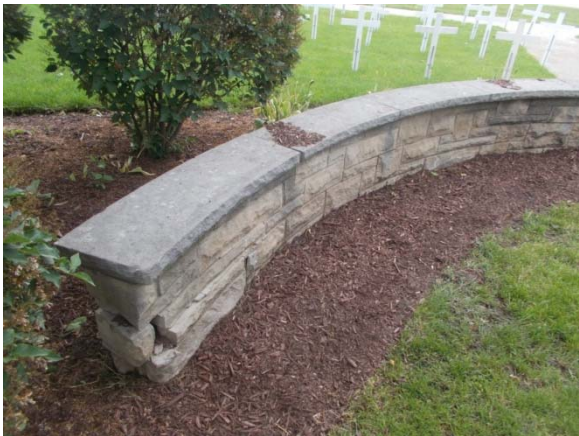
PHOTO #11: SITE WALL/FENCE

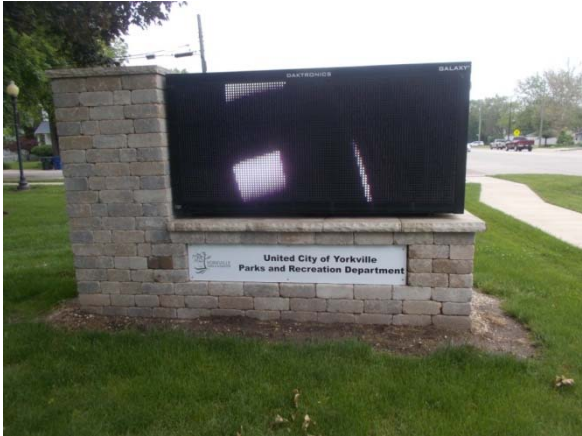
PHOTO #12: PARK SIGN

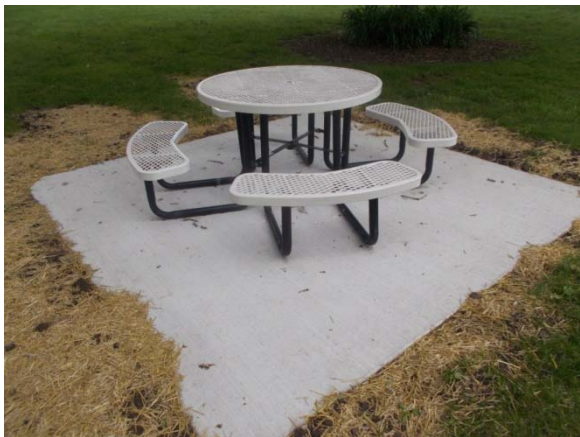
PHOTO #13: SITE PICNIC TABLE

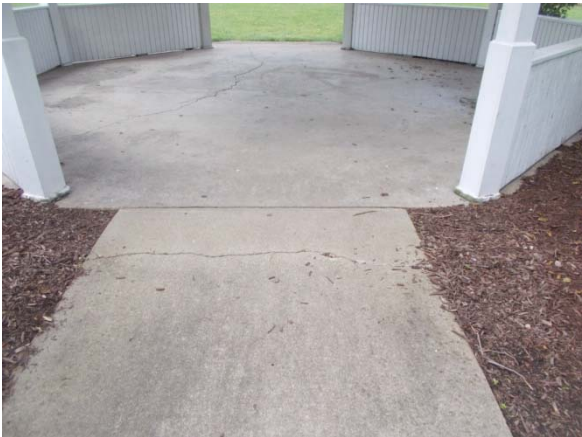
PHOTO #14: CONCRETE FOUNDATION AT GAZEBO

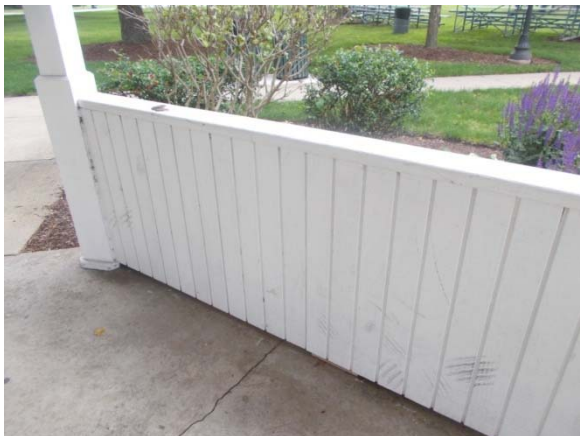
PHOTO #15: GAZEBO WALL

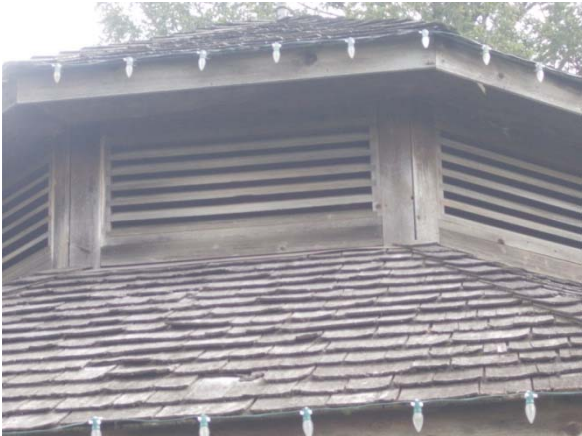
PHOTO #16: CEDAR ROOF SHINGLES

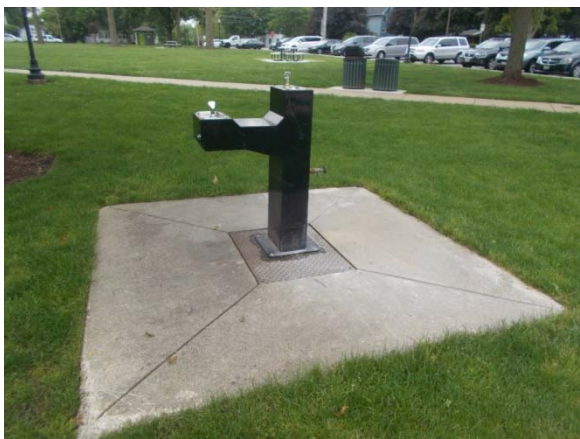
PHOTO #17: DRINKING FOUNTAIN

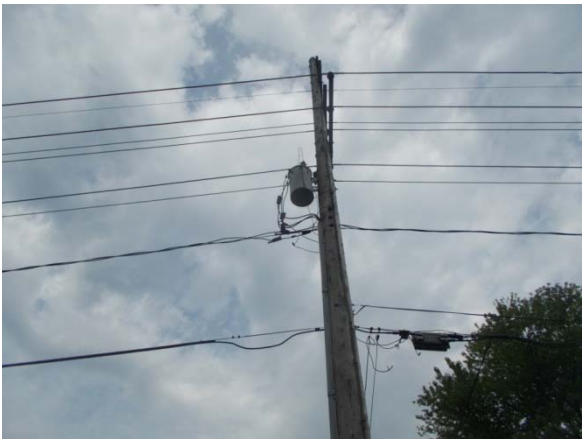
PHOTO #18: TRANSFORMER

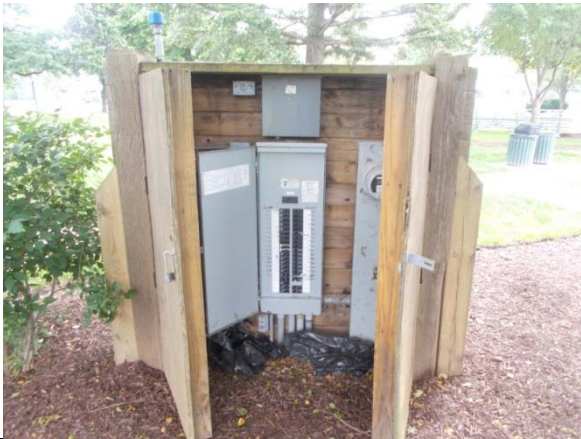
PHOTO #19: ELECTRICAL PANELS

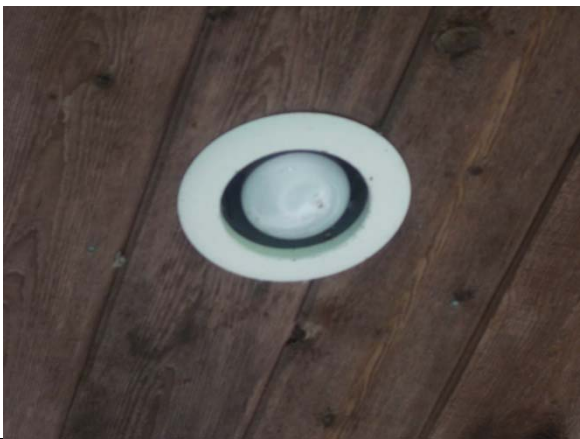
PHOTO #20: GAZEBO CEILING LIGHT

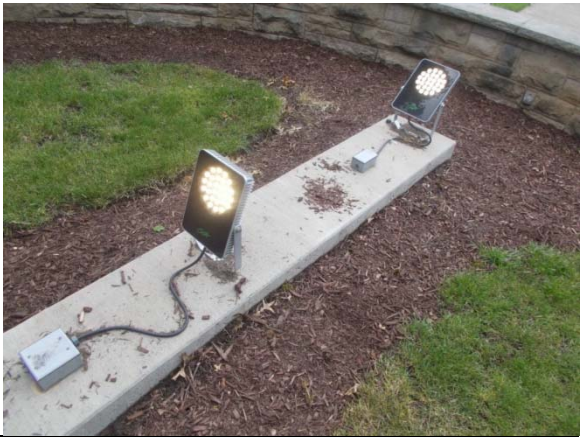
PHOTO #21: LED LIGHT

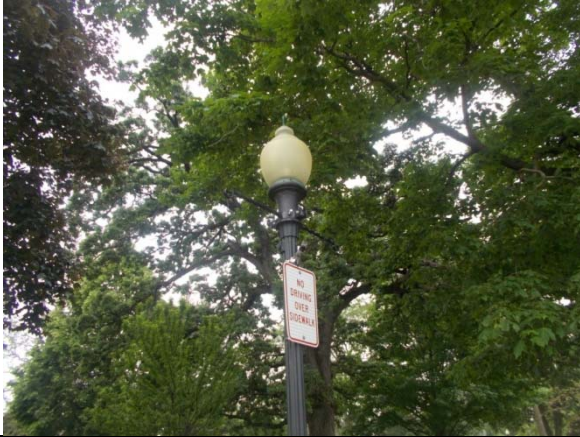
PHOTO #22: POLE LIGHT

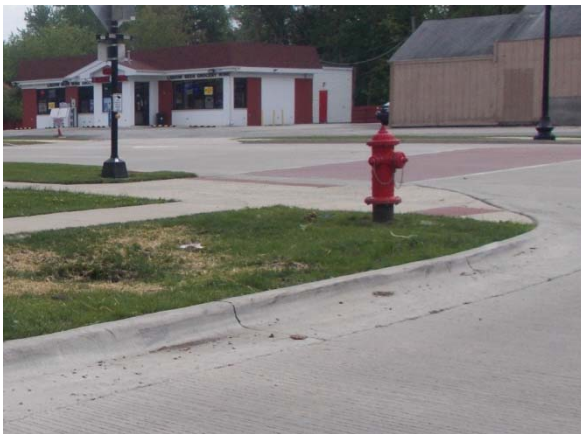
PHOTO #23: HYDRANT

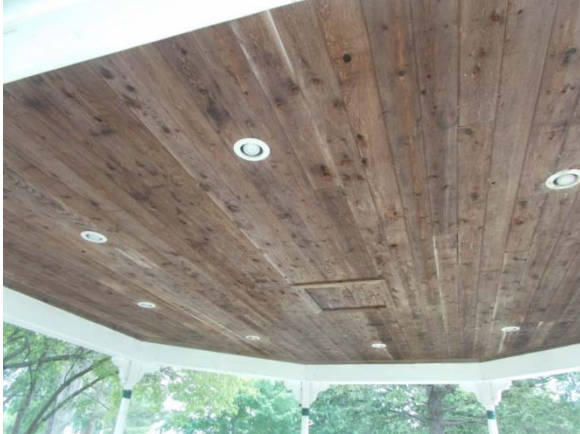
PHOTO #24: GAZEBO WOODEN CEILING

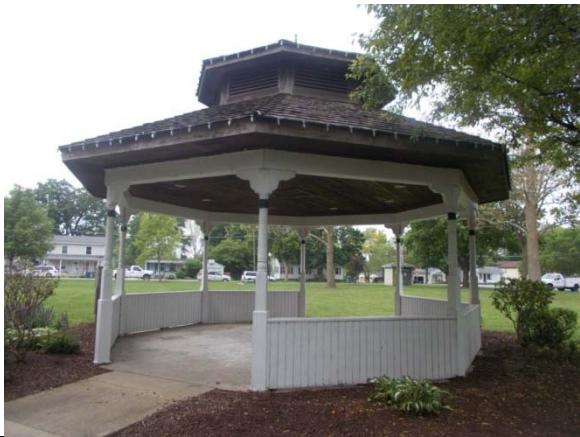
PHOTO #25: PAINTED EXTERIOR

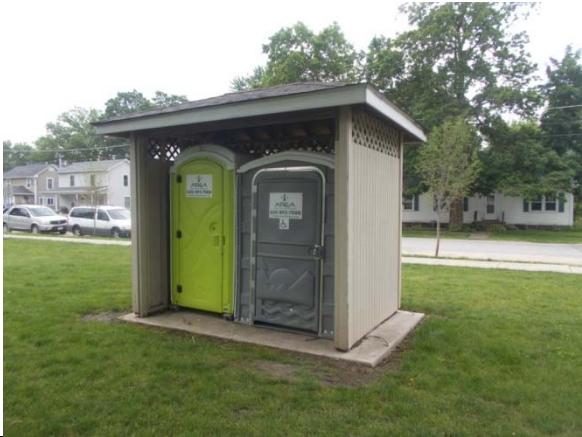
PHOTO #26: SITE STRUCTURE

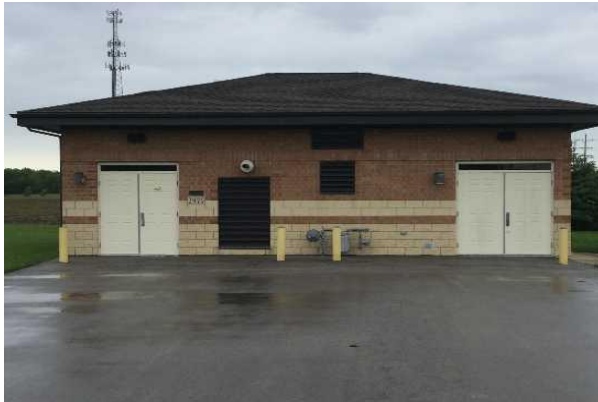
#1: FRONT ELEVATION

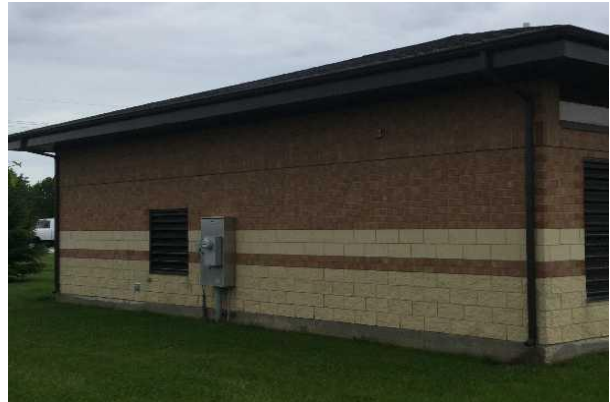
#2: LEFT ELEVATION

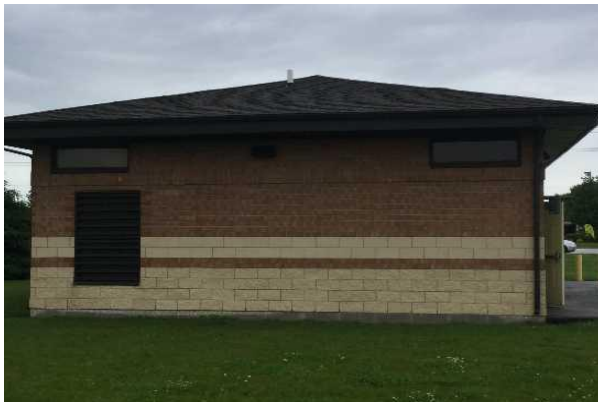
#3: REAR ELEVATION

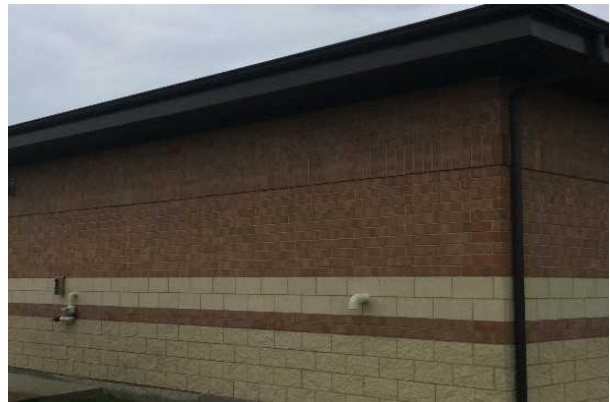
#4: RIGHT ELEVATION

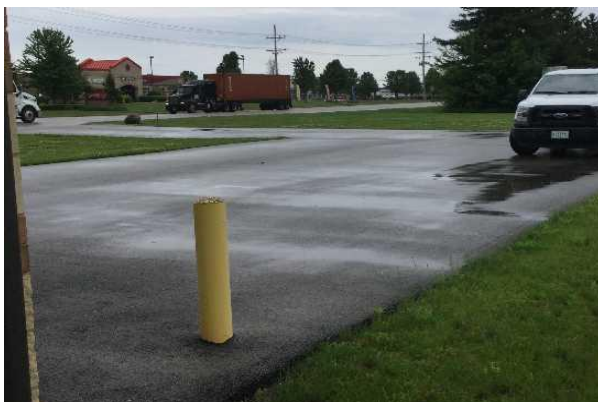
#5: PARKING LOTS, ASPHALT PAVEMENT

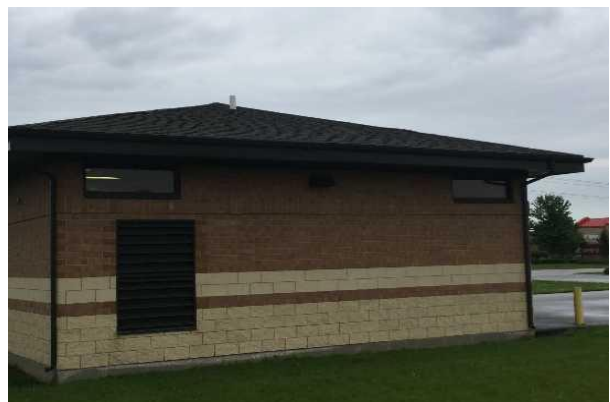
#6: ROOF, ASPHALT SHINGLE

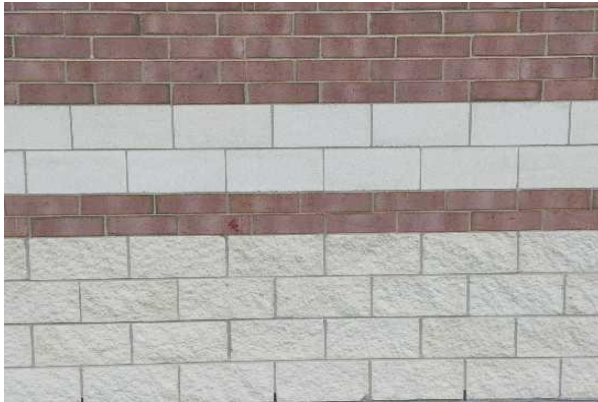
#7:

EXTERIOR WALL, CONCRETE
BLOCK (CMU)

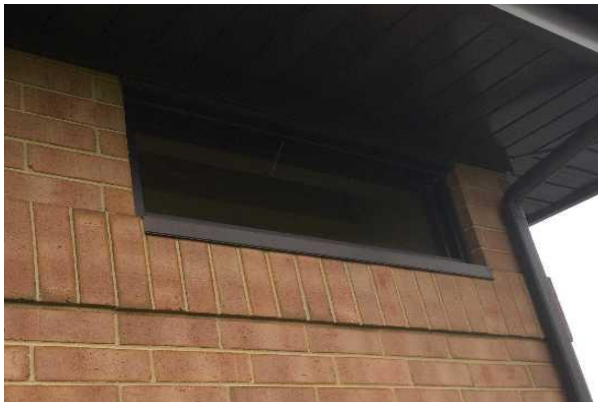
#8:

EXTERIOR WALL, BRICK VENEER

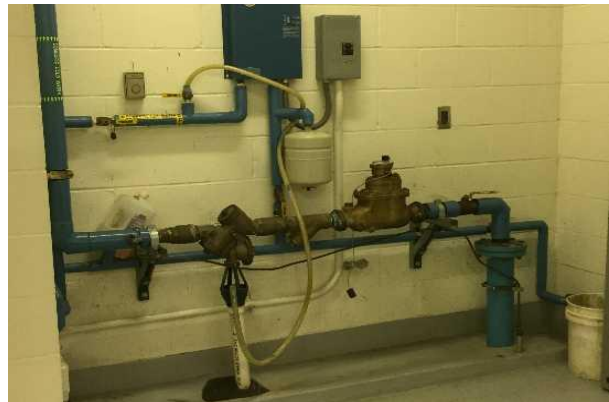
#16: BACKFLOW PREVENTER

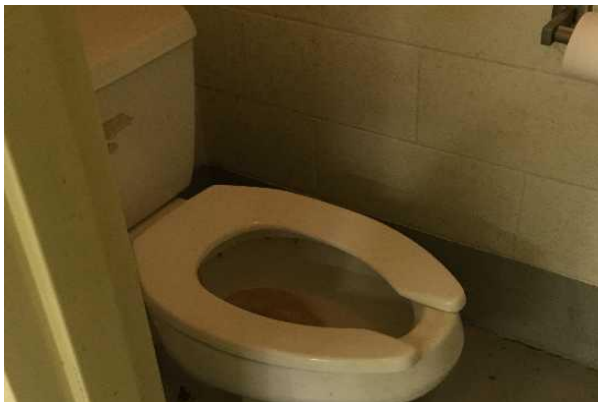
#17: TOILET, FLUSH TANK (WATER CLOSET)

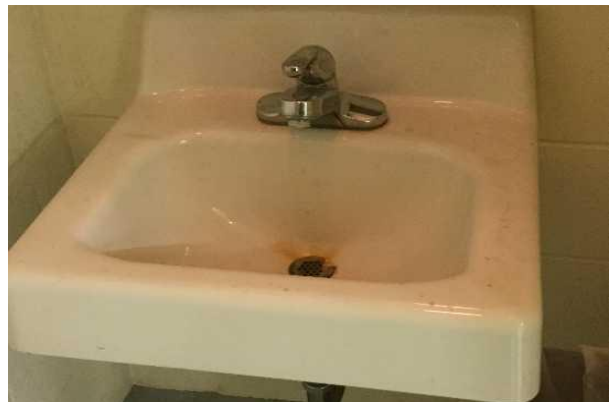
#18: LAVATORY, VITREOUS CHINA

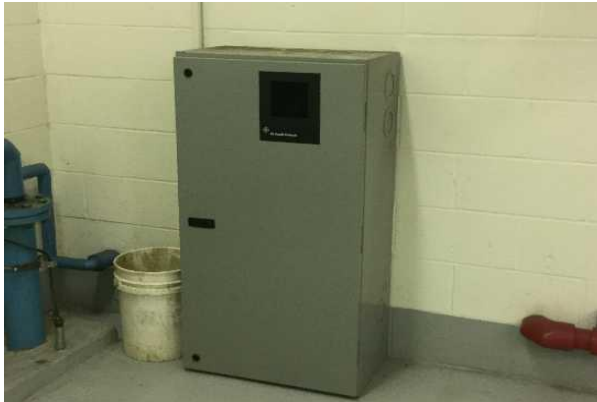
#19:

TRANSFER SWITCH, AUTOMATIC
(ATS)

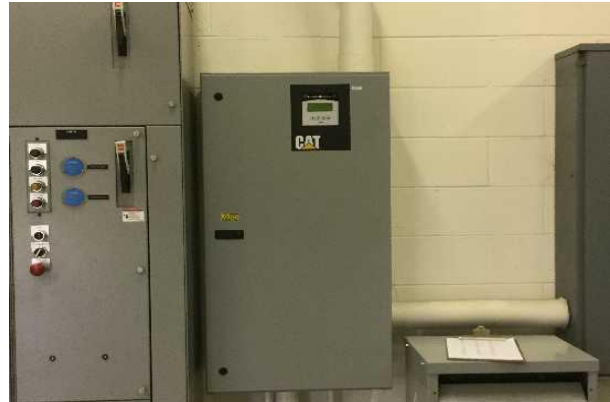
#20:

TRANSFER SWITCH, AUTOMATIC
(ATS)

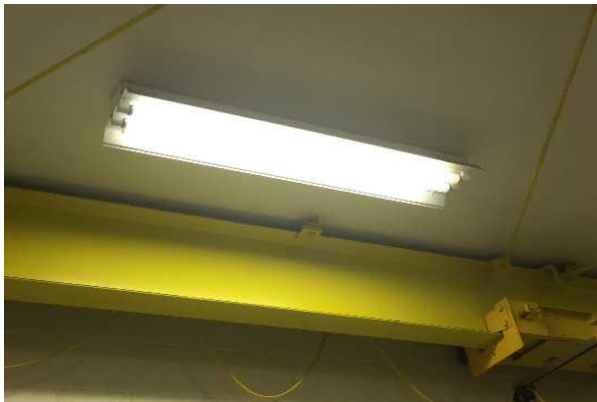
#21:

LIGHTING SYSTEM, INTERIOR,
OFFICE BUILDING

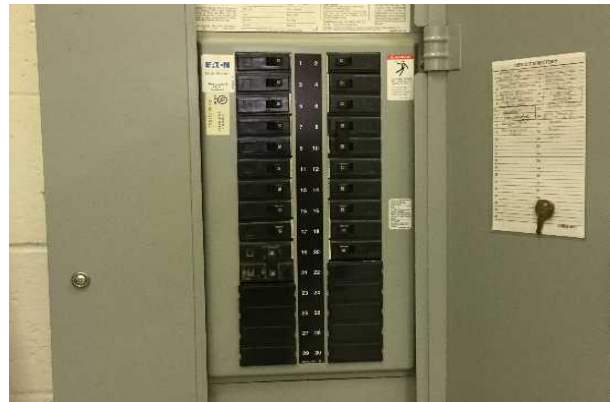
#22:

DISTRIBUTION PANEL

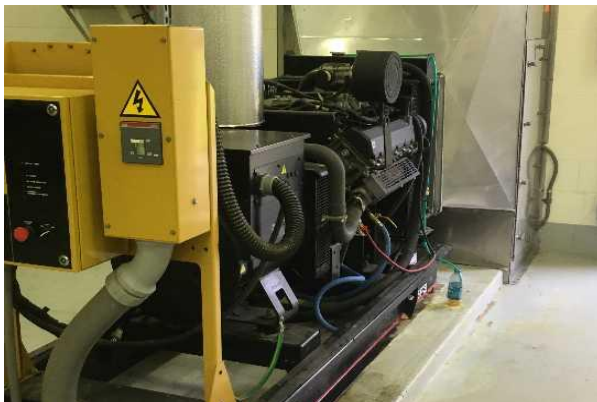
#23:

GENERATOR, GAS OR
GASOLINE

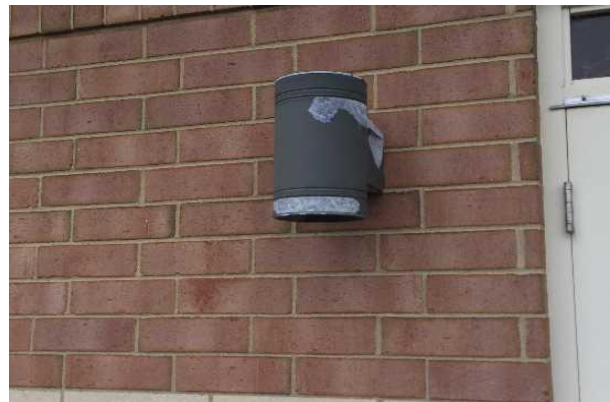
#24:

INCANDESCENT LIGHTING
FIXTURE

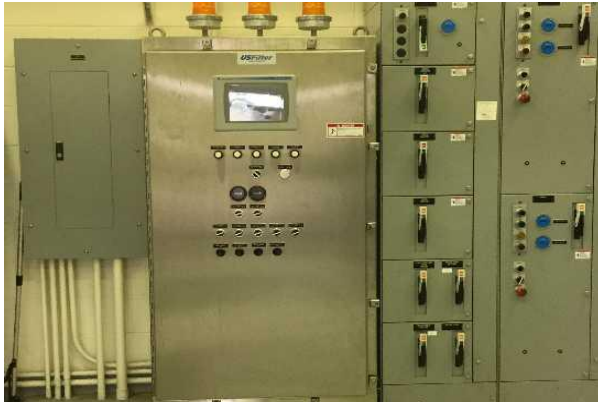
#25: STORM WATER LIFT STATION

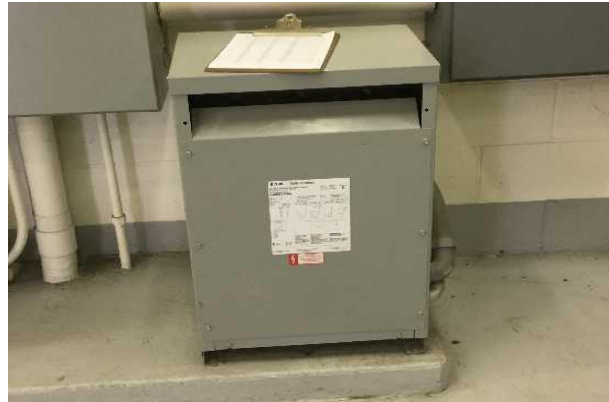
#26: SECONDARY TRANSFORMER

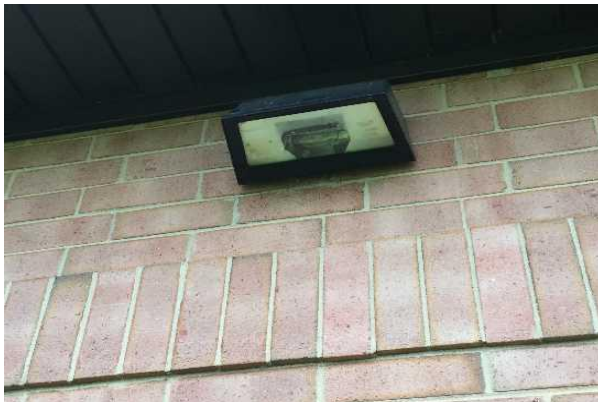
#27: HIGH PRESSURE SODIUM
LIGHTING FIXTURE

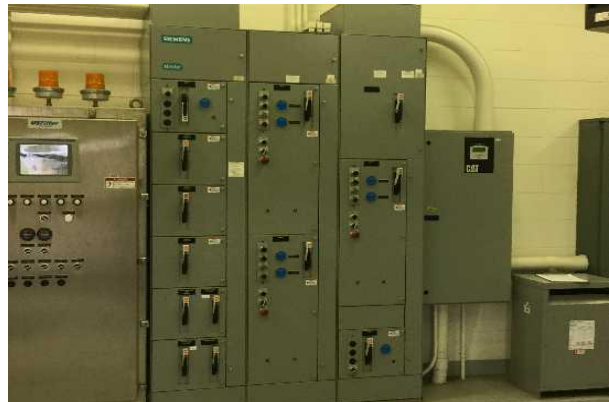
#28: MOTOR CONTROL CENTER W/
MAIN BREAKER, 3-PHASE

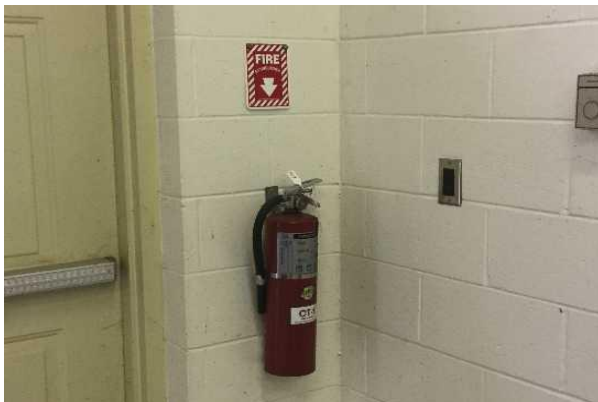
#29: FIRE EXTINGUISHER

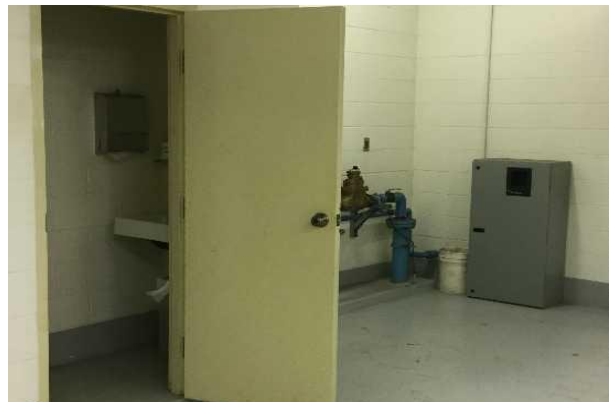
#30: INTERIOR DOOR, ALUMINUM

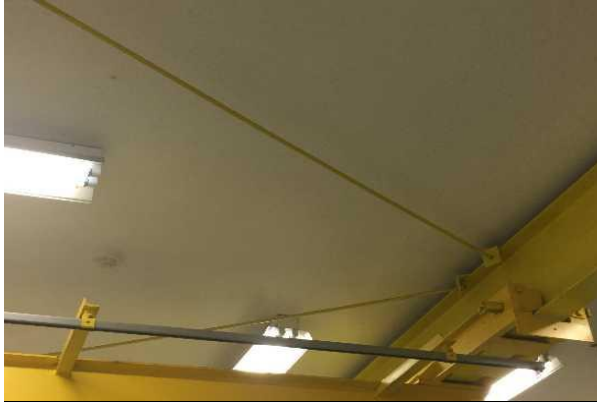
#31:

INTERIOR CEILING FINISH,
GYPSUM BOARD/PLASTER

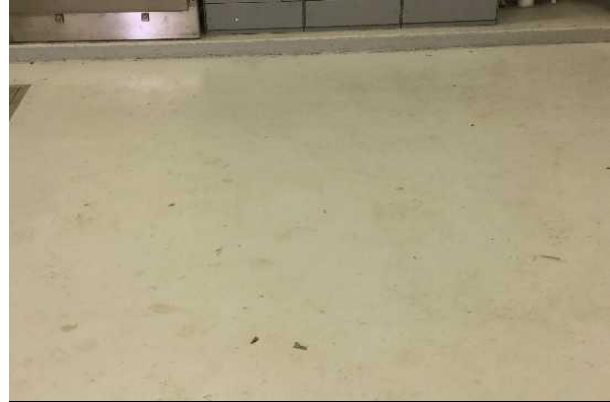
#32:

INTERIOR FLOOR FINISH,
CONCRETE

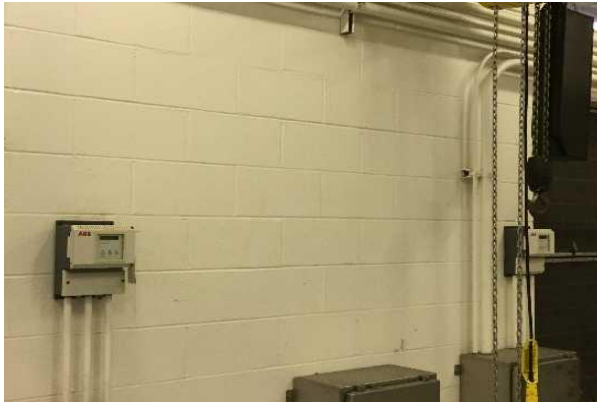
#33:

INTERIOR WALL FINISH,
CONCRETE/MASONRY

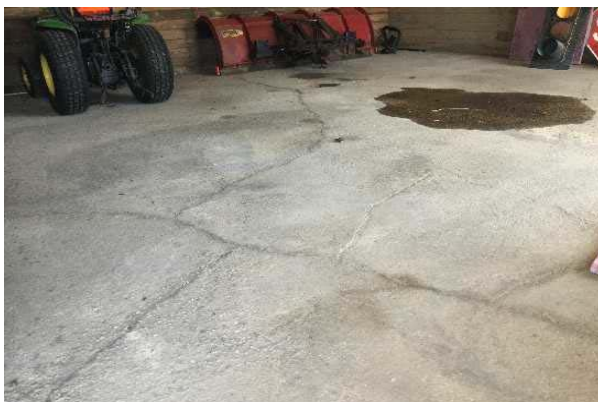
#5: FOUNDATIONS, CONCRETE
SLAB-ON-GRADE

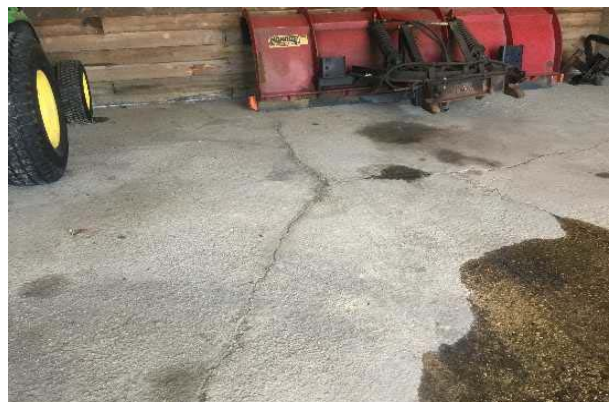
#6: CRACKING THROUGHOUT
CONCRETE SLAB-ON-GRADE

- Installation of a complete fire suppression system
- Installation of a complete fire alarm system
- Interior floor repair

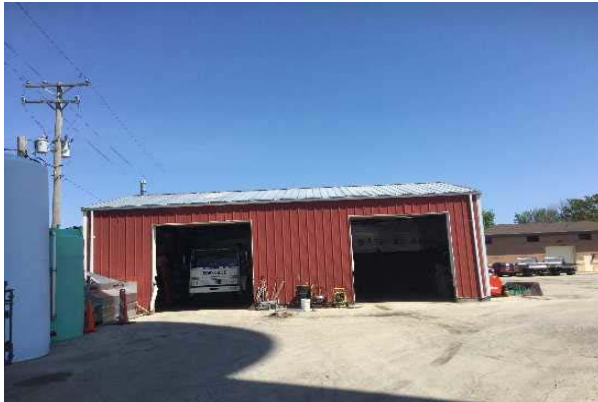
#7: ROOF, METAL

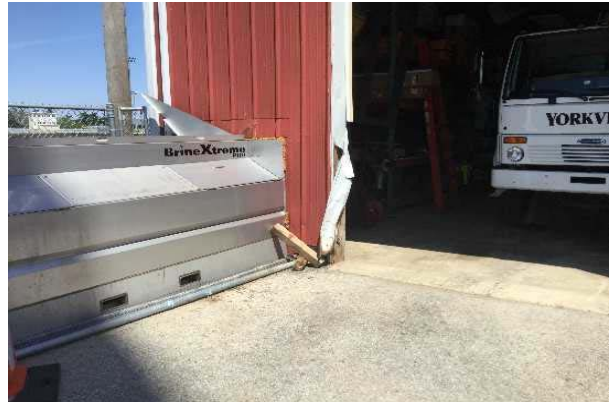
#8: SIDING PEELING OFF LEFT GARAGE ON SOUTH ELEVATION

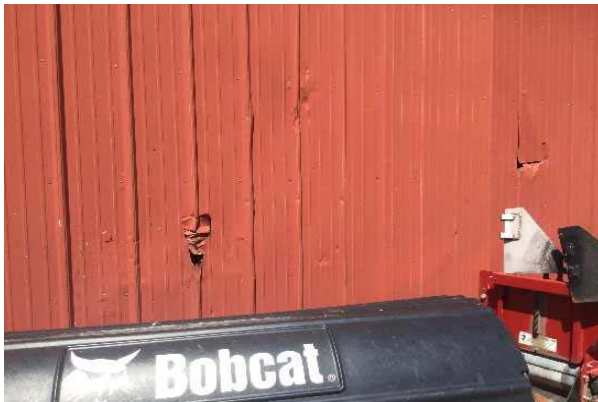
#9: DAMAGE TO SIDING ON EAST ELEVATION OF BUILDING

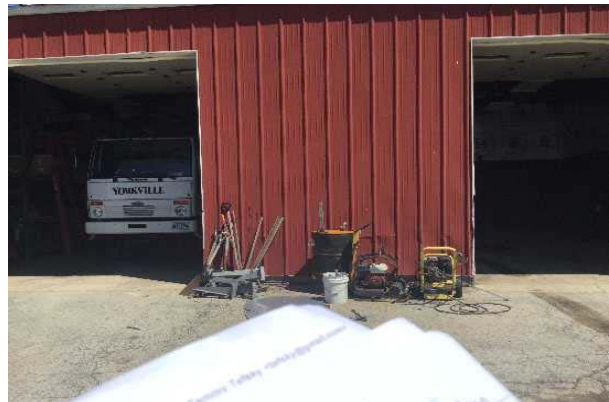
#10: EXTERIOR WALL, ALUMINUM SIDING

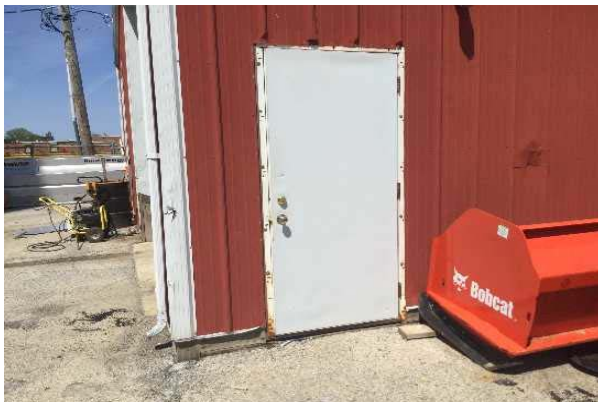
#11: EXTERIOR DOOR, STEEL

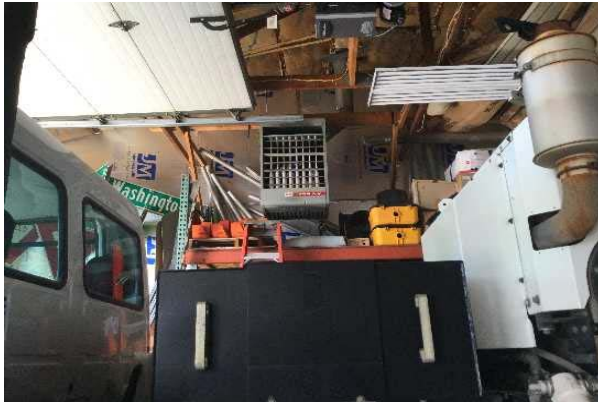
#12: OVERHEAD DOOR, ALUMINUM ROLL-UP

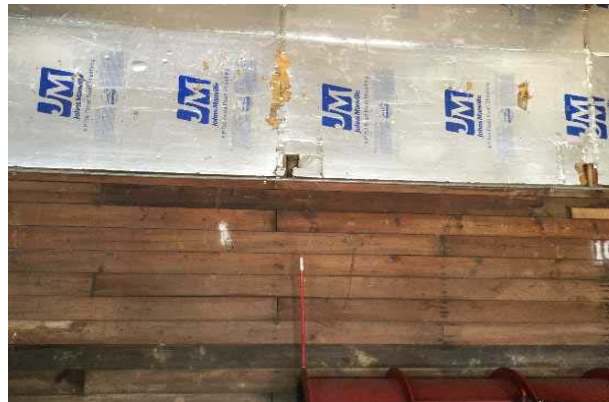
#21: DAMAGE TO INTERIOR WALL ON EAST ELEVATION OF BUILDING

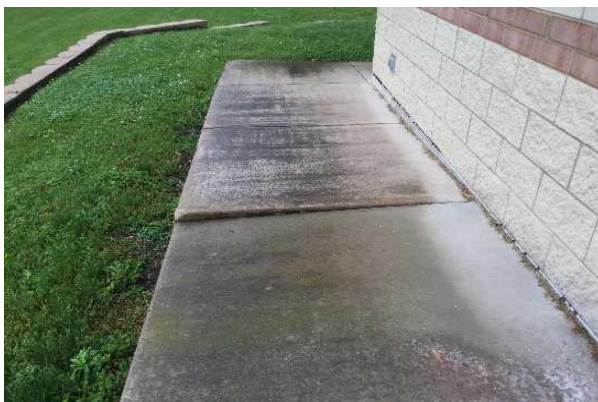
#5: PEDESTRIAN PAVEMENT,
SIDEWALK, CONCRETE

5.2	613278	Pedestrian Pavement, Sidewalk, Concrete, Replace			30	11	19	256	SF	\$19.82	\$5,074																			\$5,074	\$5,074								
6.3	613253	Roof, Asphalt Shingle, Replace			20	11	9	1440	SF	\$3.42	\$4,926										\$4,926											\$4,926

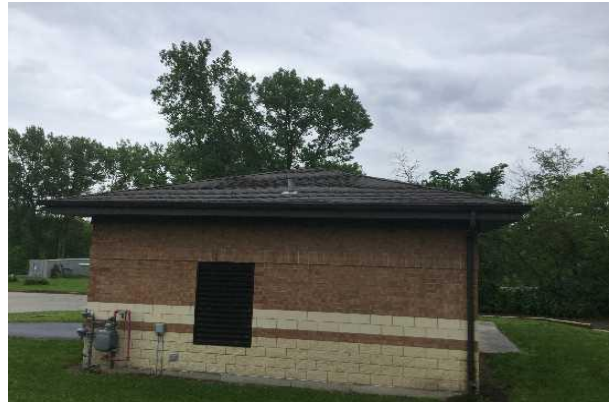
#8:

ROOF, ASPHALT SHINGLE

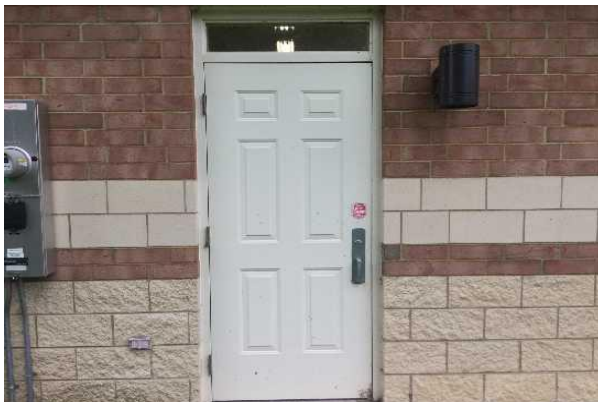
#11:

EXTERIOR DOOR, STEEL

6.6	613269	Exterior Door, Steel, Replace			25	11	14	2	EA	\$950.12	\$1,900															\$1,900						\$1,900							
7.1	613436	Exhaust Fan, Propeller, Replace			15	11	4	1	EA	\$930.50	\$931					\$931															\$931	\$1,861

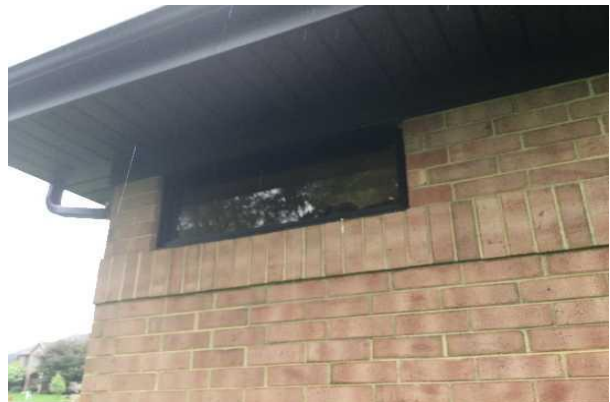
#12:

WINDOW, ALUMINUM DOUBLE-
GLAZED

6.5	613437	Interior Stair/Ramp Rails, Metal, Replace			20	11	9	12	LF	\$31.31	\$376										\$376											\$376							
6.6	613264	Window, Aluminum Double-Glazed, Replace			30	11	19	4	EA	\$292.10	\$1,168																				\$1,168	\$1,168

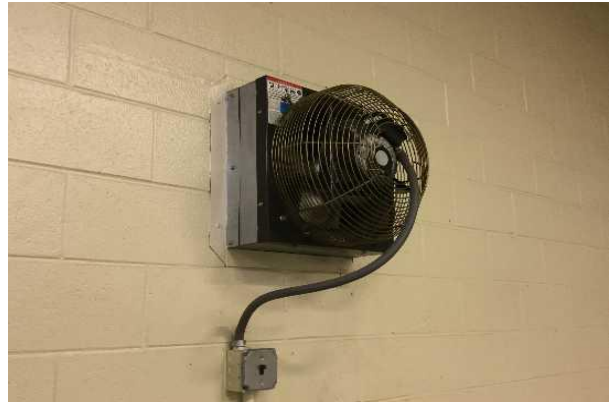
#14: EXHAUST FAN, PROPELLER

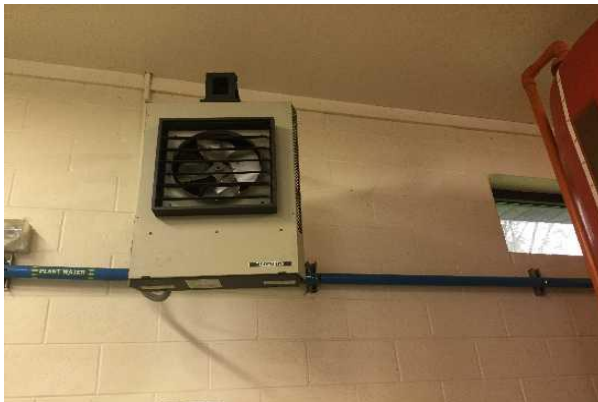
#15: UNIT HEATER, ELECTRIC

7.1	613416	Unit Heater, Electric, Replace			20	11	9	1	EA	\$2,961.56	\$2,962										\$2,962											\$2,962							
7.2	613422	Sink, Porcelain Enamel, Cast Iron, Replace			20	11	9	1	EA	\$1,167.28	\$1,167										\$1,167											\$1,167

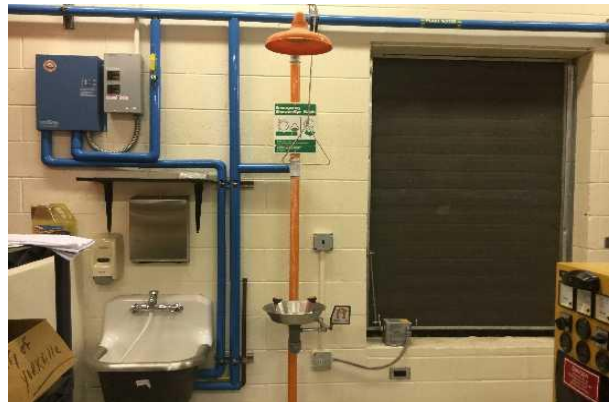
#16: EMERGENCY EYE WASH & SHOWER STATION

7.2	613423	Emergency Eye Wash & Shower Station, Replace			15	11	4	1	EA	\$2,114.70	\$2,115					\$2,115															\$2,115	\$4,229							
7.2	613426	Backflow Preventer, 2", Replace			15	11	4	1	EA	\$2,603.17	\$2,603					\$2,603															\$2,603	\$5,206

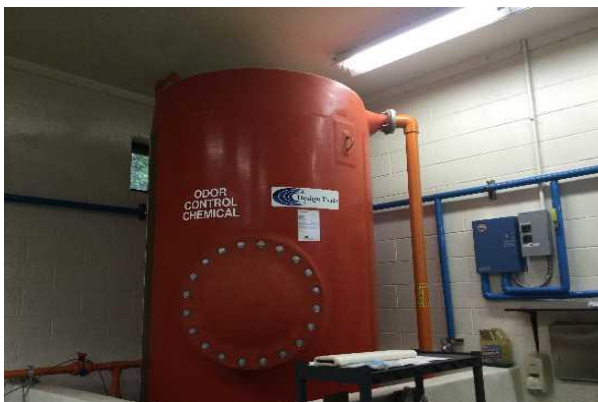
#17: WATER STORAGE TANK

7.2	617484	Water Heater, Instant Hot, Electric, Replace			15	10	5	1	EA	\$1,907.74	\$1,908						\$1,908															\$1,908							
7.2	613419	Water Storage Tank, 1,001 to 2,500 GAL, Replace			20	12	8	1	EA	\$9,704.81	\$9,705									\$9,705												\$9,705
