Title: Building Condition Reports 2017

Meeting and Date: Administration Committee - September 20, 2017

Synopsis: Discussion of the Preliminary Reports from the Building Condition Survey that
EMG performed on City-owned structures and facilities.

FACILITY CONDITION ASSESSMENT

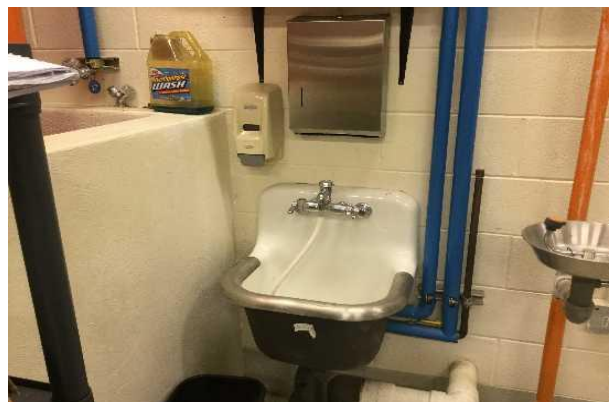
#18: SINK, PORCELAIN ENAMEL, CAST IRON

7.1	613416	Unit Heater, Electric, Replace			20	11	9	1	EA	\$2,961.56	\$2,962										\$2,962											\$2,962							
7.2	613422	Sink, Porcelain Enamel, Cast Iron, Replace			20	11	9	1	EA	\$1,167.28	\$1,167										\$1,167											\$1,167

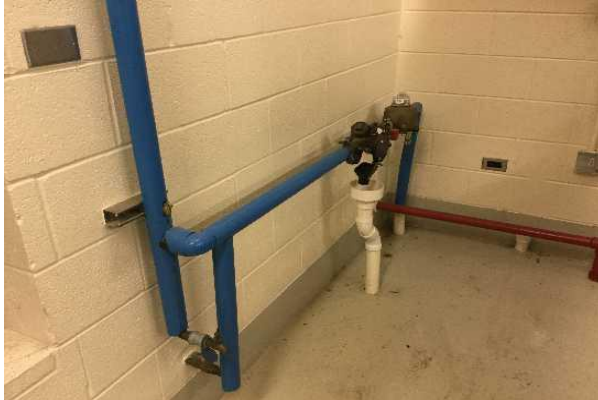
#19: BACKFLOW PREVENTER

7.2	613423	Emergency Eye Wash & Shower Station, Replace			15	11	4	1	EA	\$2,114.70	\$2,115					\$2,115															\$2,115	\$4,229							
7.2	613426	Backflow Preventer, 2", Replace			15	11	4	1	EA	\$2,603.17	\$2,603					\$2,603															\$2,603	\$5,206

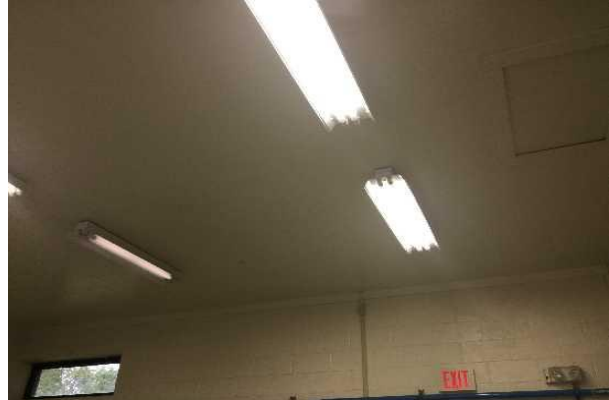
#20: LIGHTING SYSTEM, INTERIOR, OFFICE BUILDING

7.4	613415	Lighting System, Interior, Upgrade			25	11	14	1200	SF	\$9.24	\$11,090															\$11,090						\$11,090							
7.4	613424	Generator, Gas, 100 kW, Replace			25	13	12	1	EA	\$71,929.70	\$71,930													\$71,930								\$71,930

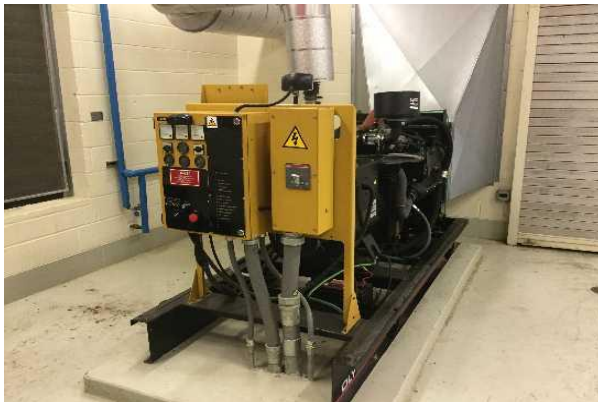
#21: GENERATOR, GAS OR GASOLINE

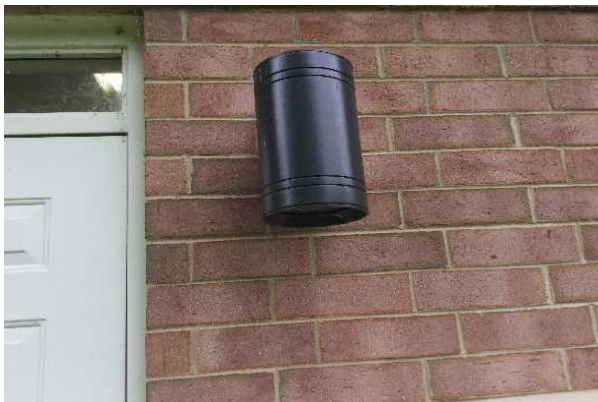
#23: INCANDESCENT LIGHTING FIXTURE

7.4	613266	Incandescent Lighting Fixture, Basic, Replace			20	11	9	4	EA	\$188.55	\$754										\$754											\$754							
7.4	613272	High Pressure Sodium Lighting Fixture, 250 W, Replace			20	11	9	2	EA	\$719.95	\$1,440										\$1,440											\$1,440

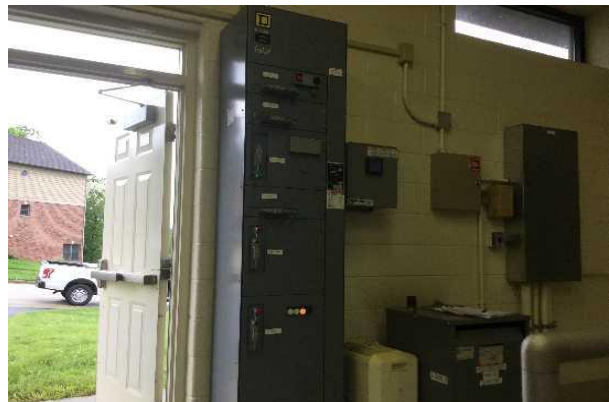
#24: MOTOR CONTROL CENTER W/ MAIN BREAKER, 3-PHASE

7.4	613432	Secondary Transformer, Dry, Replace			30	11	19	1	EA	\$6,086.36	\$6,086																				\$6,086	\$6,086							
7.4	613431	Motor Control Center w/ Main Breaker, 3-phase, up to 1,600 Amp, Replace			30	11	19	1	EA	\$26,276.97	\$26,277																				\$26,277	\$26,277

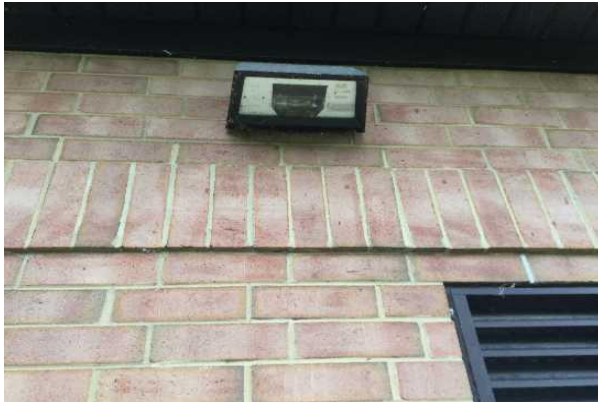
#25: HIGH PRESSURE SODIUM LIGHTING FIXTURE

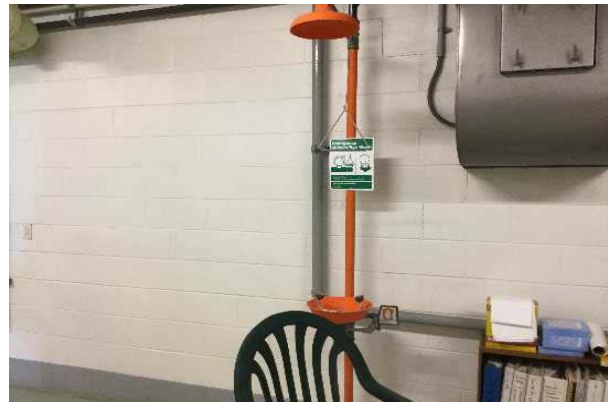
#22: EMERGENCY EYE WASH & SHOWER STATION,

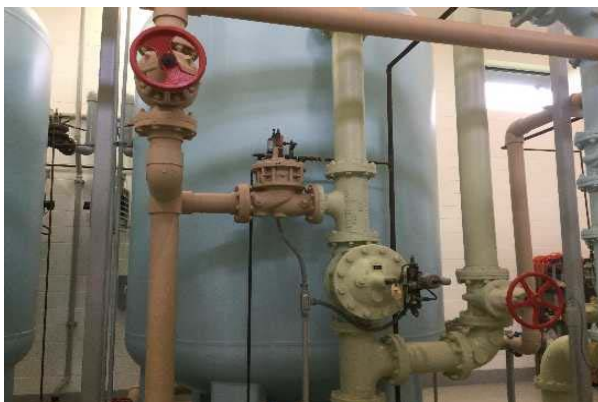
#23: WATER STORAGE TANK, UNIT 1

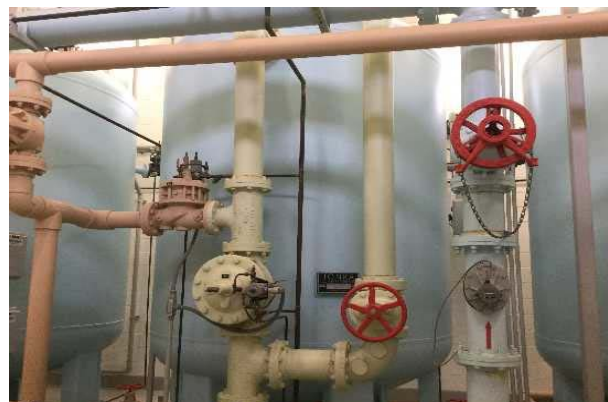
#24: WATER STORAGE TANK, UNIT 2

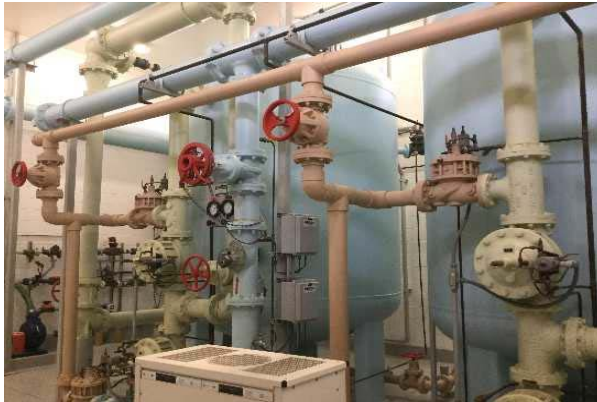
#25: WATER STORAGE TANK, UNIT 3

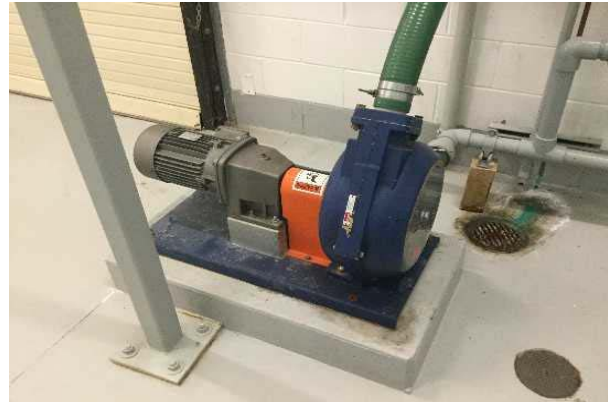
#26: BOOSTER PUMP

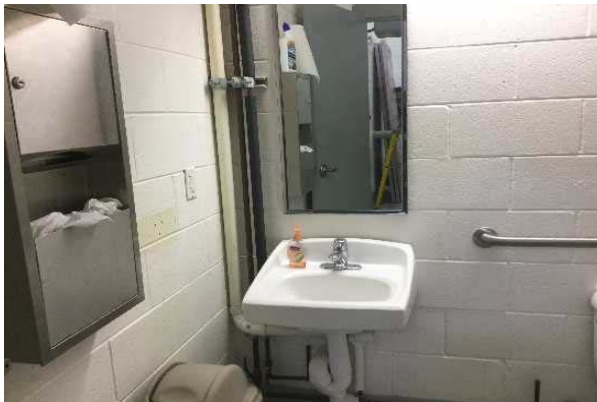
#27: LAVATORY, VITREOUS CHINA

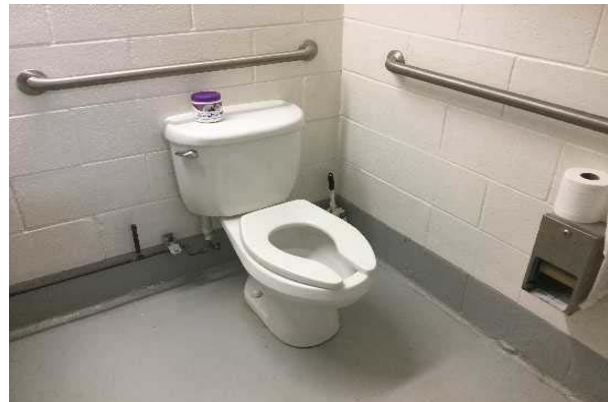
#28: TOILET, FLUSH TANK (WATER CLOSET)

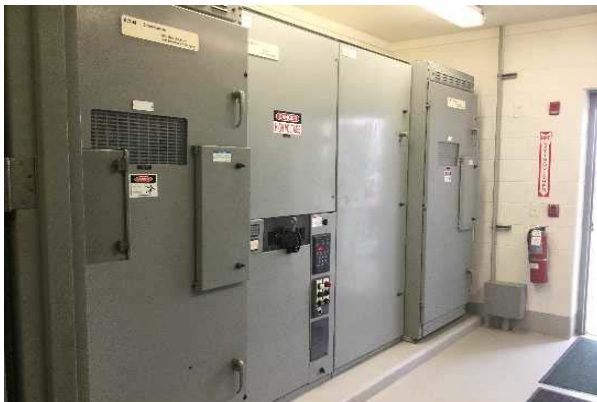
#29: BUILDING/MAIN SWITCHGEAR

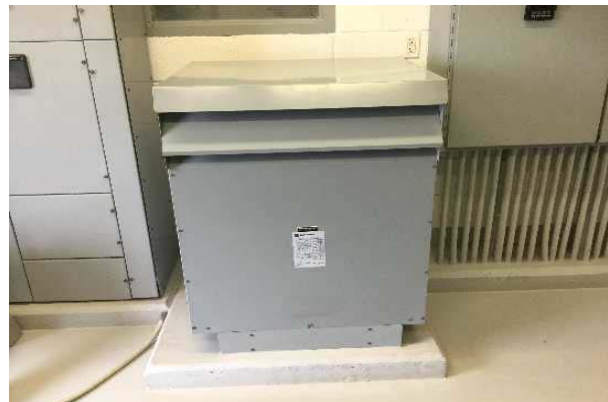
#30: SECONDARY TRANSFORMER, DRY

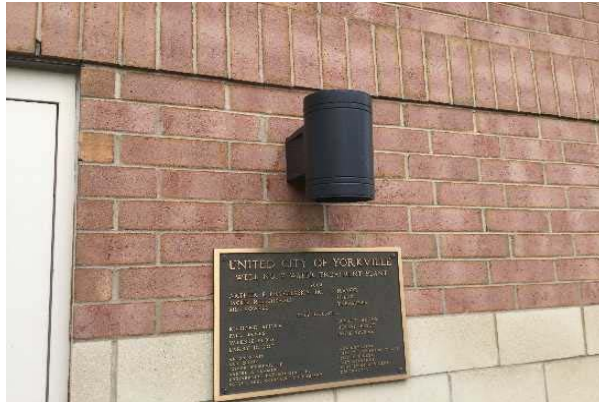
#31:

INCANDESCENT LIGHTING
FIXTURE, BASIC

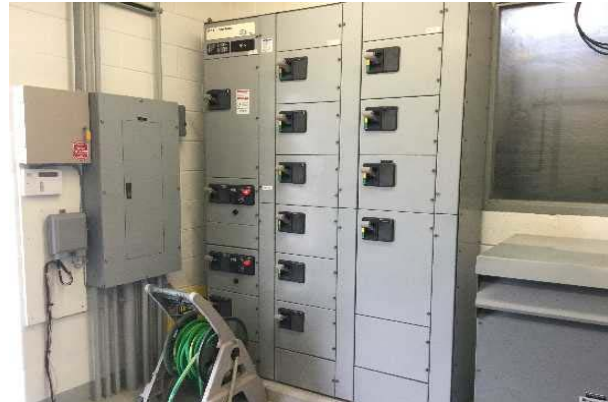
#32:

MOTOR CONTROL CENTER W/
MAIN BREAKER, 3-PHASE

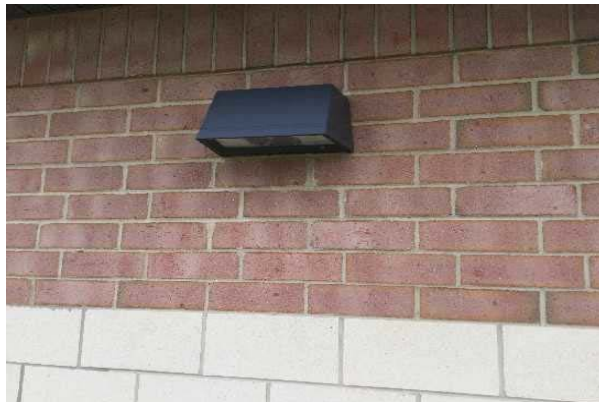
#33:

HIGH PRESSURE SODIUM
LIGHTING FIXTURE

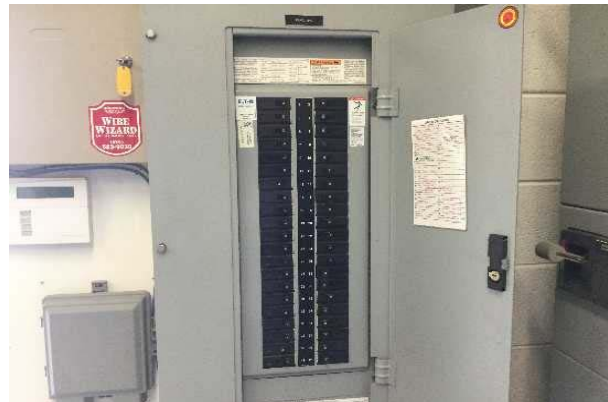
#34:

DISTRIBUTION PANEL

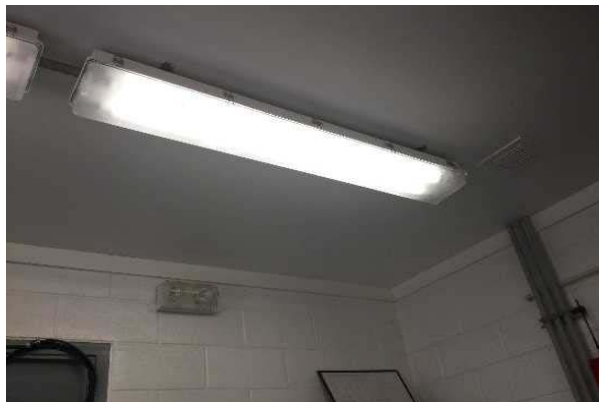
#35:

LIGHTING SYSTEM, INTERIOR

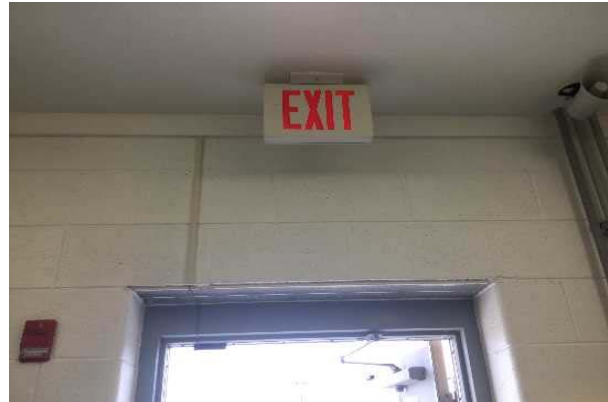
#38: EXIT LIGHTING FIXTURE

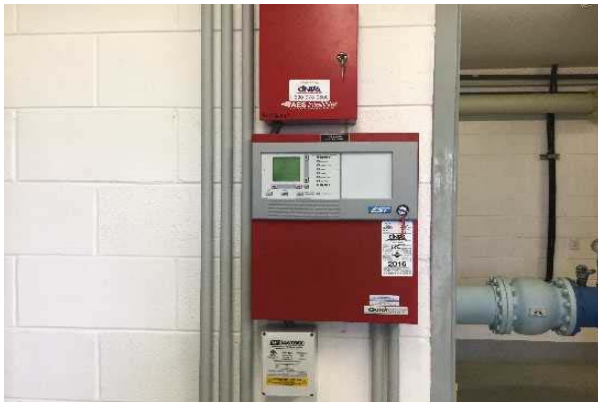
#39: FIRE ALARM SYSTEM

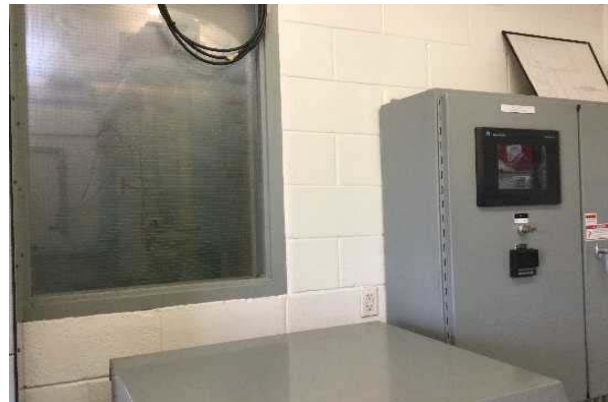
#40: INTERIOR WALL FINISH,
CONCRETE BLOCK

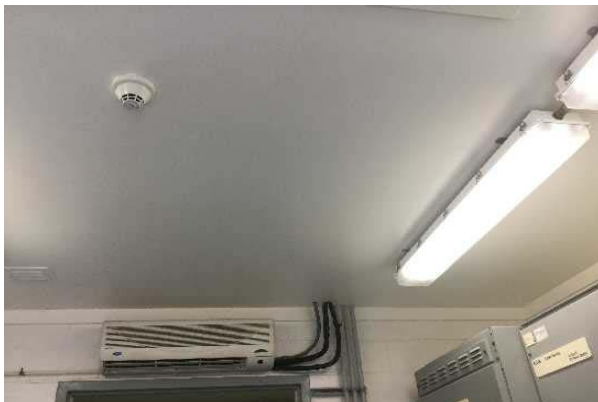
#41: INTERIOR CEILING FINISH,
GYPSUM BOARD

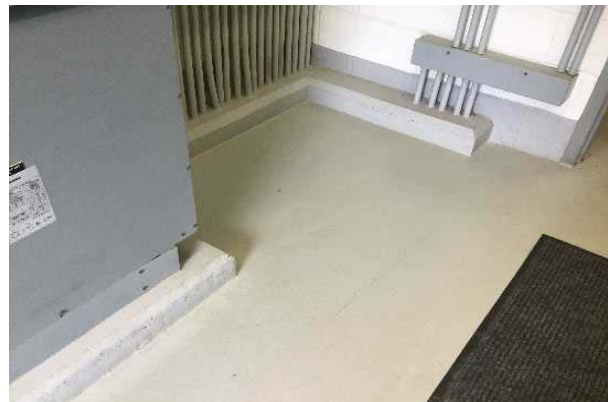
#42: INTERIOR FLOOR FINISH,
CONCRETE

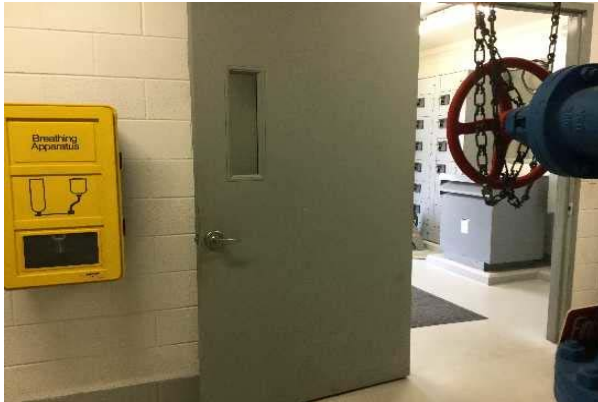
#43: INTERIOR DOOR, ALUMINUM

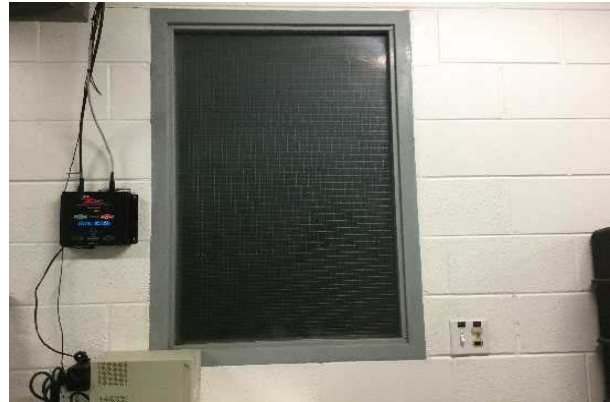
#44: INTERIOR WINDOW

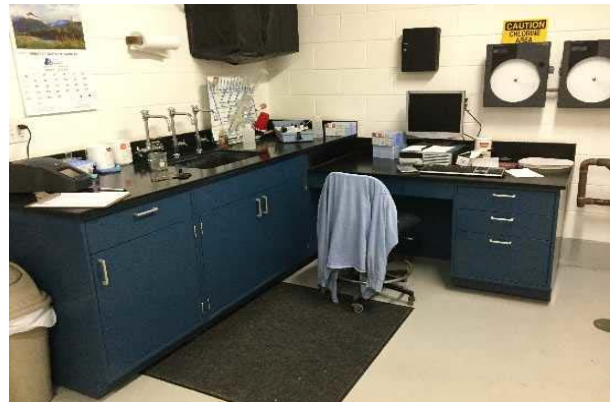
#46: CABINET, BASE AND WALL SECTION, WOOD

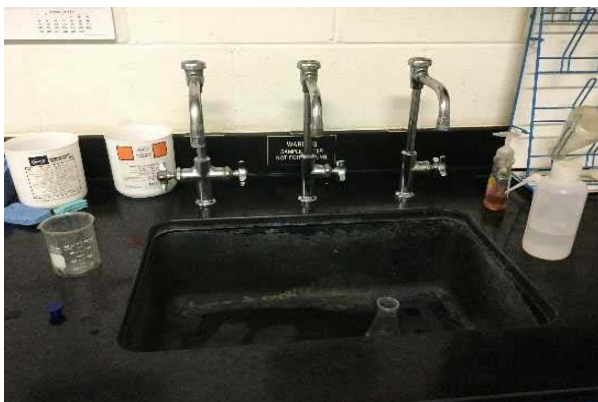
#47: SINK, EPOXY RESIN, LABORATORY

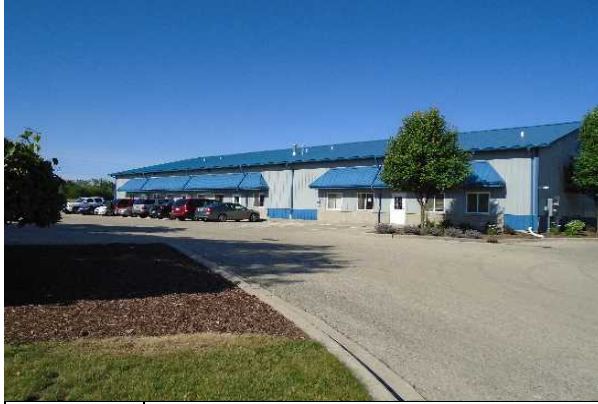
#1: FRONT ELEVATION

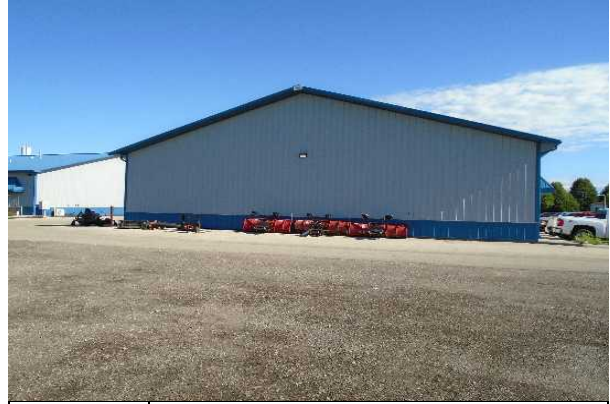
#2: LEFT ELEVATION

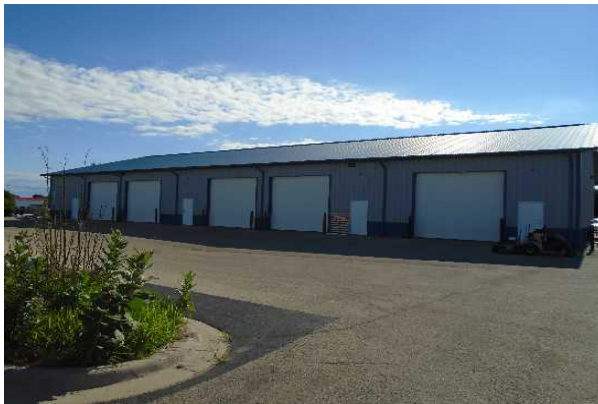
#3: REAR ELEVATION

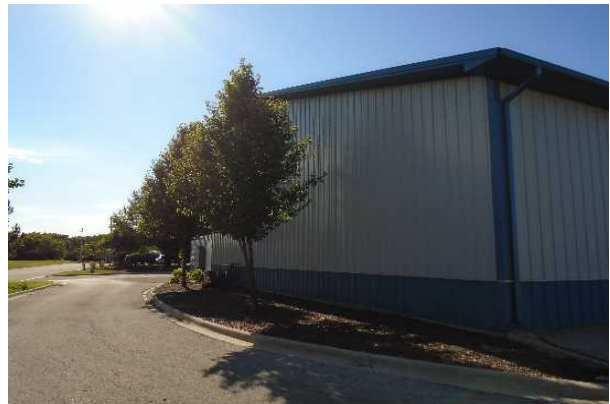
#4: RIGHT ELEVATION

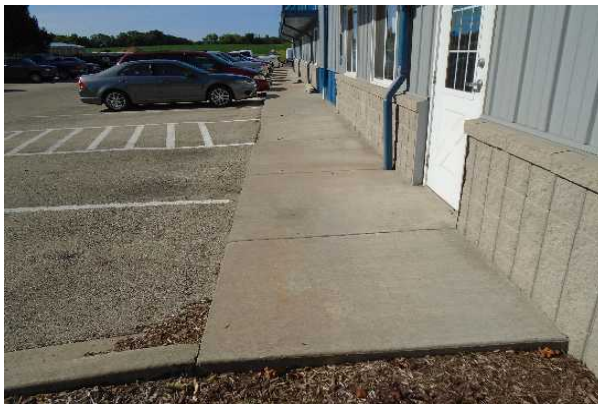
#5: SIDEWALK, CONCRETE

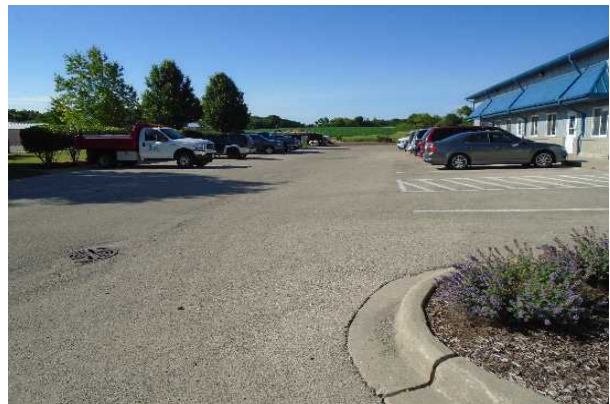
#6: ASPHALT PAVEMENT

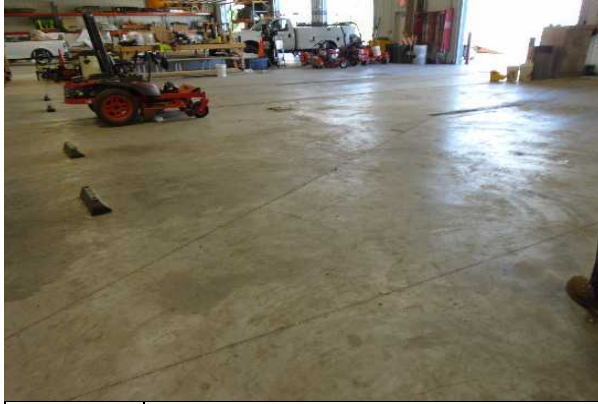
#7:

FOUNDATIONS, CONCRETE
SLAB-ON-GRADE

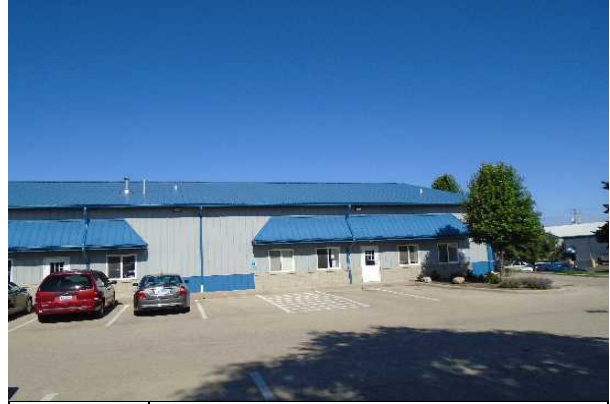
#8:

ROOF, METAL

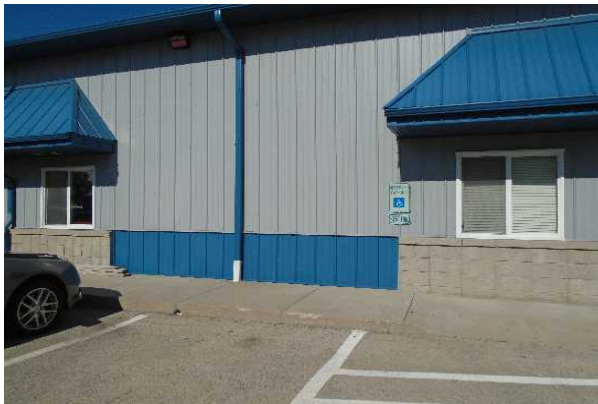
#9:

EXTERIOR WALL, ALUMINUM
SIDING

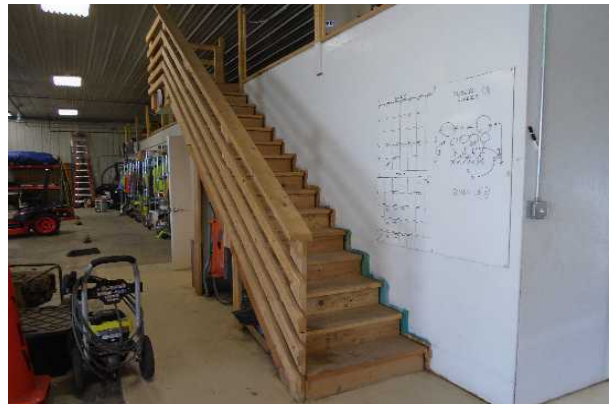
#10:

INTERIOR STAIR/RAMP RAILS,
WOOD

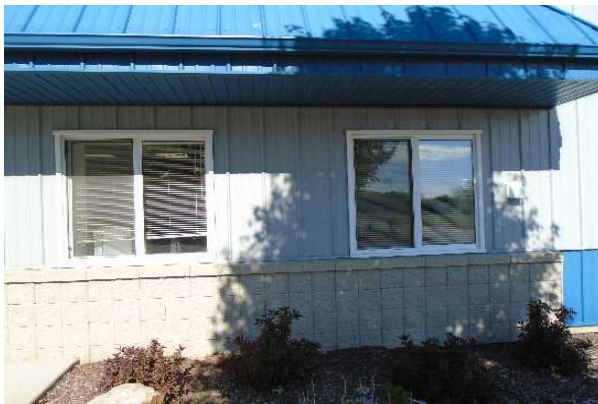
#11:

WINDOW, ALUMINUM DOUBLE-
GLAZED

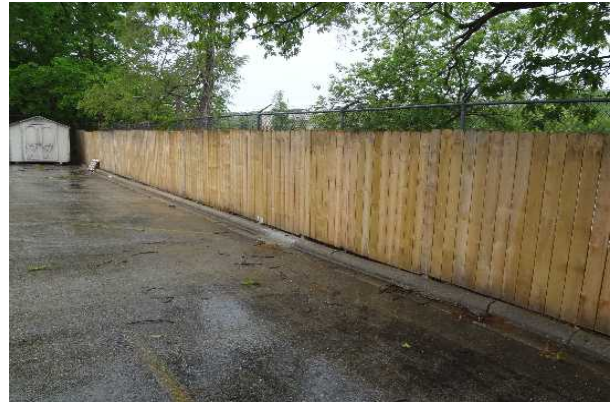
#8:

FENCES & GATES, WOOD
BOARD

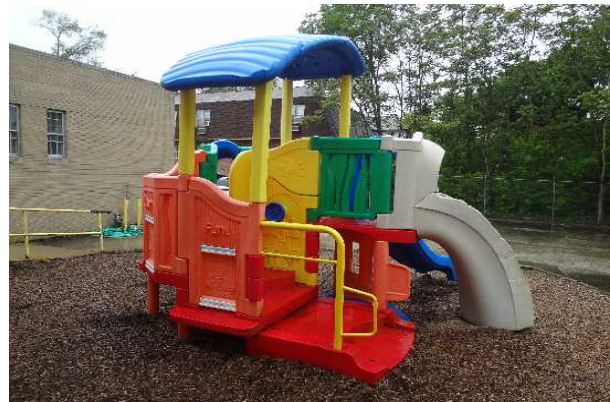
#10:

PLAY STRUCTURE, PRE-
SCHOOL

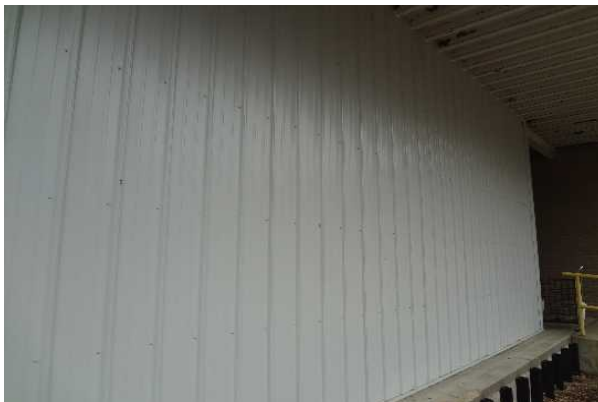
#11:

EXTERIOR WALL, ALUMINUM
SIDING

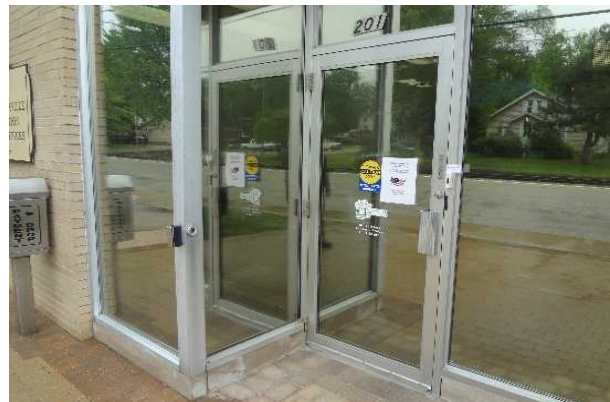
#12:

EXTERIOR DOOR, FULLY-
GLAZED ALUMINUM-FRAMED
SWINGING MOTOR-OPERATED

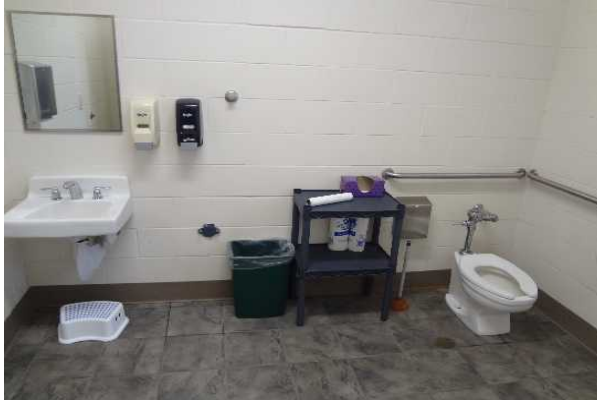
#19:

TOILET, TANKLESS (WATER CLOSET)

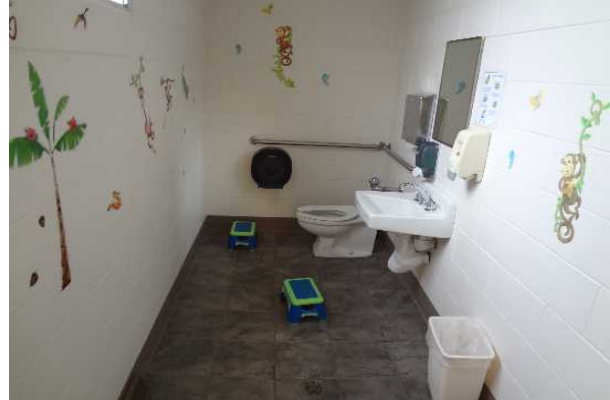
#20:

LAVATORY, VITREOUS CHINA

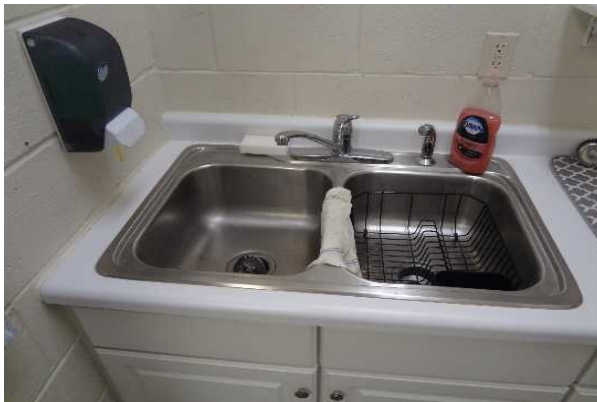
#21:

SINK, STAINLESS STEEL

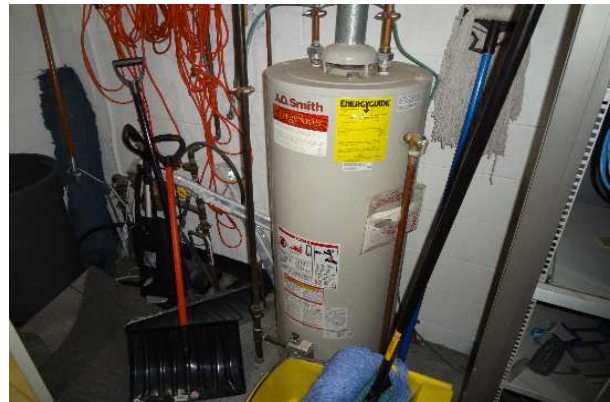
#22:

WATER HEATER, GAS

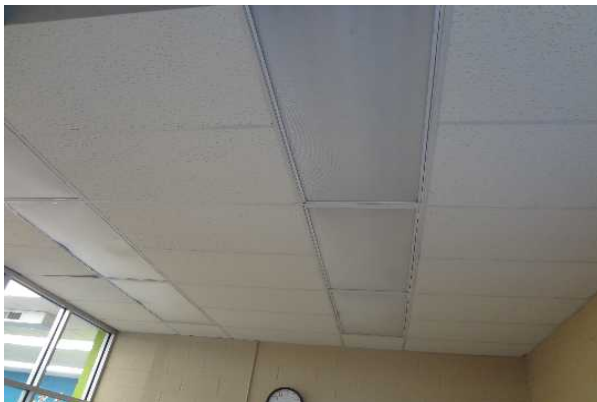
#23:

LIGHTING SYSTEM, INTERIOR

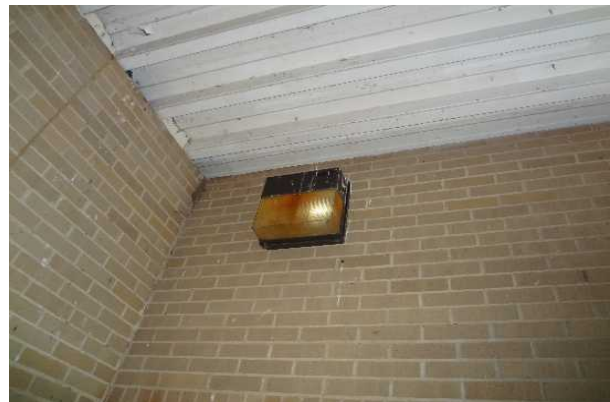
#24:

METAL HALIDE LIGHTING FIXTURE

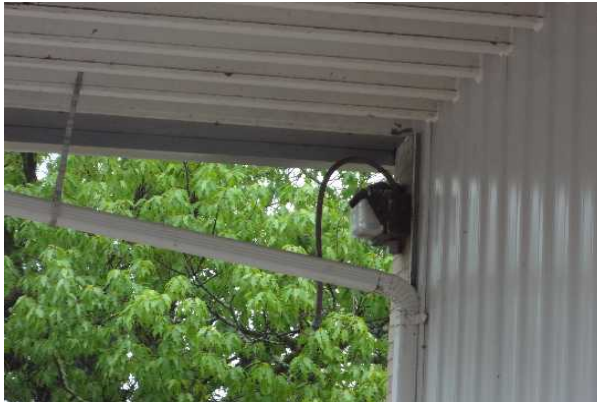
#25:

HIGH PRESSURE SODIUM
LIGHTING FIXTURE

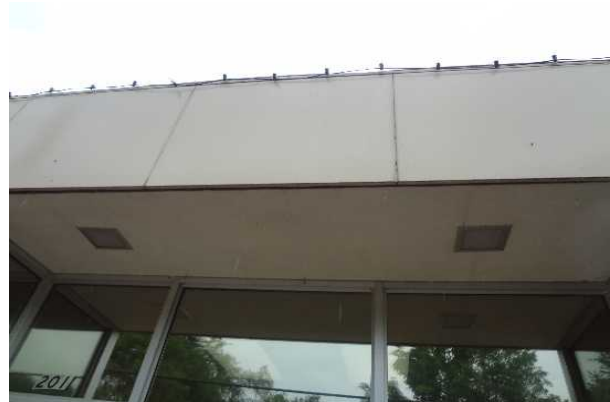
#26:

COMPACT FLUORESCENT
LIGHTING FIXTURE

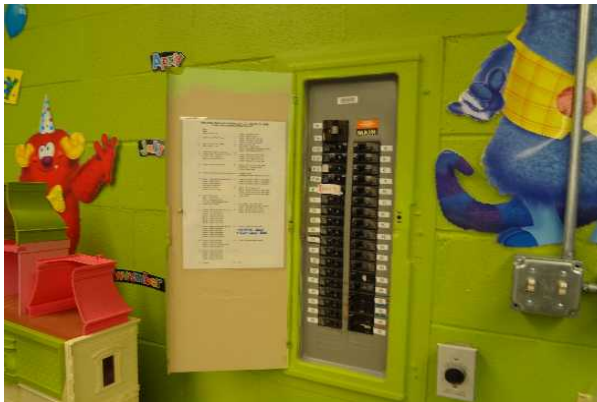
#27:

MAIN DISTRIBUTION PANEL

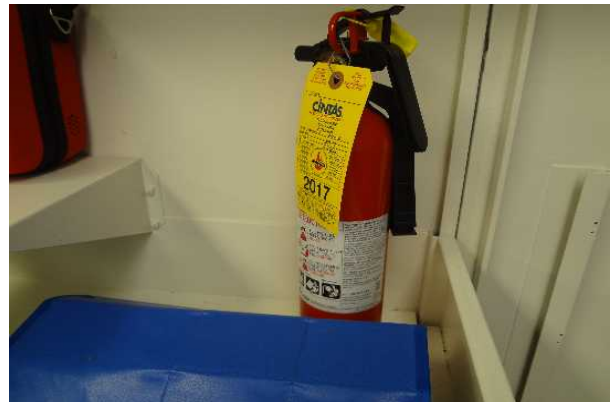
#28:

FIRE EXTINGUISHER

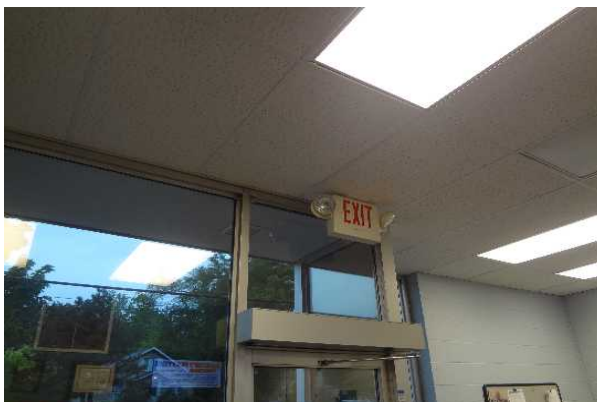
#29:

EMERGENCY/EXIT COMBO

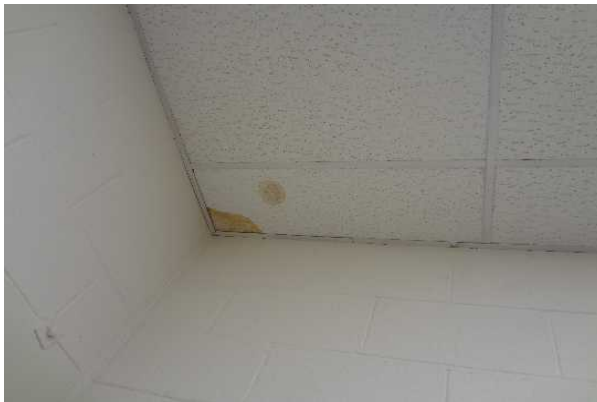
#39: STAINED ACOUSTICAL CEILING
TILE

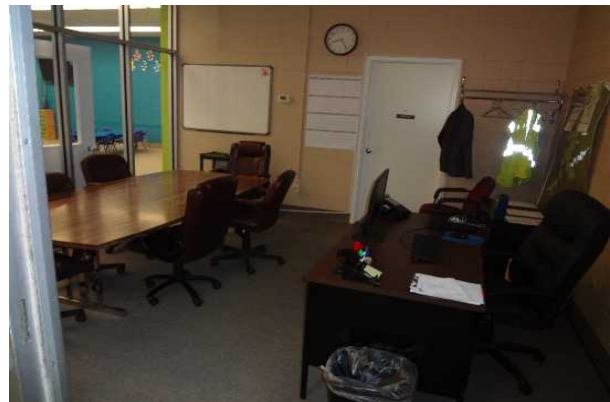
#42: INTERIOR FLOOR FINISH,
CARPET STANDARD-
COMMERCIAL MEDIUM-TRAFFIC

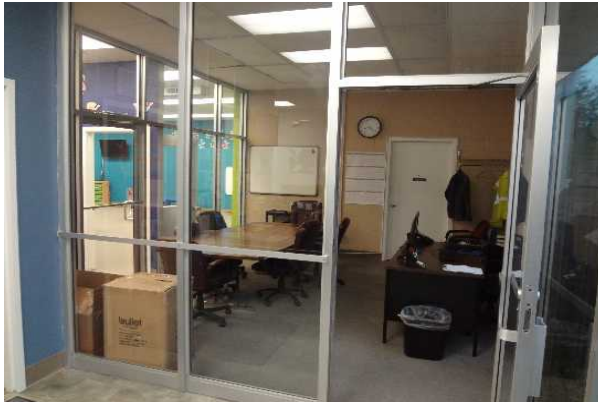
#43: INTERIOR WINDOW

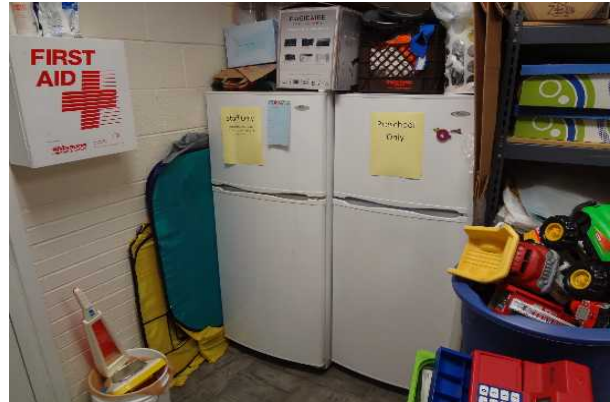
#44: RESIDENTIAL APPLIANCES,
REFRIGERATOR

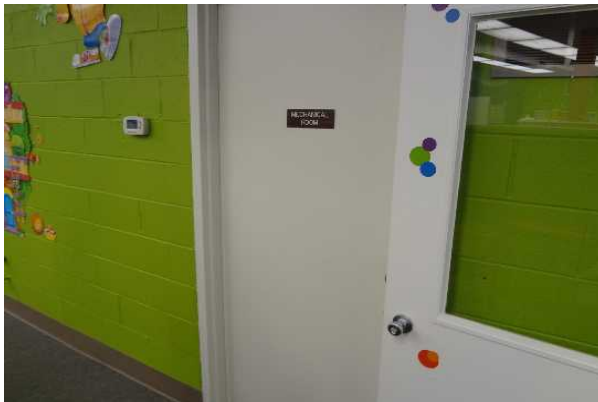
#45: INTERIOR DOOR, FIRE 90-
MINUTES AND OVER

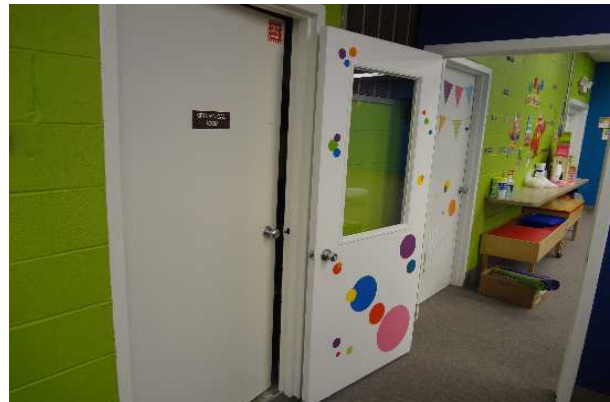
#46: INTERIOR DOOR, FULLY-GLAZED
WOOD-FRAMED

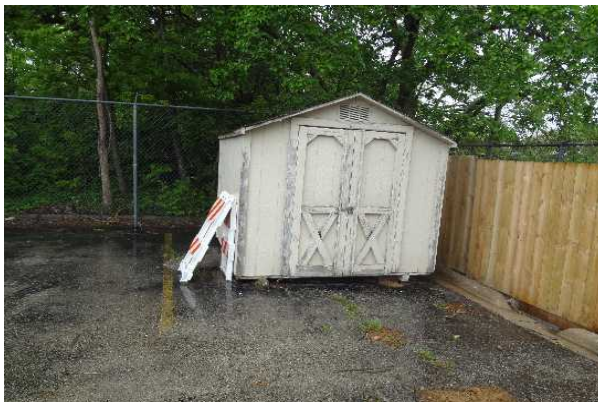
#47: STORAGE SHED

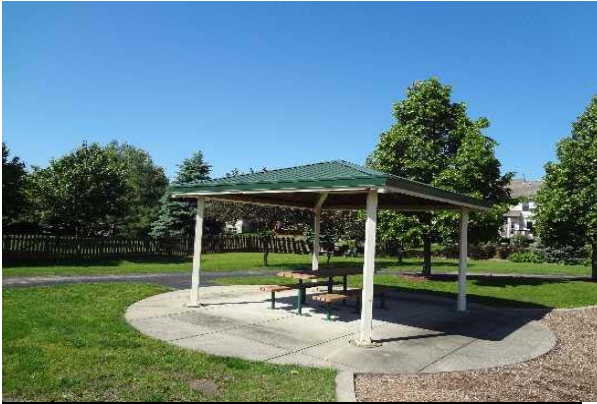
#1:	FRONT ELEVATION
-----	-----------------

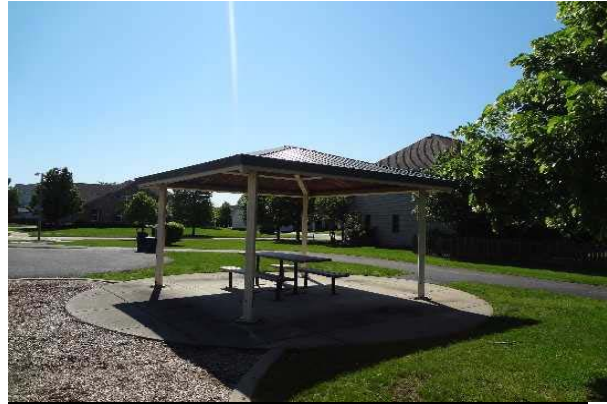
#2:	REAR ELEVATION
-----	----------------

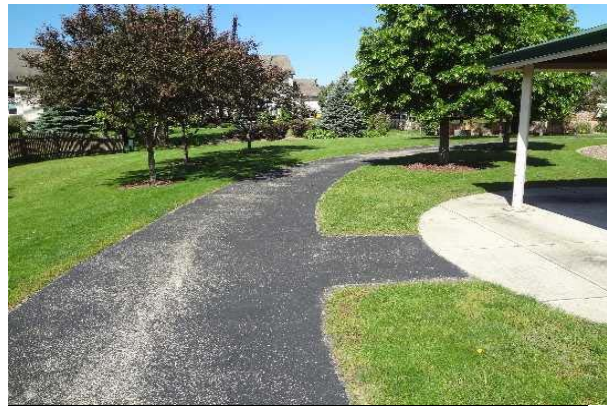
#4:	PEDESTRIAN PAVEMENT, SIDEWALK, ASPHALT
-----	---

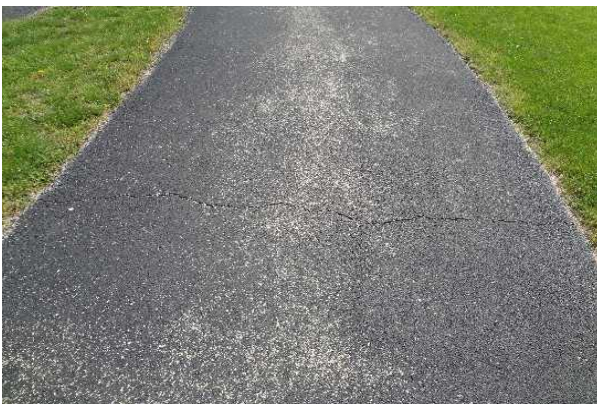
#5:	PEDESTRIAN PAVEMENT, MINOR CRACKING
-----	--

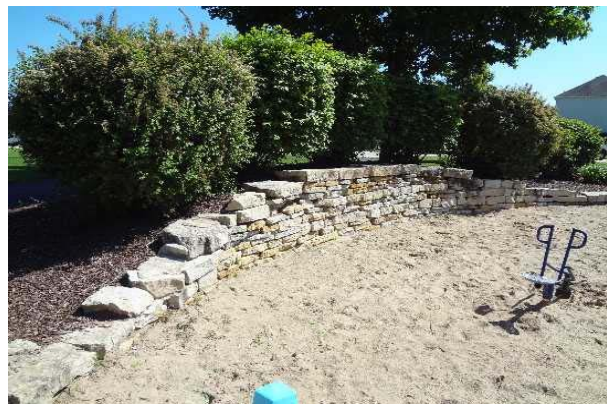
#6:	RETAINING WALL, BRICK/STONE
-----	--------------------------------

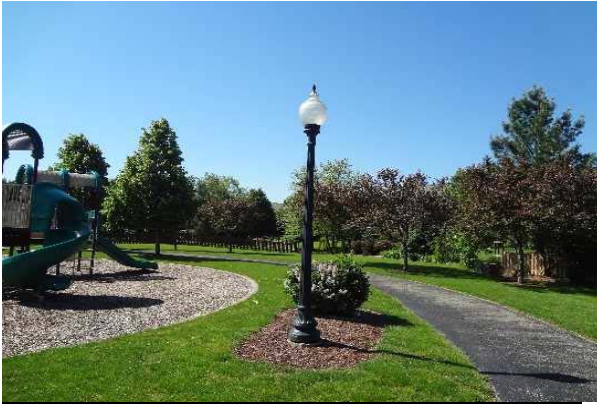
#7:	POLE LIGHT, EXTERIOR, DECORATIVE
-----	-------------------------------------

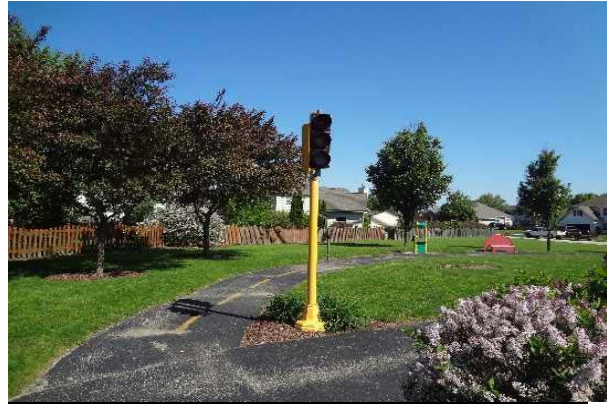
#8:	TRAFFIC LIGHT
-----	---------------

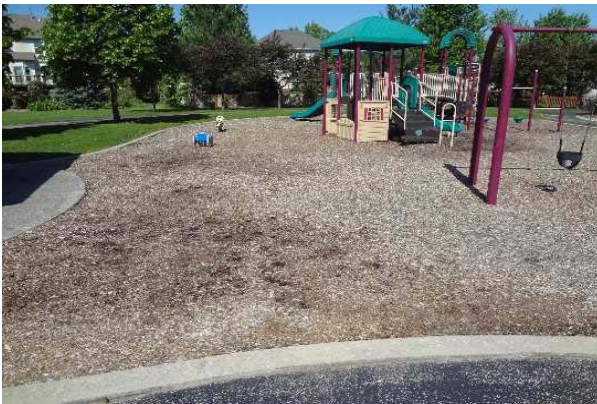
#9:	PLAY SURFACES, WOOD CHIPS
-----	---------------------------

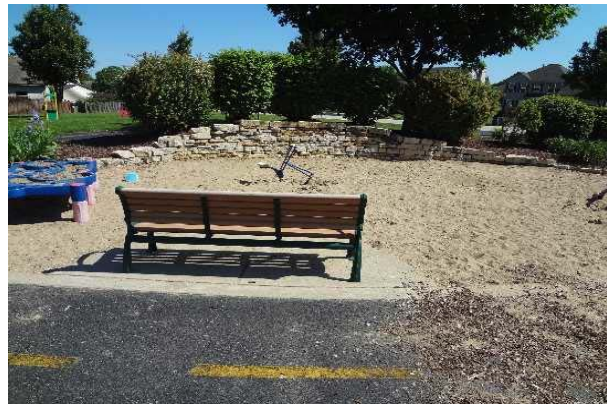
#10:	PLAY SURFACES, SAND
------	---------------------

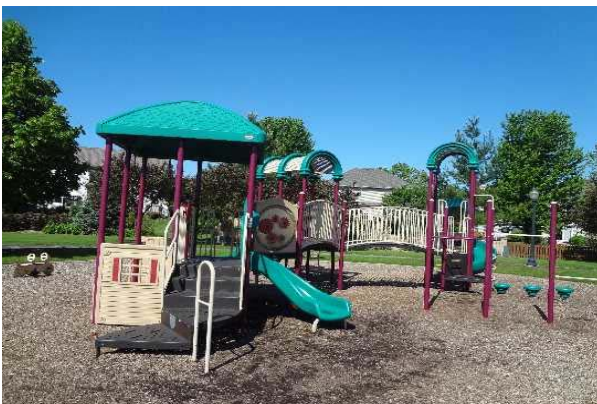
#11:	PLAY STRUCTURE, LARGE
------	-----------------------

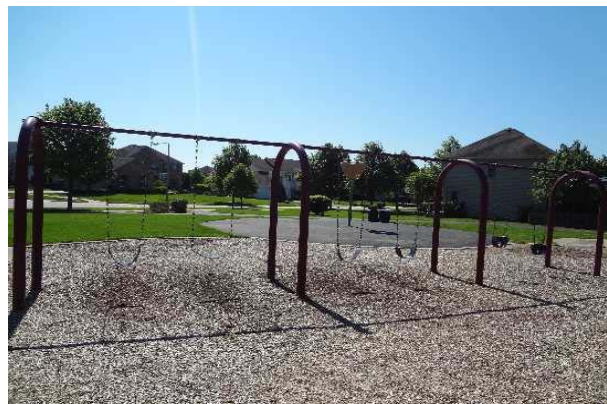
#12:	PLAY STRUCTURE, SWING SET
------	---------------------------

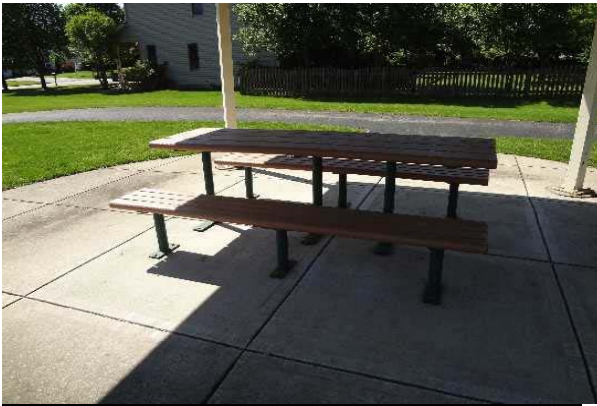
#13: PICNIC TABLE, COMPOSITE

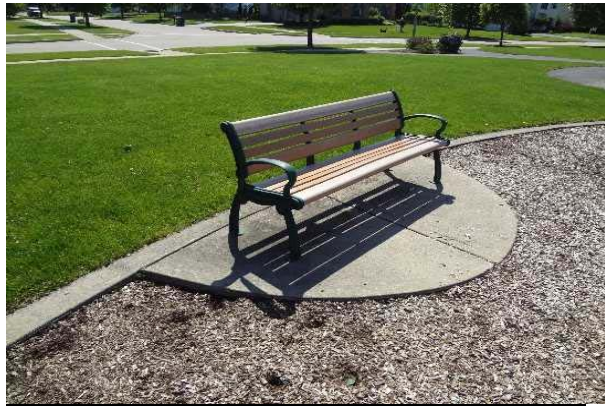
#14: PARK BENCH,
METAL/WOOD/PLASTIC

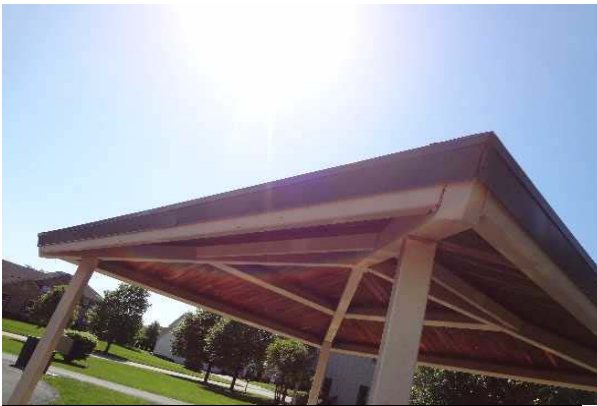
#15: STRUCTURAL FRAME, STEEL
COLUMNS & BEAMS

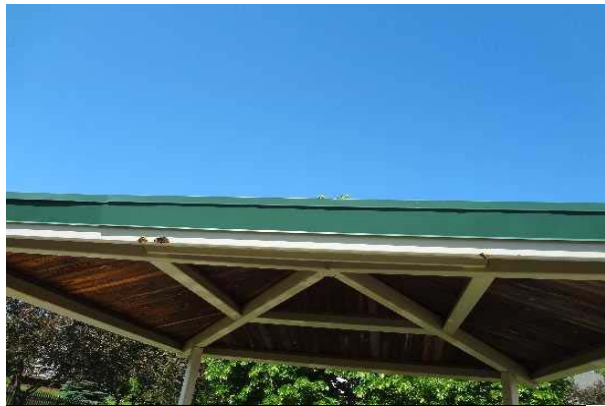
#16: CHIPPED PAINT AND
CORROSION

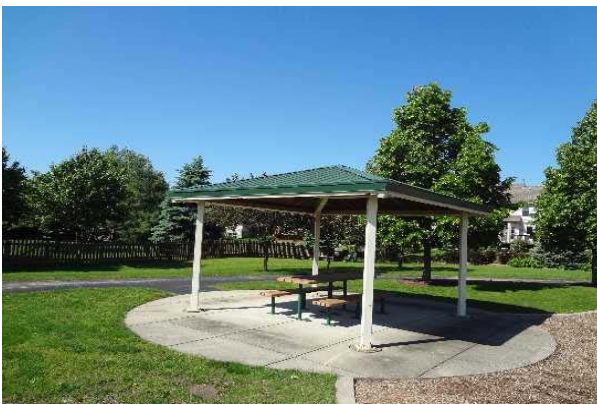
#17: ROOF, METAL

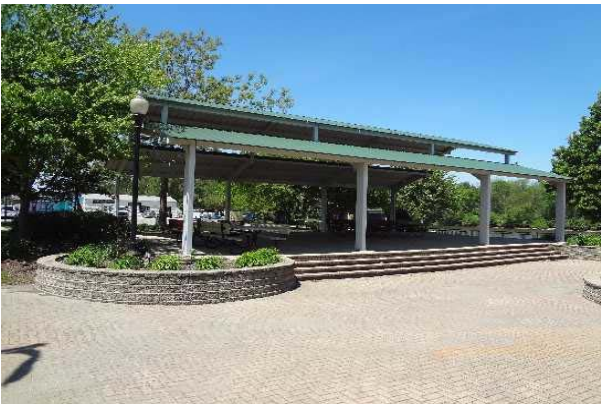
#1:	FRONT ELEVATION
-----	-----------------

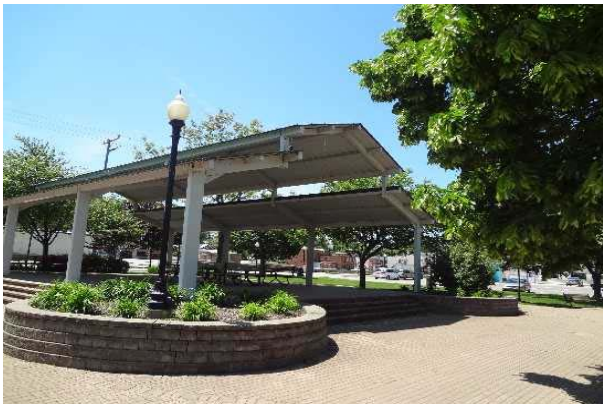
#2:	RIGHT ELEVATION
-----	-----------------

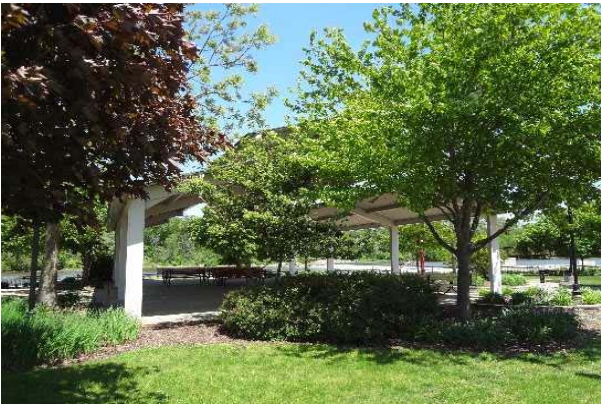
#3:	LEFT ELEVATION
-----	----------------

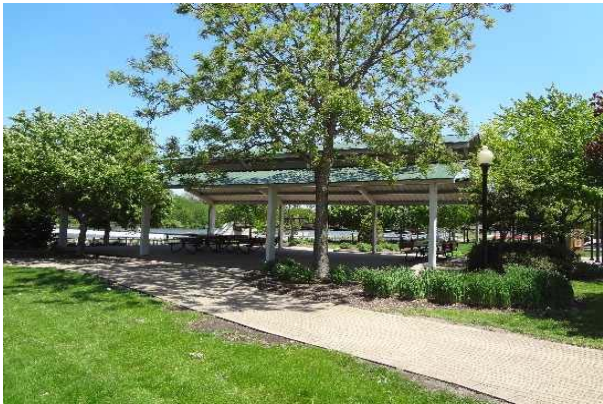
#4:	REAR ELEVATION
-----	----------------

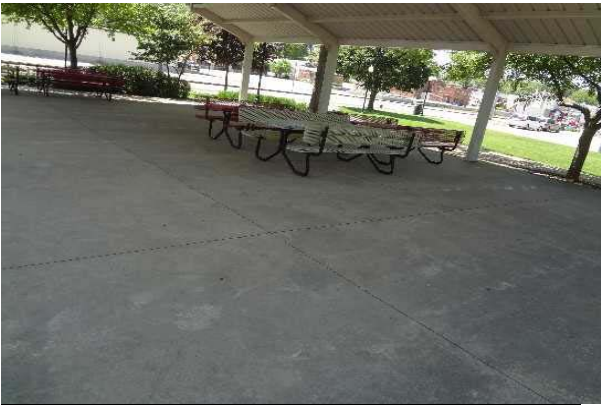
#5:	PEDESTRIAN PAVEMENT, SIDEWALK, CONCRETE
-----	--

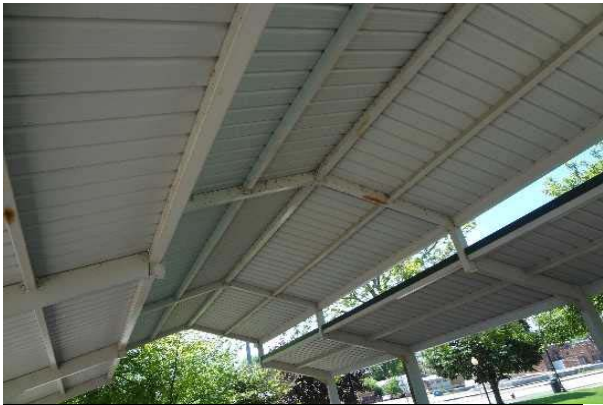
#6:	STRUCTURAL FRAME, STEEL COLUMNS & BEAMS
-----	--

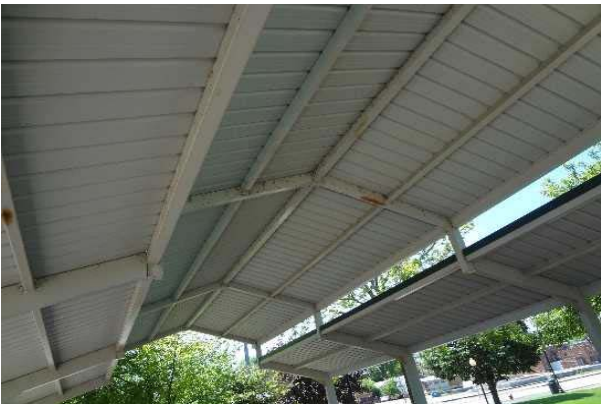
#7:	PAINTED SURFACES
-----	------------------

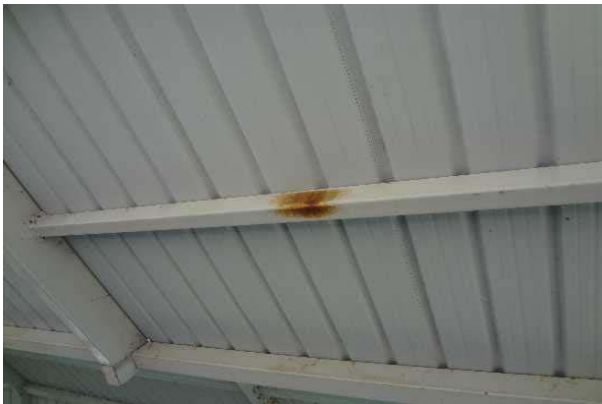
#8:	PAINTED SURFACE, SURFACE CORROSION
-----	------------------------------------

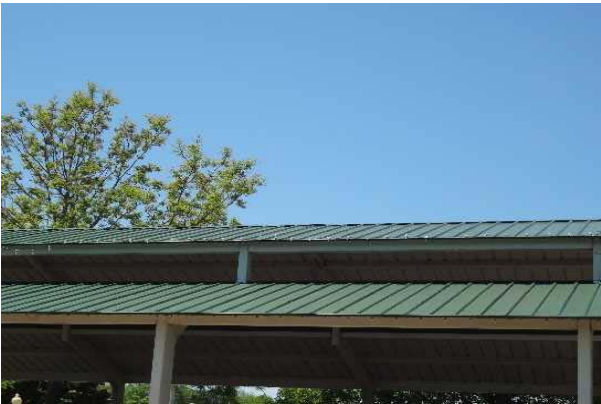
#9:	ROOF, METAL
-----	-------------

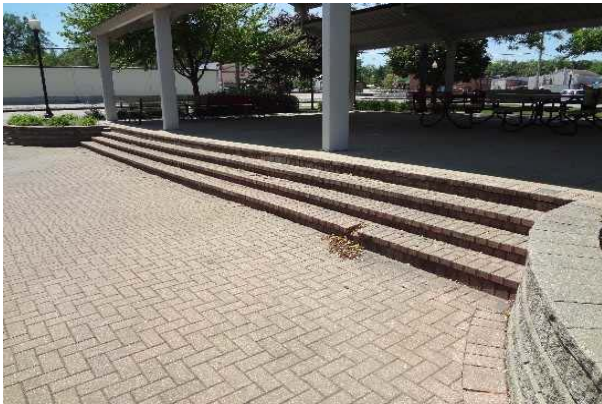
#10:	STAIRS, CLAY BRICK/MASONRY PAVERS
------	-----------------------------------

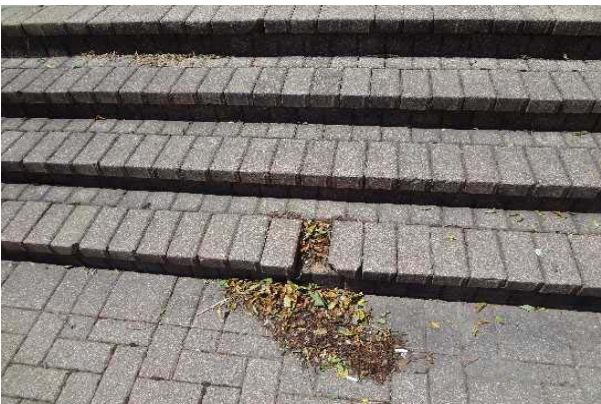
#11:	STAIR, MISSING BRICK
------	----------------------
