Title: Building Condition Reports 2017

Meeting and Date: Administration Committee - September 20, 2017

Synopsis: Discussion of the Preliminary Reports from the Building Condition Survey that
EMG performed on City-owned structures and facilities.

FACILITY CONDITION ASSESSMENT

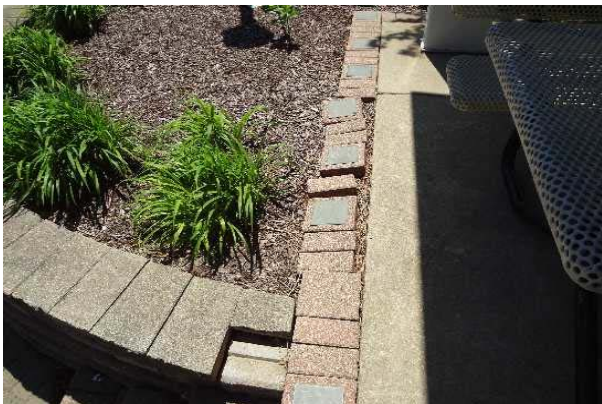
#12:	CLAY BRICK/MASONRY PAVERS, MISSING AND DISLODGED BRICKS
------	---

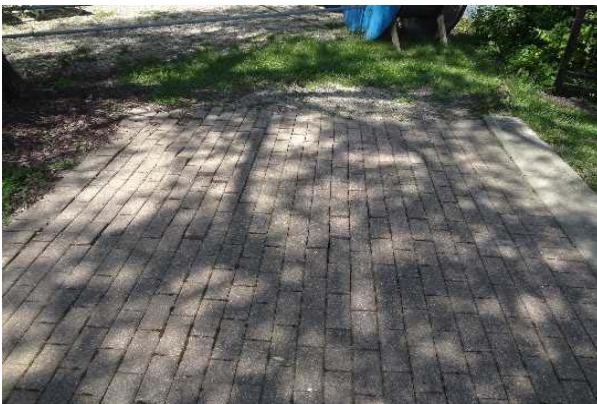
#5:	SIDEWALK, DISPLACED PAVERS
-----	-------------------------------

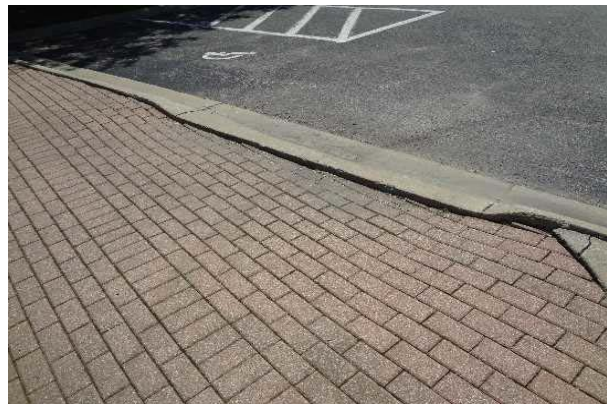
#6:	SIDEWALK, DEPRESSED PAVERS
-----	-------------------------------

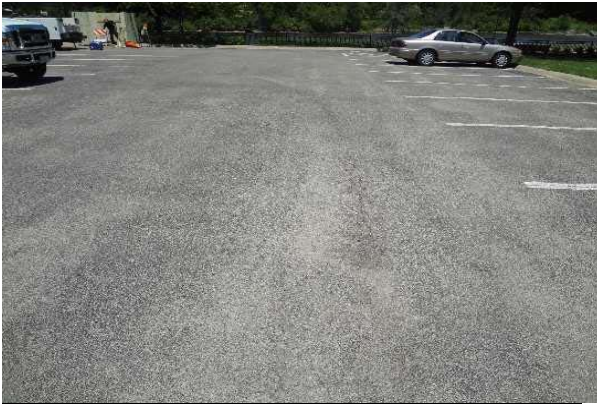
#7:	PARKING LOTS, ASPHALT PAVEMENT
-----	--------------------------------

- Parking lot seal and stripe
- Repair of concrete retaining wall

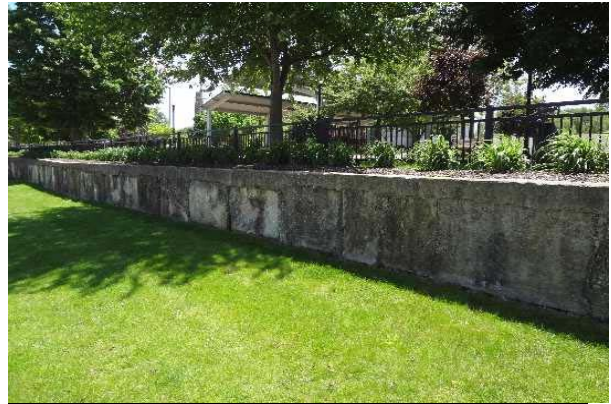
#8:	RETAINING WALL, CAST-IN-PLACE CONCRETE
-----	--

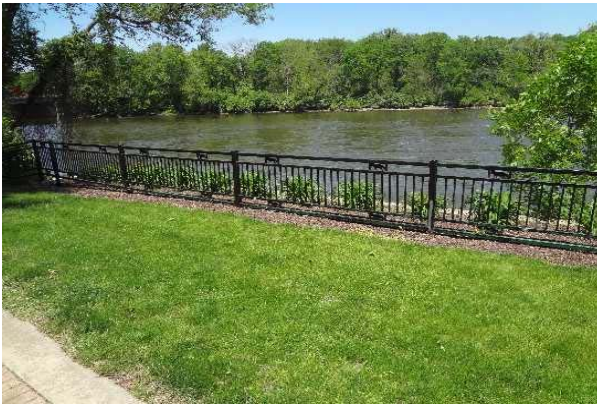
#15:	FENCES, WROUGHT IRON, 4' HIGH
------	-------------------------------

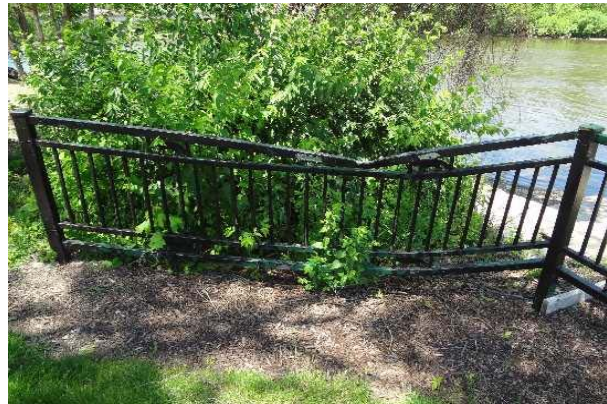
#16:	FENCES, DAMAGED
------	-----------------

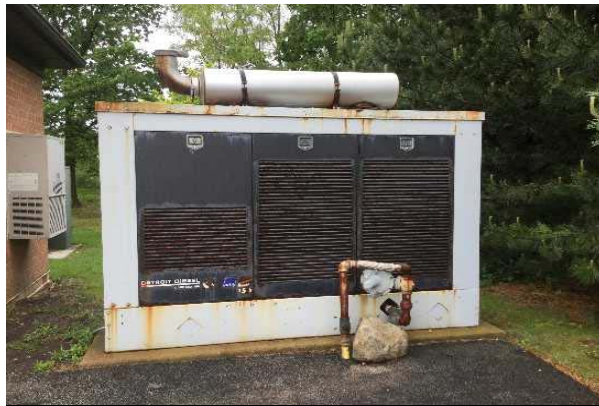
#13: GENERATOR, DIESEL

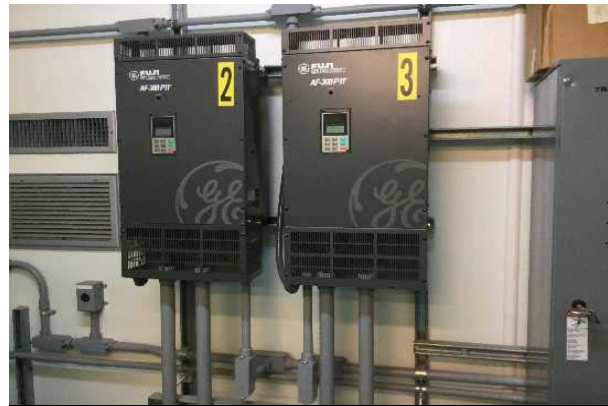
#14: VARIABLE FREQUENCY DRIVE (VFD)

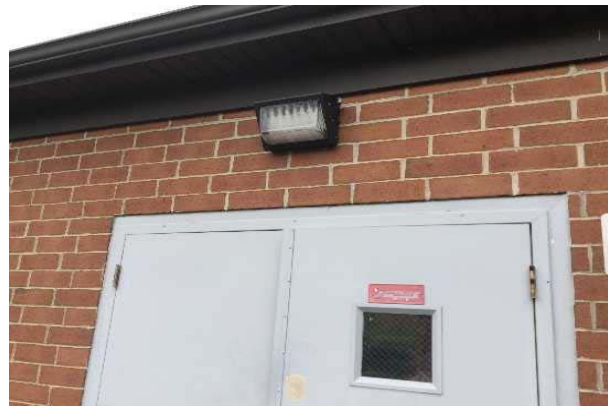
#16: HIGH PRESSURE SODIUM LIGHTING FIXTURE

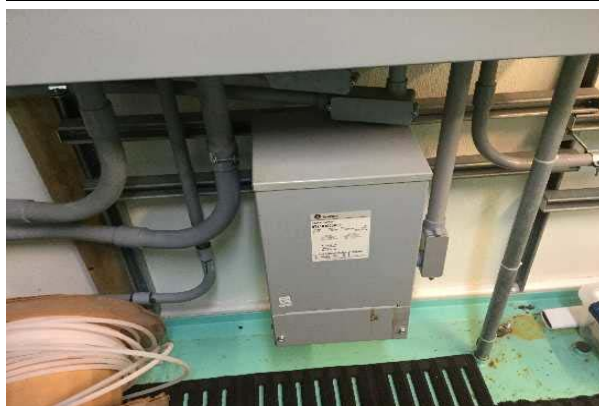
#17: SECONDARY TRANSFORMER, DRY

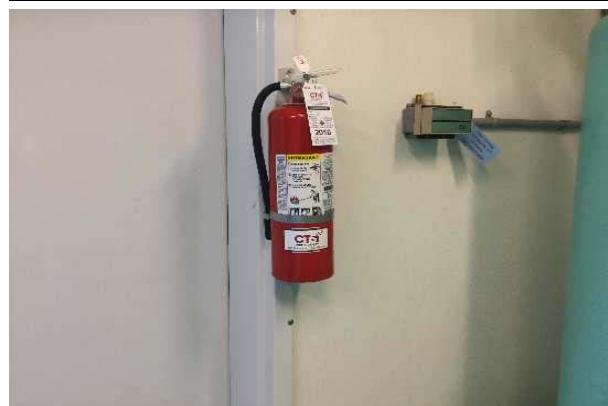
#18: FIRE EXTINGUISHER

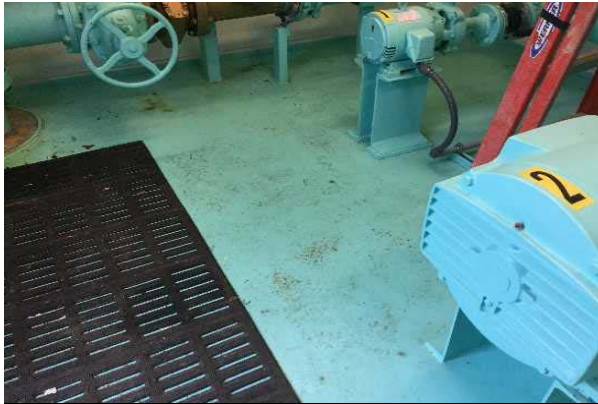
#19:

INTERIOR FLOOR FINISH,
CONCRETE

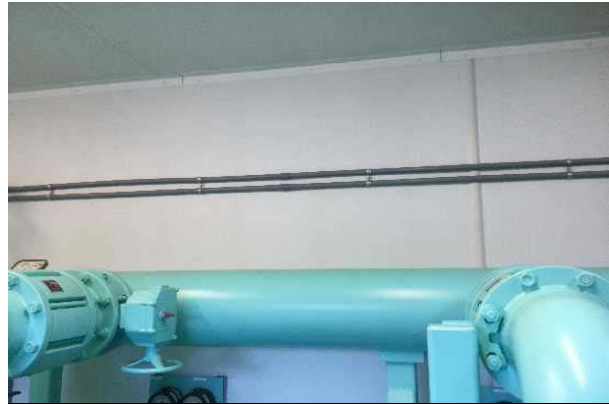
#20:

INTERIOR WALL FINISH,
GYPSUM BOARD

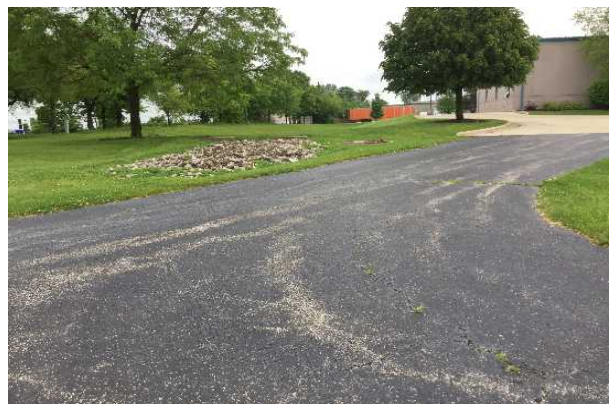
#6: PARKING LOT, ASPHALT PAVEMENT

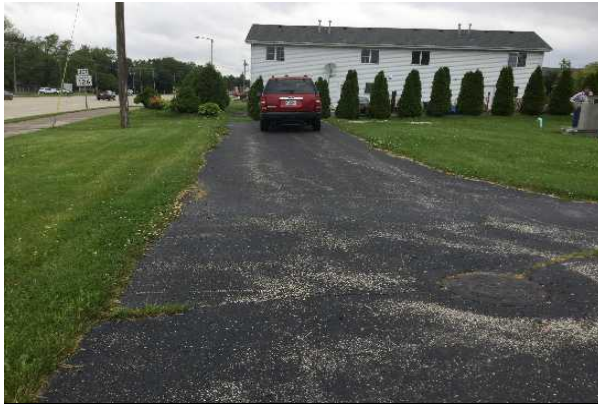
#7:

PARKING LOT, ASPHALT
PAVEMENT

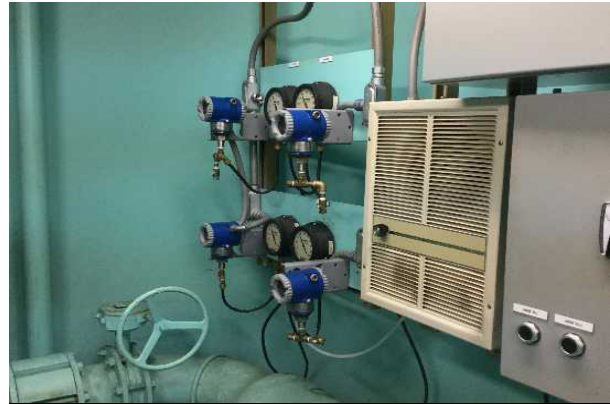
#8:

UNIT HEATER, ELECTRIC

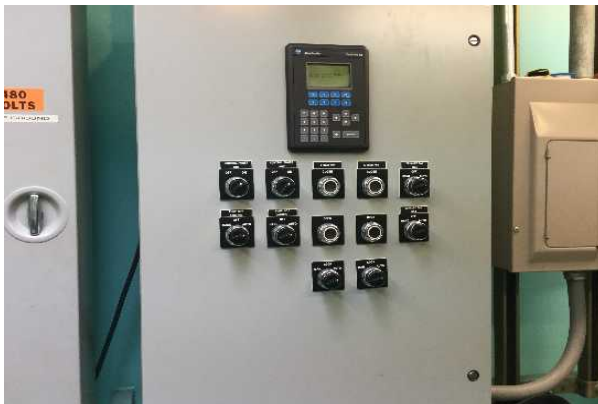
#9:

BUILDING AUTOMATION SYSTEM
(HVAC CONTROLS)

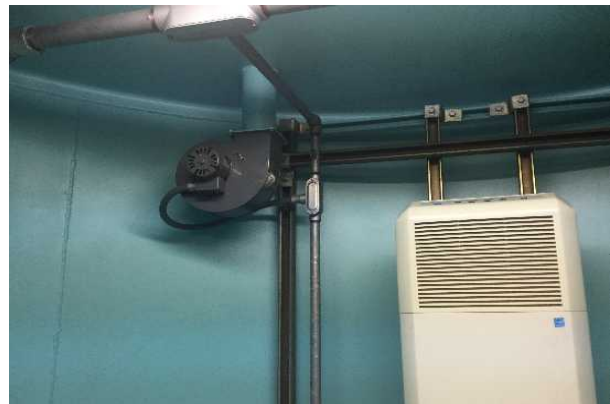
#10:

EXHAUST FAN, CENTRIFUGAL

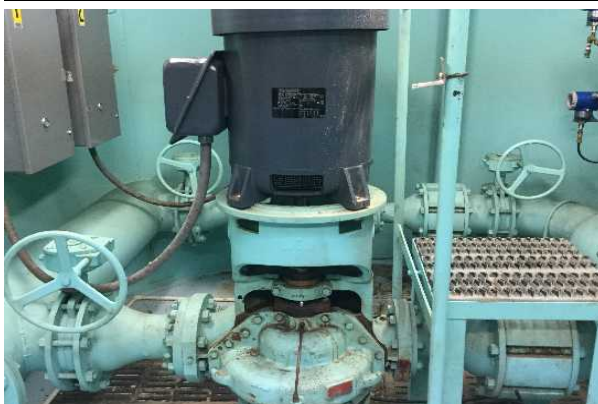
#11:

BOOSTER PUMP

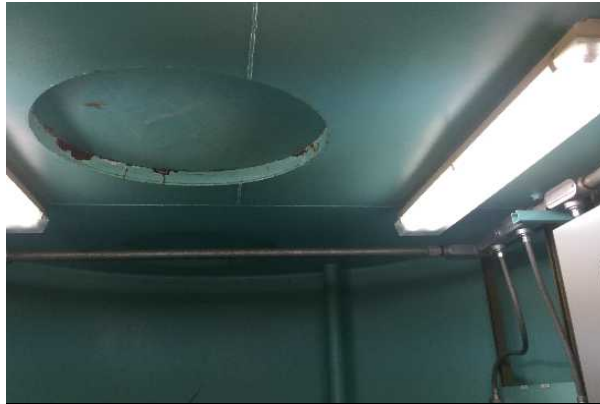
#13: LIGHTING SYSTEM, INTERIOR

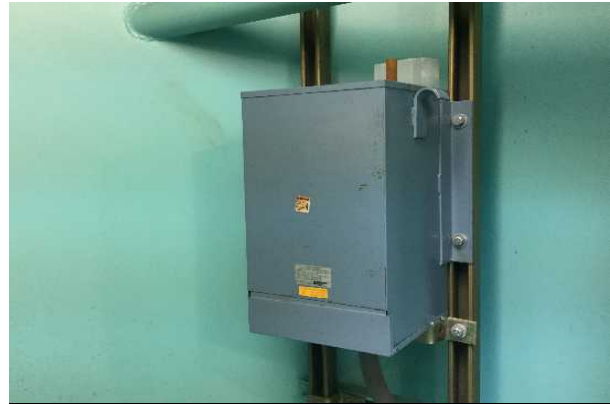
#14: SECONDARY TRANSFORMER, DRY

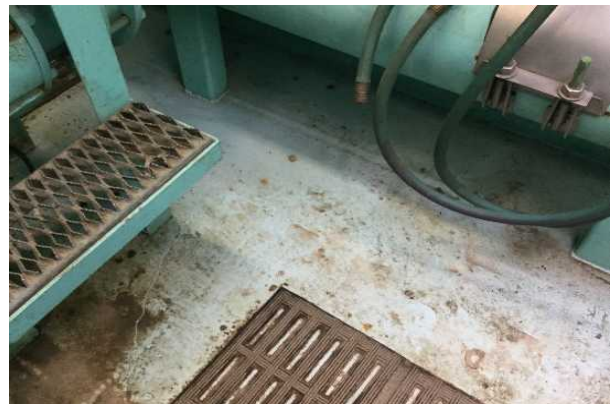
#16: INTERIOR FLOOR FINISH, CONCRETE

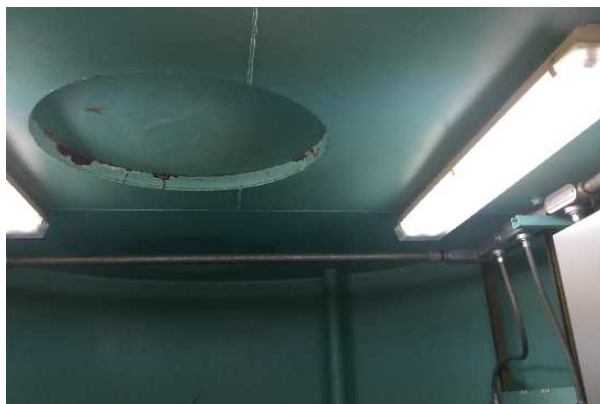
#17: INTERIOR CEILING FINISH, CONCRETE

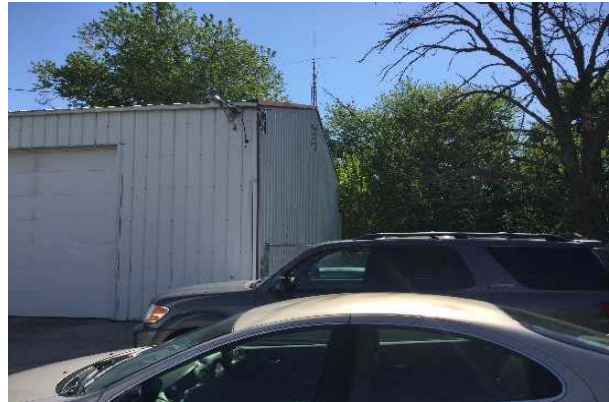
#8: RIGHT ELEVATION-GARAGE

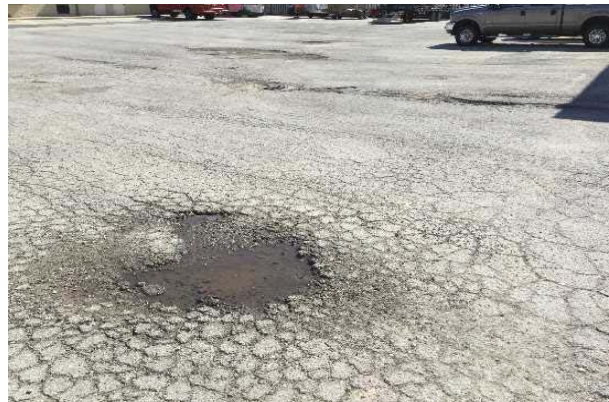
#10: PARKING LOTS, CRACKING IN ASPHALT

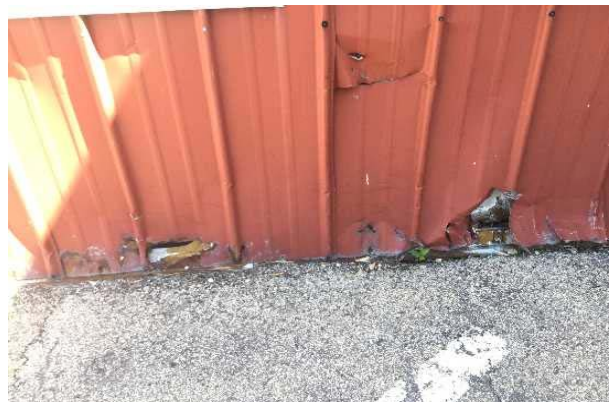
#18:

PUNCTURE AND CRACKING TO
ALUMINUM SIDING ON SOUTH
ELEVATION OF BUILDING

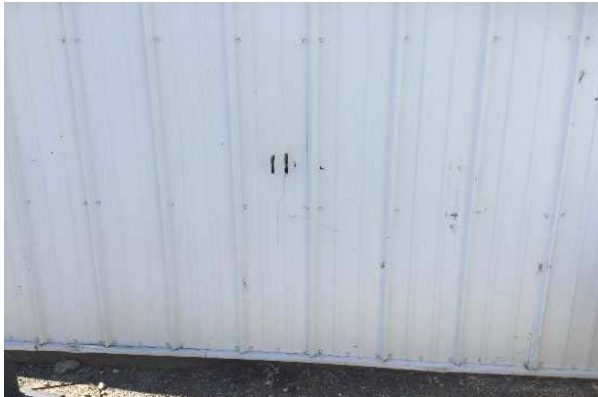
#19:

PUNCTURE TO ALUMINUM
SIDING ON NORTH ELEVATION
OF BUILDING

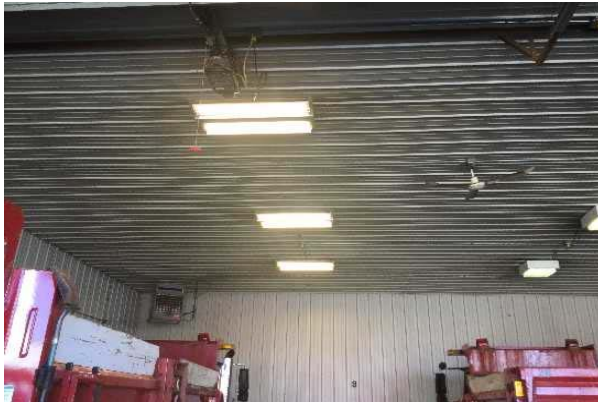
- The light fixtures throughout most of the facility utilize older, inefficient T-12 lamps. Replacement with newer fixtures with electronic ballasts and T-8 lamps is highly recommended to save substantial amounts of energy.

#40: HALOGEN LIGHTING FIXTURE

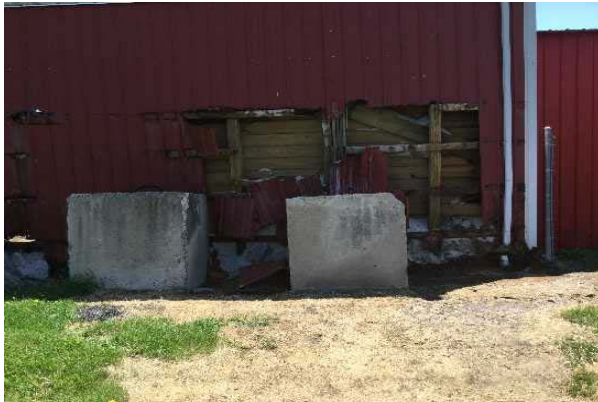
#7:

MISSING PIECES OF EXTERIOR
SIDING

- Full replacement of exterior metal siding

- Replace exterior metal siding

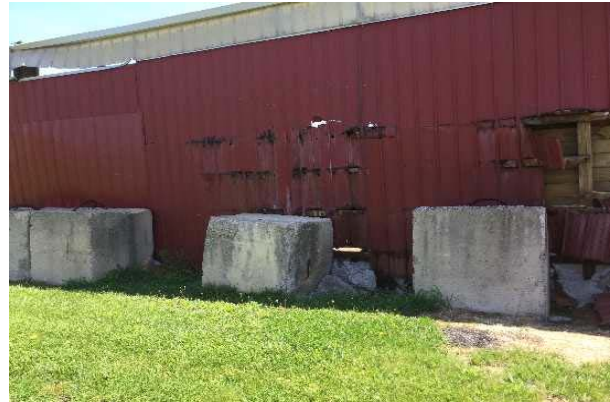
#8:

Additional Issues or Concerns That EMG Should Know About?	
1.	SIDING IS RUSTING AWAY. WOOD UNDER SIDING IS ROTTING
2.	
3.

DETERIORATED AND RUSTED
SIDING

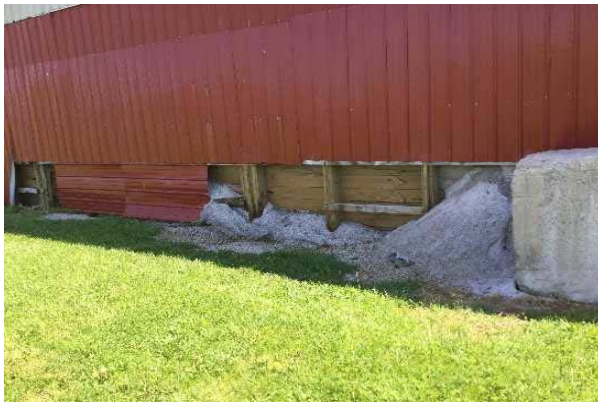
#9:

EXTERIOR WALL, ALUMINUM
SIDING

Location Name	EMG Renamed Item Number	ID	Cost Description	Quantity	Unit	Unit Cost	Subtotal	Deficiency Repair Estimate *
Salt Storage Building	6.4	612898	Exterior Wall, Aluminum Siding, Repair	2500	SF	\$8.67	\$21,687	\$21,687
Salt Storage Building		670822	Foundation, , Repair/Replace	100	LF	\$105.56	\$10,556	\$10,556
Immediate Repairs Total								\$32,243

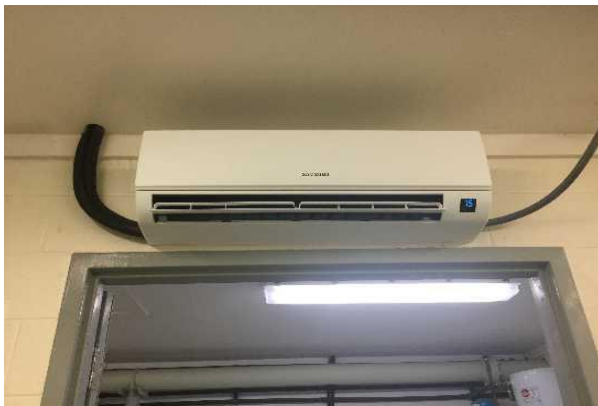
#15: DUCTLESS SPLIT SYSTEM, SINGLE ZONE
